Infiltration Trench Inspection Report					
Facility Name	Fairview Riverdale	Facility ID	STMF0090080	Type of Inspection: Initial Inspection	
Location	Lat: 38.747968 Long: -77.460524	Watershed	Lower Bull Run	Previous 48 Hour Precipitation Total	0.35"
Materials available for inspection	N/A	Owner Notification Date	N/A	Owners/ Owner's Representative	City of Manassas
Inspectors	gky_mfreeman	Date of Inspection	6/28/2023	Date of Last Inspection	3/29/2022
Overall Condition Score					
	1	Adequate	No deficiencies identified.		
	2	Monitor	No maintenance may be needed at the time, but might become an issue in the future. Will revisit next inspection. Examples include minor erosion, small sediment accumulation, or small structural issues of facility components.		
	3	Routine Maintenance Needed	Facility is functional but preventative maintenance is required. Examples includes vegetation management, minor erosion, or trash/debris removal.

Facility ID: STMF0090080
Facility Name: Fairview Riverdale

Inspection Date: 06/28/2023

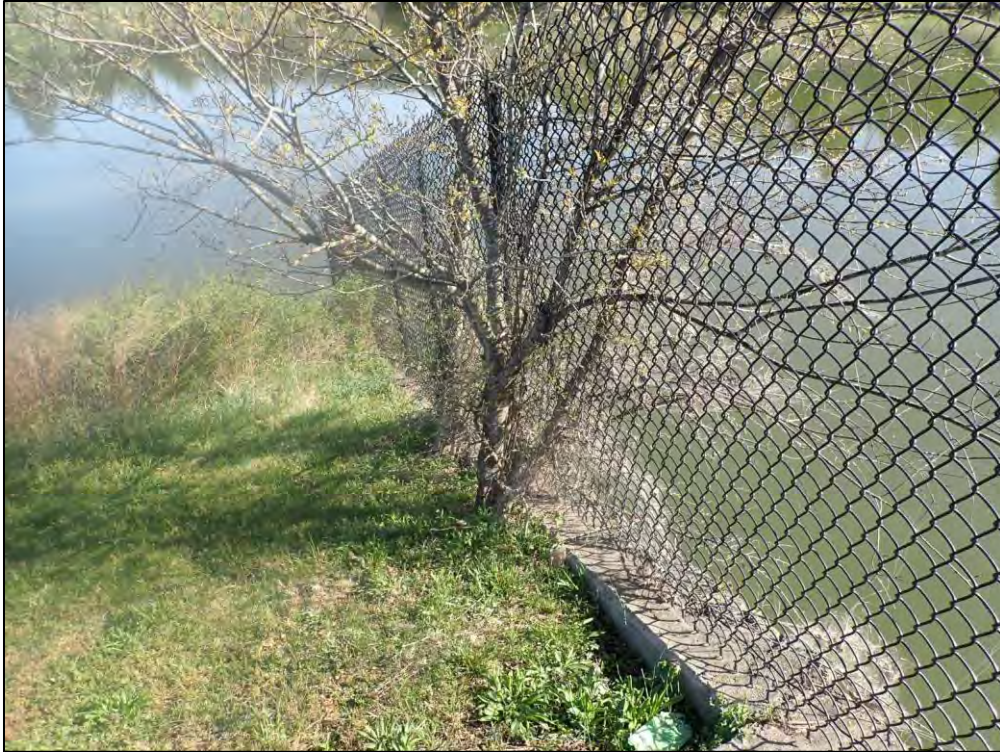
Score	Description	Comment(s) / Corrective Action(s)	Reference Image
Dam Embankment (Includes emergency spillway if applicable)			
3	Woody vegetation on embankment	Trees observed growing on the dam (1, 2-6" tree and 4, 7-12" trees).	2734, 2737
1	Shrubbery, low growing vegetation, and/or vine material growing on embankment		
1	Sparse vegetative coverage		
1	Signs of erosion, settlement, piping, or slope slippage		
1	Signs of seepage, soft spots, and sinkhole formation		
1	Evidence of nuisance animals		
1	Buildup of trash or debris on embankment		
1	Trash, debris, or obstructions in emergency spillway		
Outlet/Riser Structure			
1	Low-flow orifice is blocked		
1	BMP device is deteriorated, misaligned, and/or damaged		
1	BMP device is missing		
1	Low-level gate drain is accessible and operational. Drain has been exercised in last three years.		
1	Trash, debris, or other material in BMP device		
Principal Spillway Pipe

2737: Dam, closeup. Woody vegetation on the embankment (Routine Maintenance Needed).

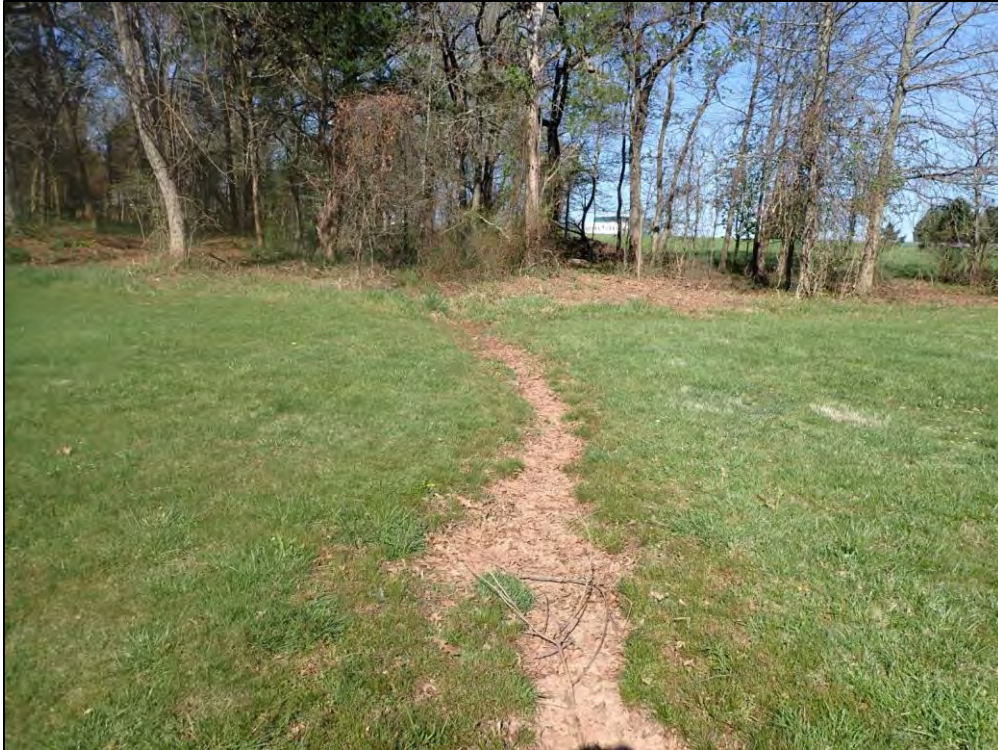
2739: Looking upstream along Inflow 1. Evidence of erosion or undermining around inlet (Routine Maintenance Needed).

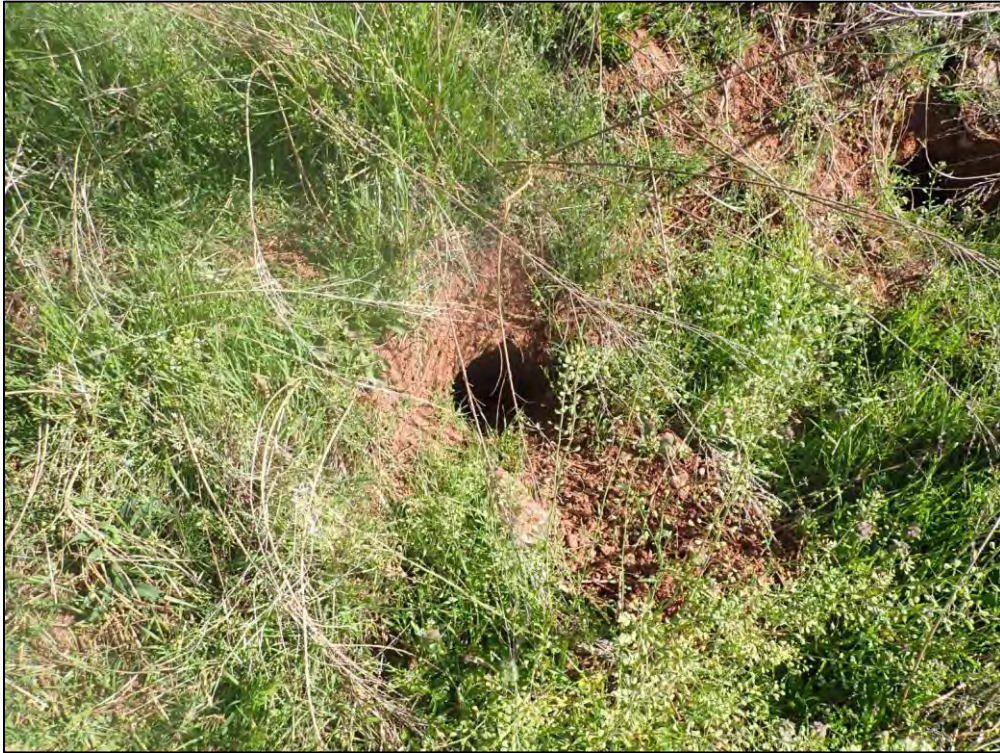
2745: Animal Hole 1, overall. Evidence of nuisance animals (Routine Maintenance Needed).

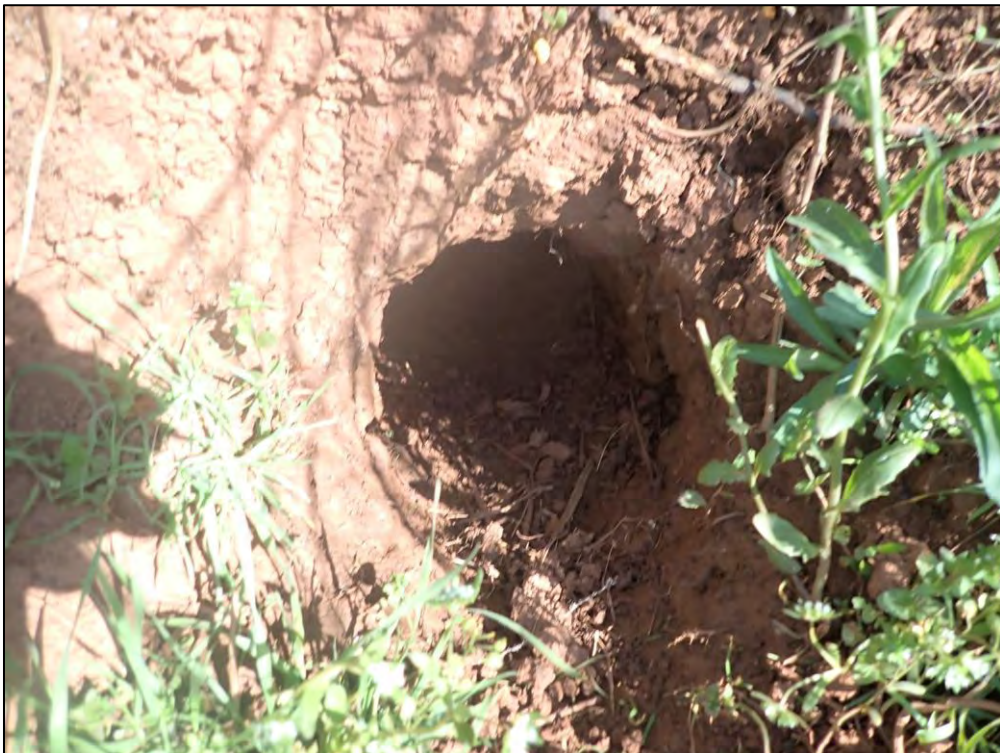
2746: Animal Hole 1, closeup. Evidence of nuisance animals (Routine Maintenance Needed).

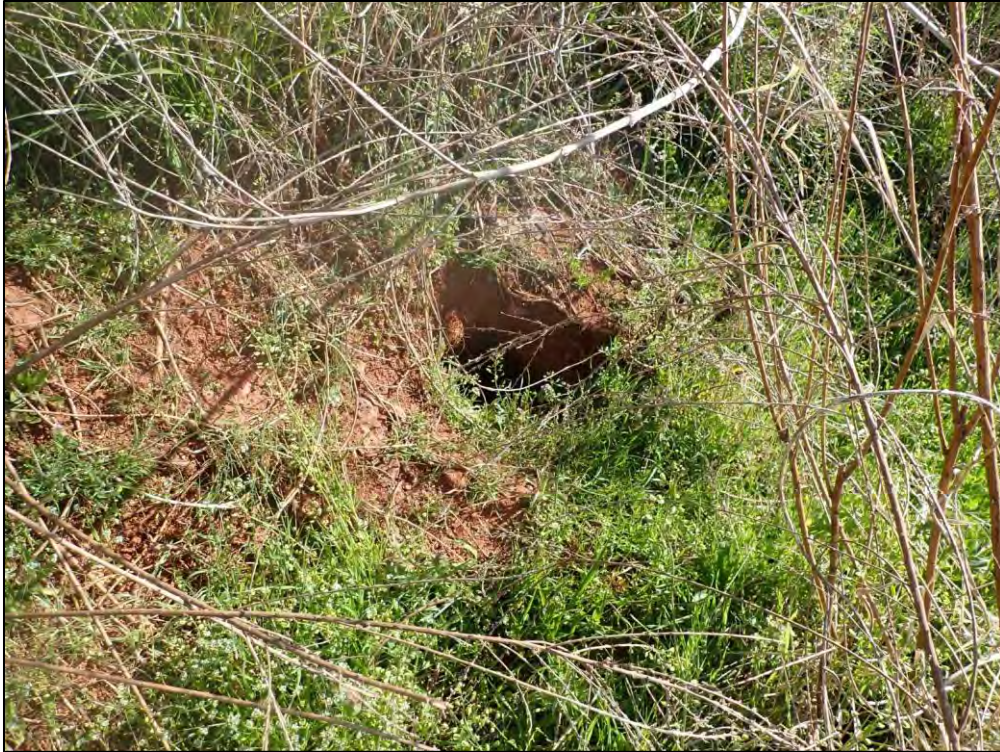
2747: Animal Hole 2, overall. Evidence of nuisance animals (Routine Maintenance Needed).

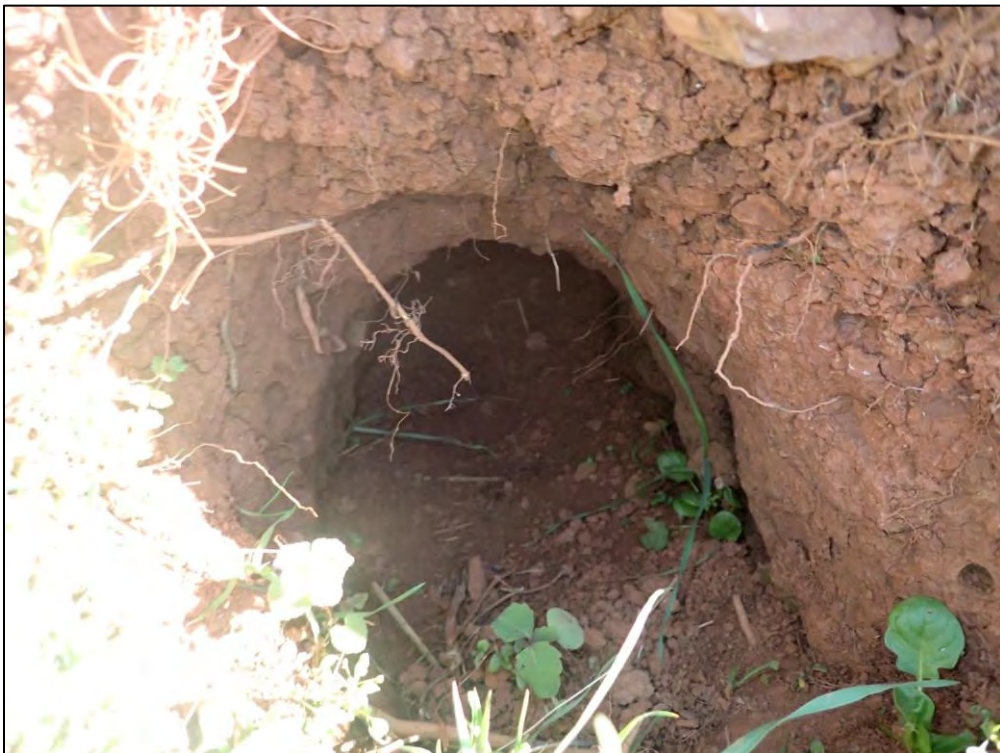
2748: Animal Hole 2, closeup. Evidence of nuisance animals (Routine Maintenance Needed).

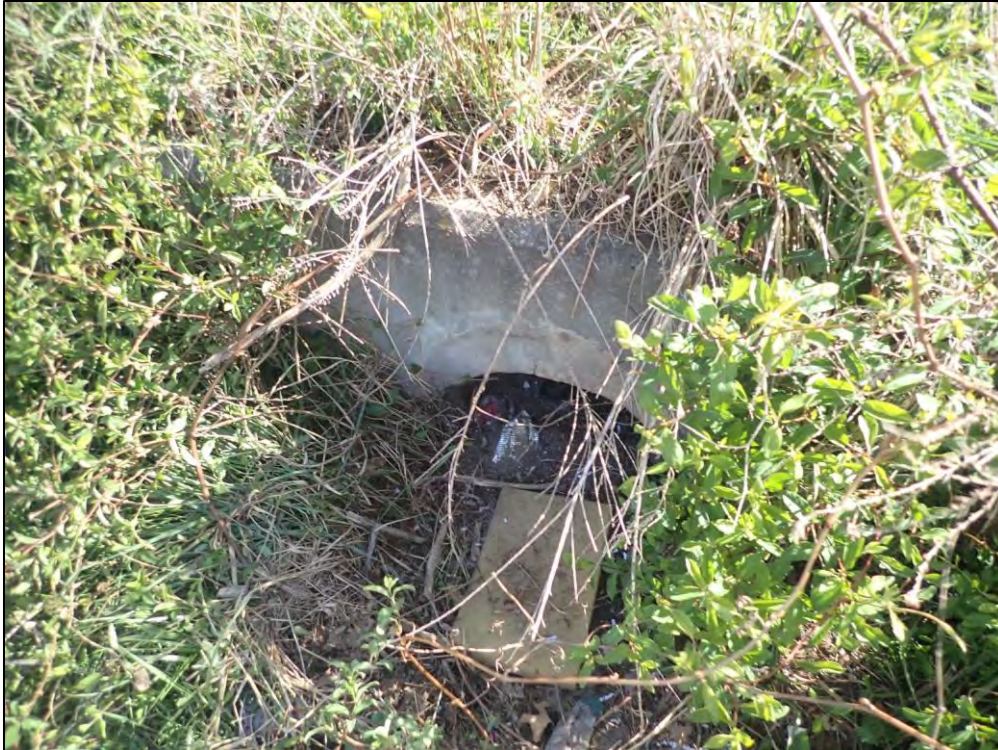
1	Vegetation does not match original design				
Inlet					
3	Buildup of trash, debris, and sediment		Trash, debris, and sediment accumulation at Inflow 4 (12 Cubic Feet).	2754, 2755	
3	Evidence of erosion or undermining around inlet		Erosion was noted upstream of Inflow 1 (2.7 CY). Stabilize the area (150 SQ FT).	2739	
1	Woody growth around inlet structure				
1	Evidence of nuisance animals				
1	Damage to inlet pipe or structure

2754: Inflow 4, front. Buildup of trash, debris, and sediment (Routine Maintenance Needed). Woody growth around inlet structure, Non-woody overgrown veg. (Routine Maintenance Needed).

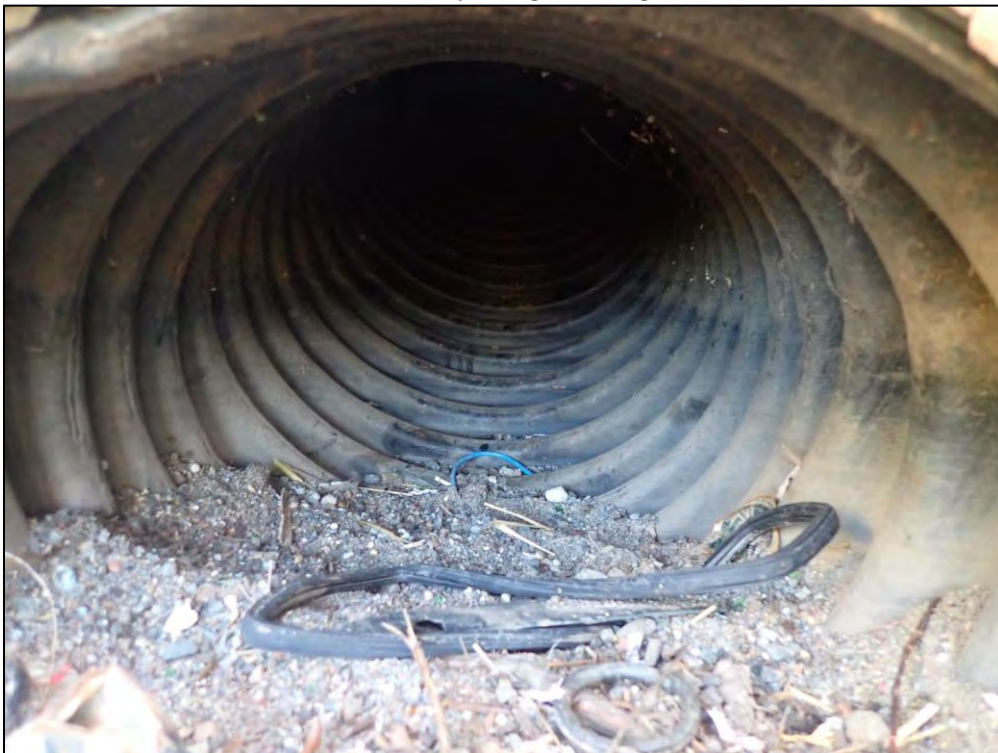
2755: Inside Inflow 4. Buildup of trash, debris, and sediment (Routine Maintenance Needed). Woody growth around inlet structure, Non-woody overgrown veg. (Routine Maintenance Needed).

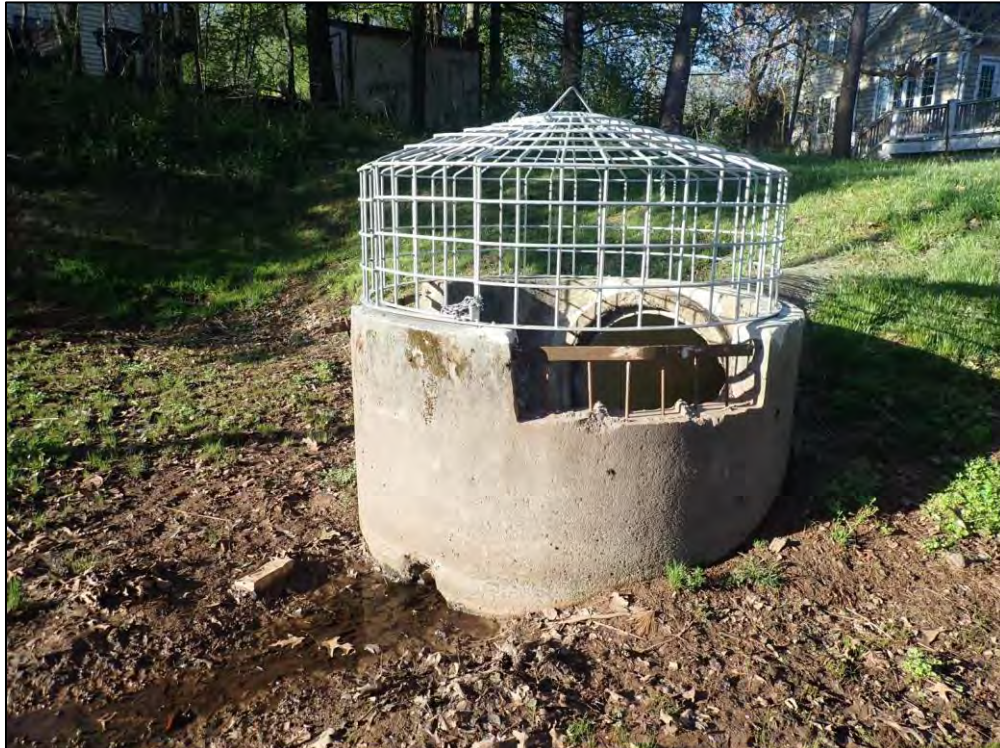
9262: Control Structure B2, front. Buildup of trash, debris, and sediment (Routine Maintenance Needed).

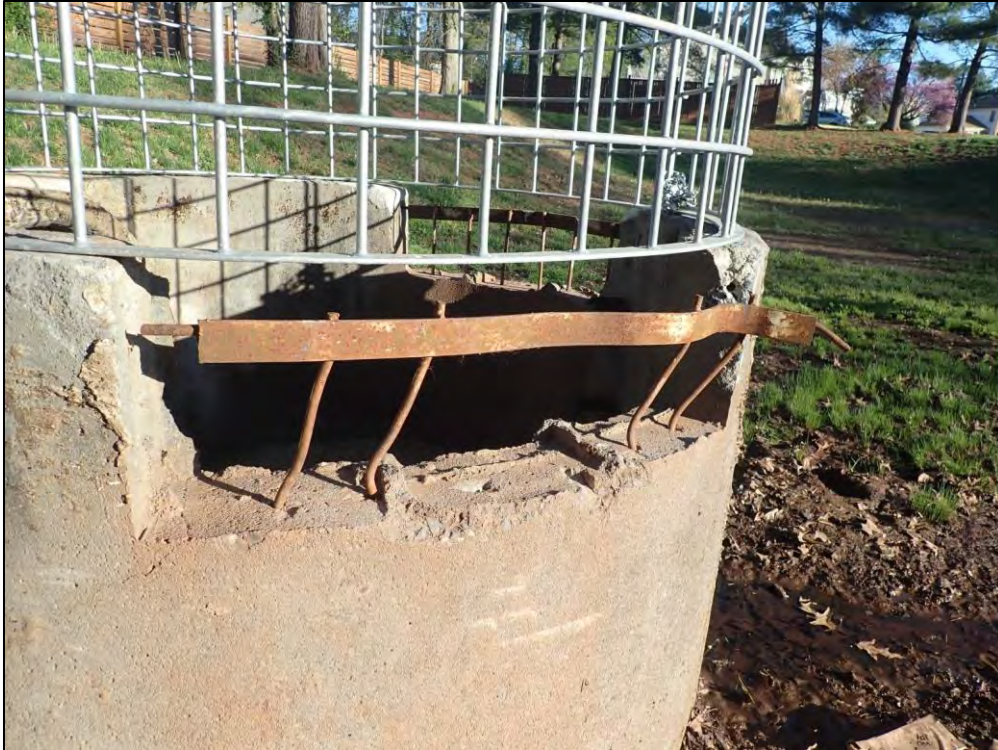
9265: Control Structure B2, Southern upper orifice close-up. Damage to trash rack. (Routine Maintenance Needed).

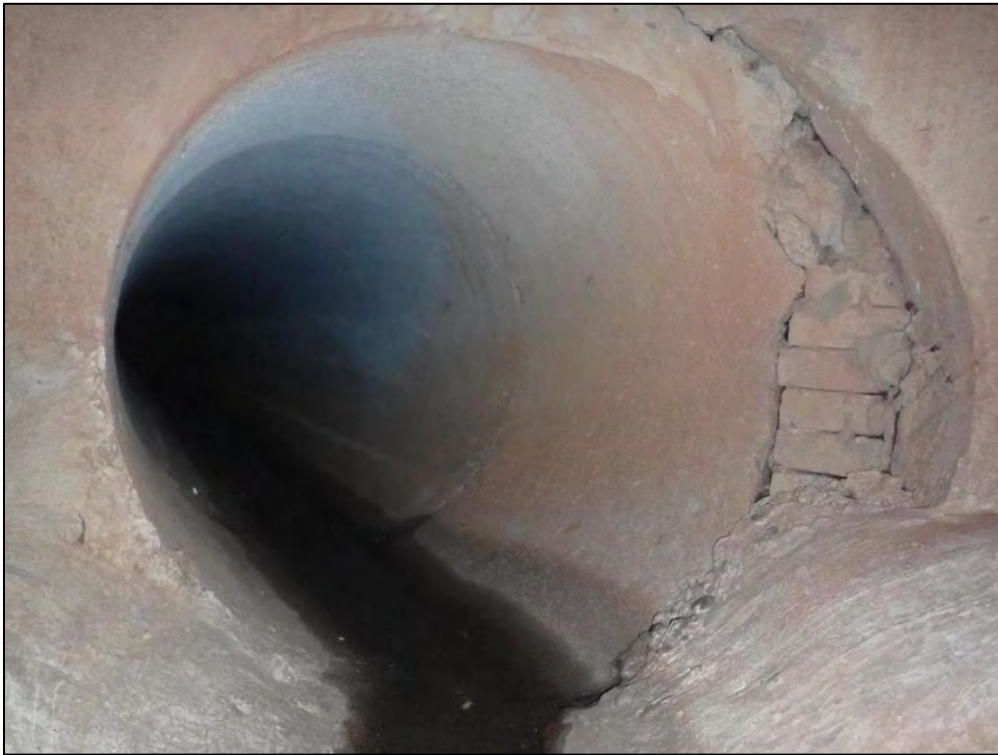
1	Trash, debris, or other material in BMP device		
Principal Spillway Pipe			
1	Spillway is blocked by debris or sediment		
1	Evidence of leaking joints		
1	One or more sections of the pipe have settled to the point that it threatens the integrity of		
Impoundment Area and Side Slopes			
1	Buildup of trash and debris		
1	Silt and sedimentation buildup		
1	Ponding area is showing signs of poor health (i.e. nutrient overload, excess aquatic		
1	Signs of erosion along shoreline		
1	Low-flow ditch is clogged with sediment/debris		
1	Sections of low-flow ditch are cracked or showing signs of undercutting		
1	Sparse vegetation or erosion		
1	Evidence of nuisance animals		
Outfall Structure and Channel			
1	Outflow is causing undercutting or erosion		
1	Outfall structure has separated more than three inches from principal spillway barrel		
3	Outfall structure is damaged or rusting	Spalling and exposed brick observed in the downstream end of the structure. (2 bags of concrete).	9275

9275: Inside Outfall Structure B1, looking downstream. Spalling (Routine Maintenance Needed).

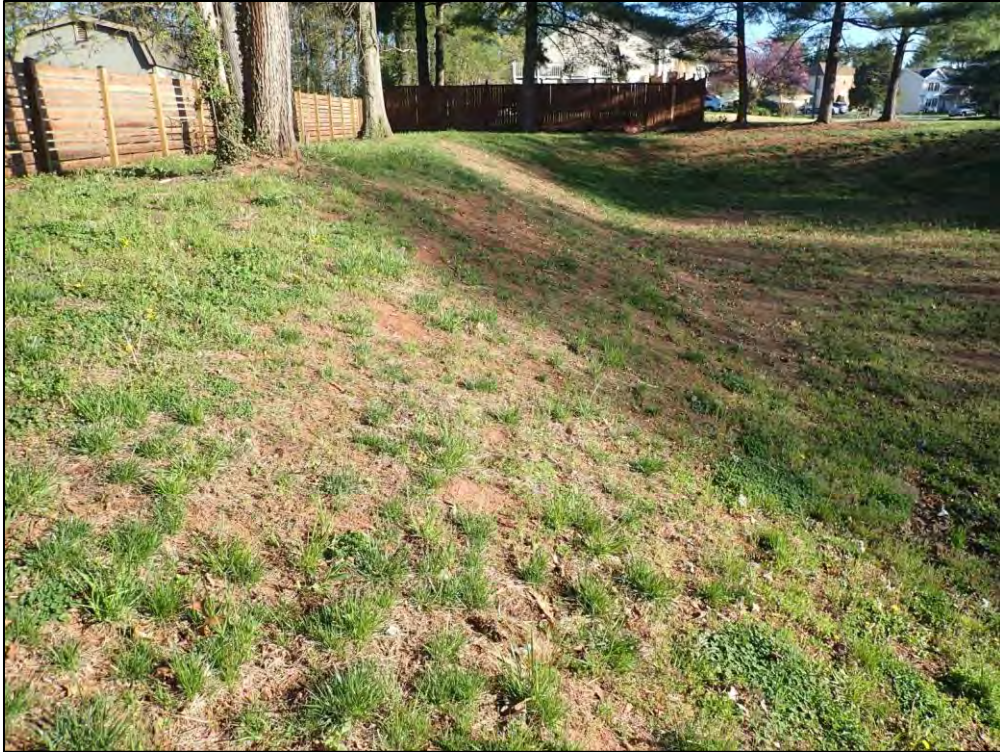
9279: Bare Spot, Overall. Sparse vegetative coverage (Routine Maintenance Needed).

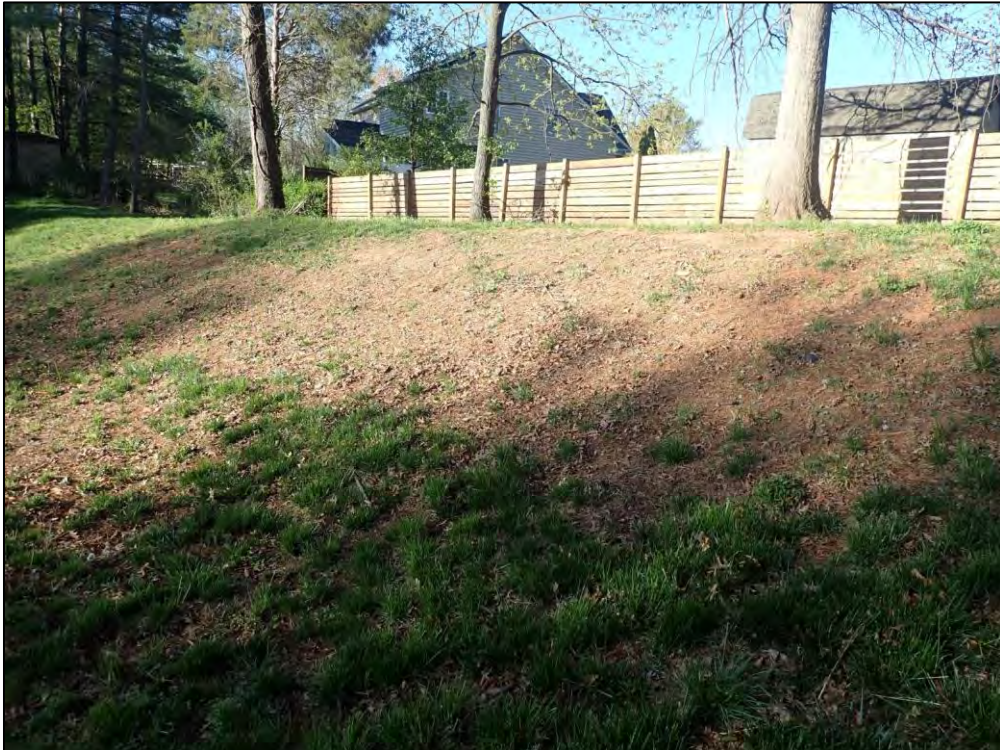
9280: Bare Spot, Overall. Sparse vegetative coverage (Routine Maintenance Needed).

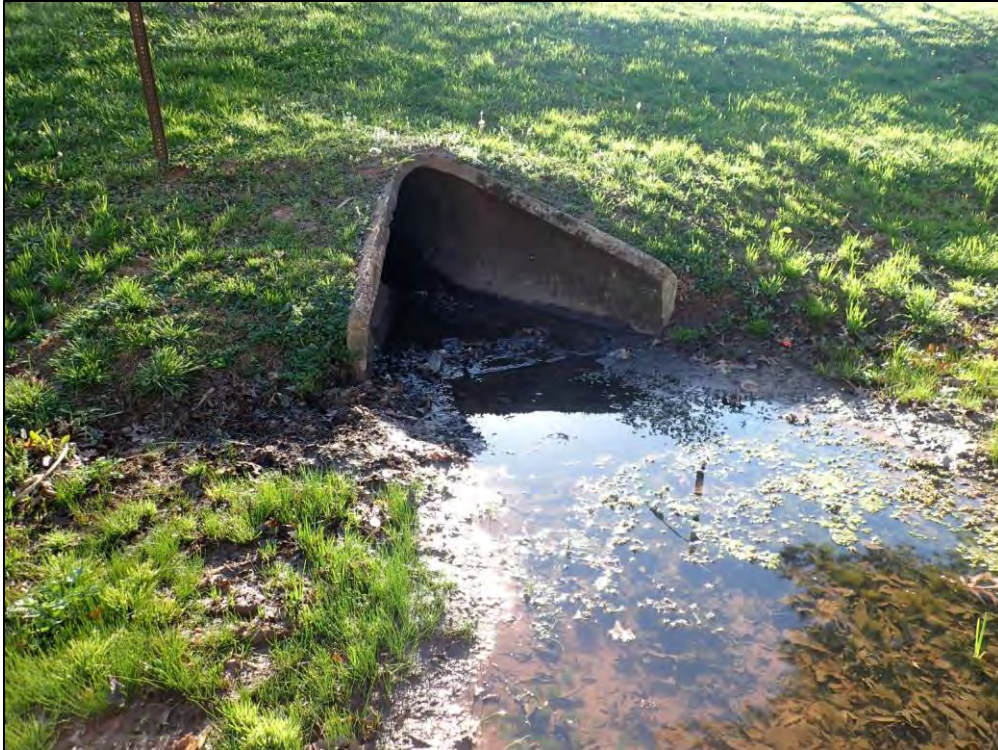
1	Vegetation does not match original design				
Inlet					
3	Buildup of trash, debris, and sediment	Trash, debris, and sediment are beginning to accumulate downstream of Inflow Structure A1 (3 Cubic Feet).		9282, 9284	
1	Evidence of erosion or undermining around inlet				
1	Woody growth around inlet structure				
1	Evidence of nuisance animals				
3	Damage to inlet pipe or structure	Joint separation was observed inside Inflow Structure A1 (9.42 Linear Feet).		9283, 9285

9282: Inflow Structure A1, front. Buildup of trash, debris, and sediment (Routine Maintenance Needed).

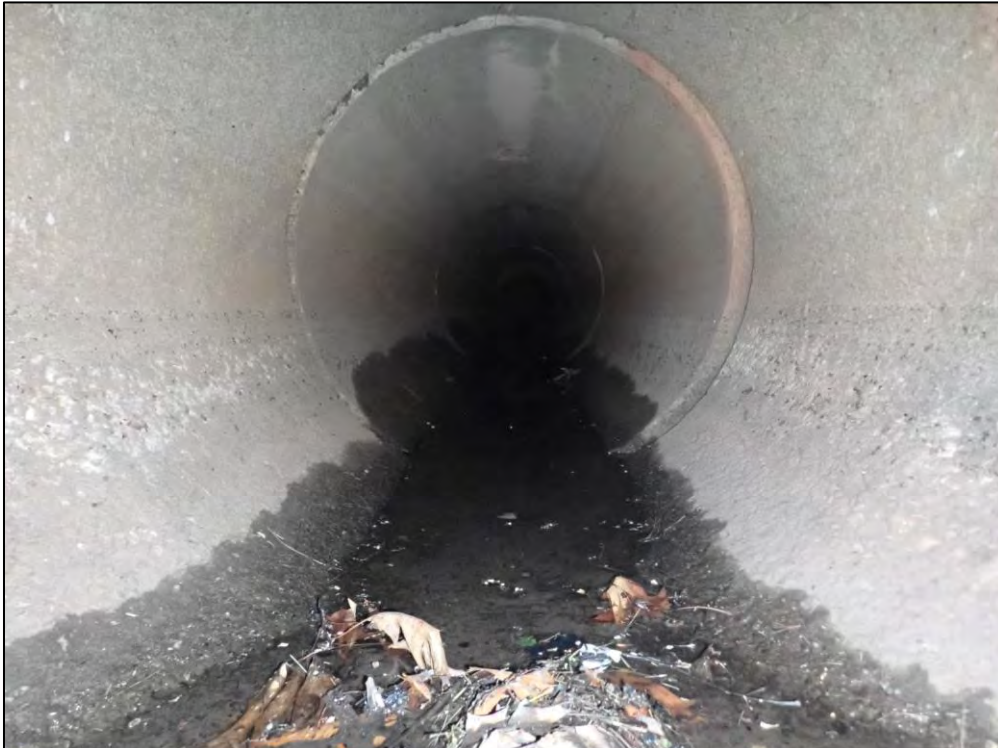
9283: Inside Inflow Structure A1. Joint Separation (Routine Maintenance Needed).

53	VDOT Class I Rip-Rap with Fabric Liner		TON	\$ 156.00	\$ -
54	VDOT Class II Rip-Rap with Fabric Liner		TON	\$ 176.00	\$ -
58	Concrete Removal and Disposal		SF	\$ 39.00	\$ -
59	Grouting Cracks and Joints	9.42	LF	\$ 189.00	\$ 1,780.38
62	Parging (per 50lb bag)	2.00	EA	\$ 452.00	\$ 904.00
70	Seed Mix (includes straw mulch and water)	0.10	0.1 acre	\$ 286.00	\$ 28.60
79	Topsoil (3")		CY	\$ 74.00	\$ -
N/A	Remove & Dispose of Sediment / Debris from Inside Drainage Structures and Pipes	9.00	CF	\$ 30.00	\$ 270.00
N/A	Install Grouted Class I Rip-Rap		SY	\$ 90.00	\$ -
N/A	Install Grouted Class II Rip-Rap		SY	\$ 141.00	\$ -
N/A	Fabricate & Install Low-Flow BMP Plate		EA	\$ 500.00	\$ -
N/A	Fabricate & Install Low-Flow Trash Rack	1.00	EA	\$ 500.00	\$ 500.00
N/A	Install HR-2 Handrail		LF	\$ 100.00	\$ -
N/A	Install Access Road Gate		EA	\$ 2,100.00	\$ -
N/A	Install Post and Cable Barrier		EA	\$ 750.00	\$ -
N/A	Install Removable Locking Bollard		EA	\$ 950.00	\$ -

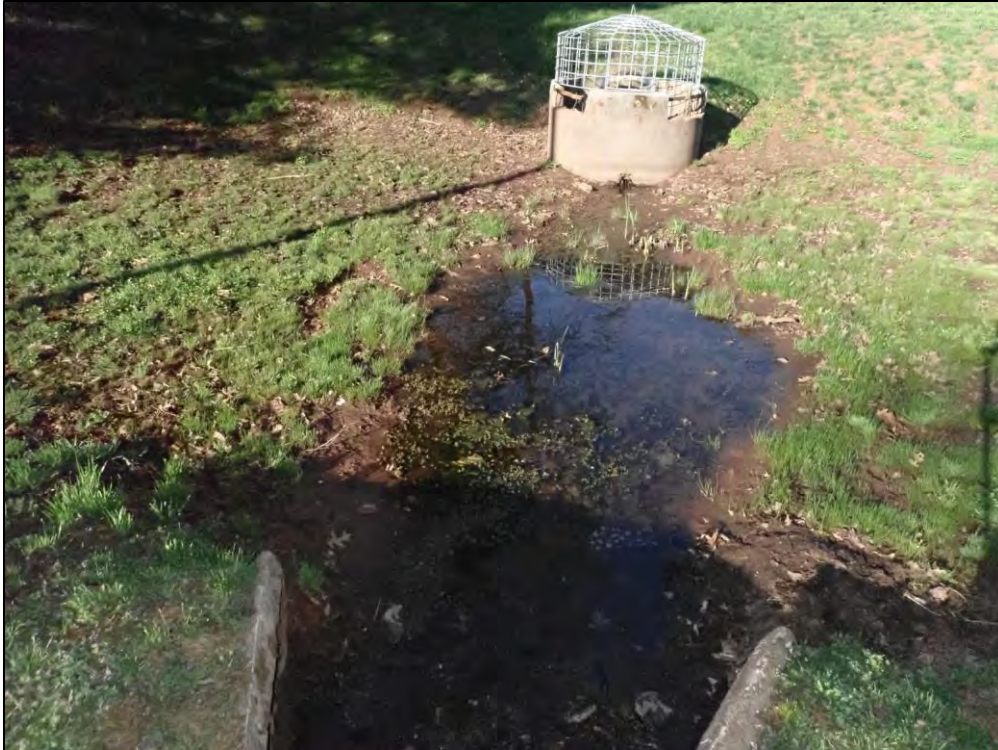
9284: From Inflow Structure A1, looking downstream. Buildup of trash, debris, and sediment (Monitor).

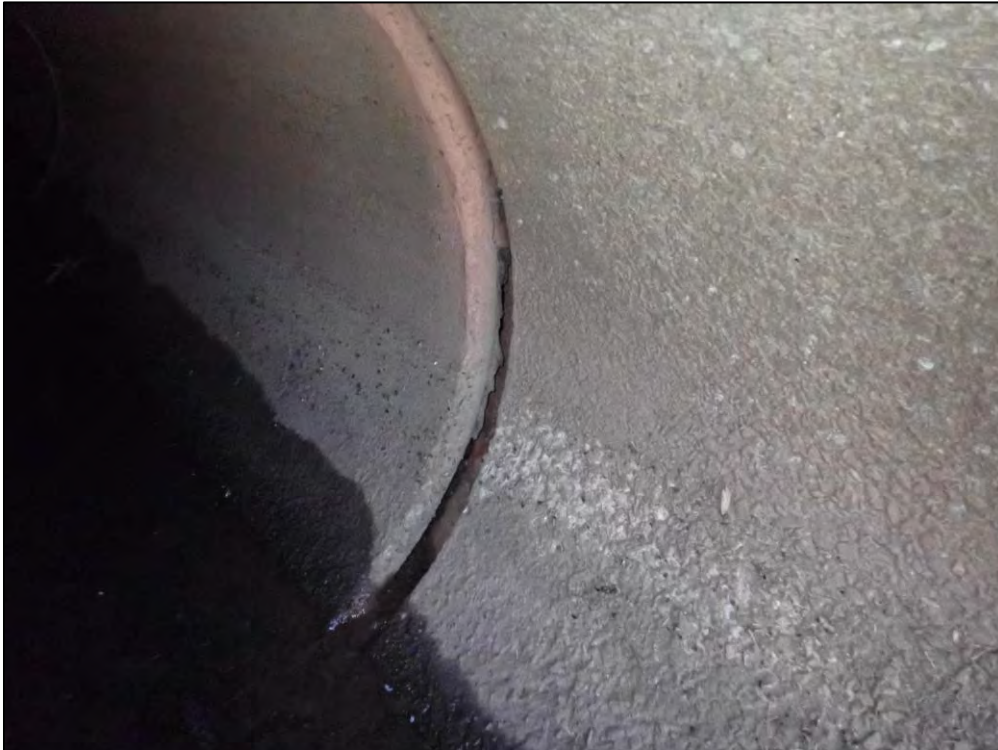
9285: Inflow Structure A1, closeup. Joint Separation (Routine Maintenance Needed).

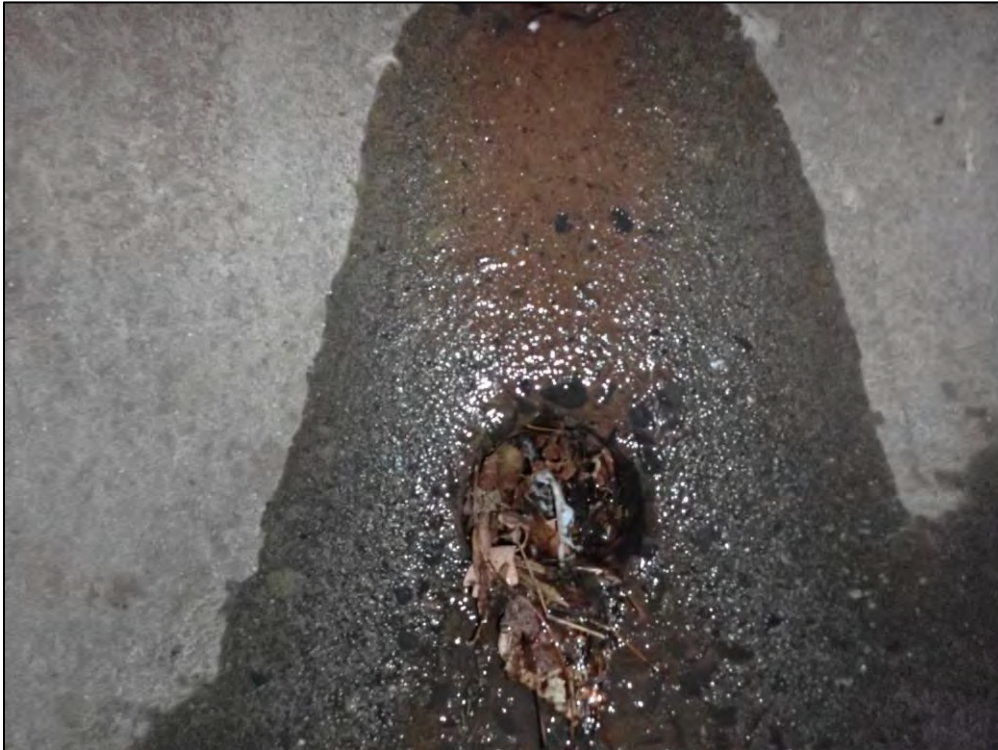
9294: Inside Control Structure D4, looking upstream toward the low-flow orifices. The low-flow orifices are blocked (Immediate Repair Needed).

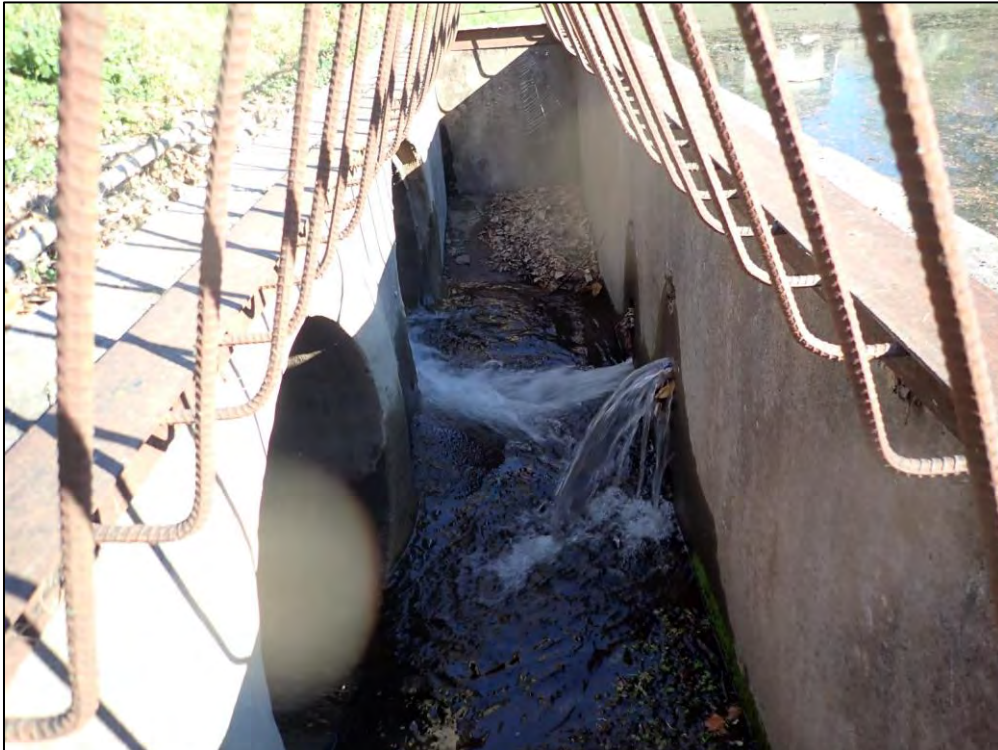
9300: Inside Control Structure D4. The low-flow orifices are blocked (Immediate Repair Needed).

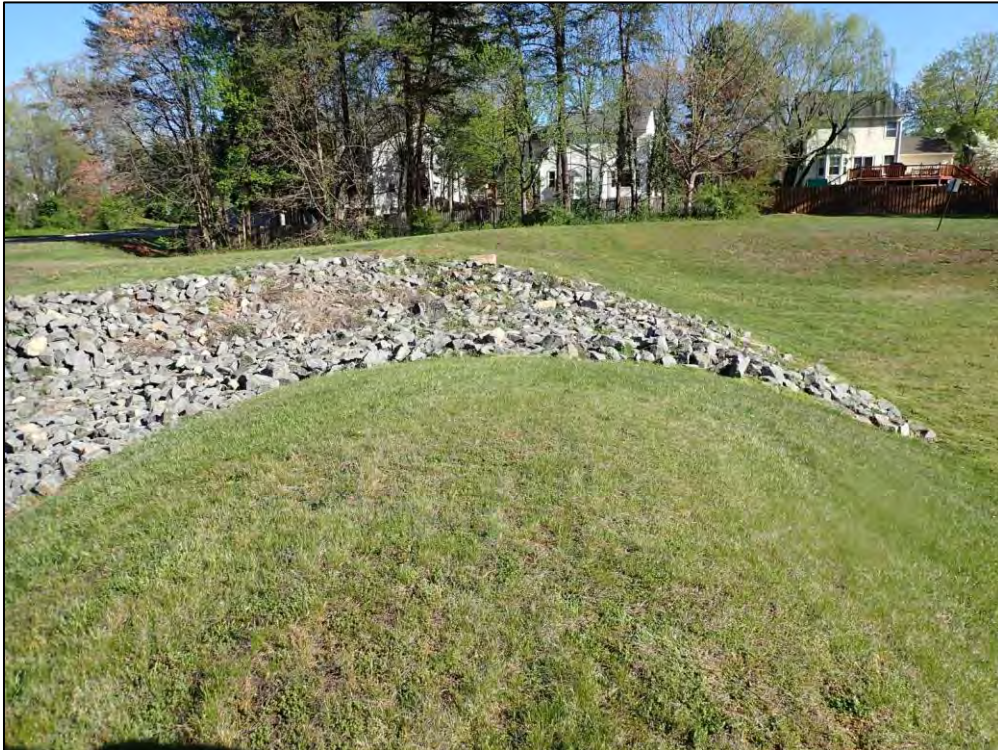
9309: Emergency Spillway, Overall. Shrubby, low-growing vegetation, and/or vine material growing on the embankment (Monitor).

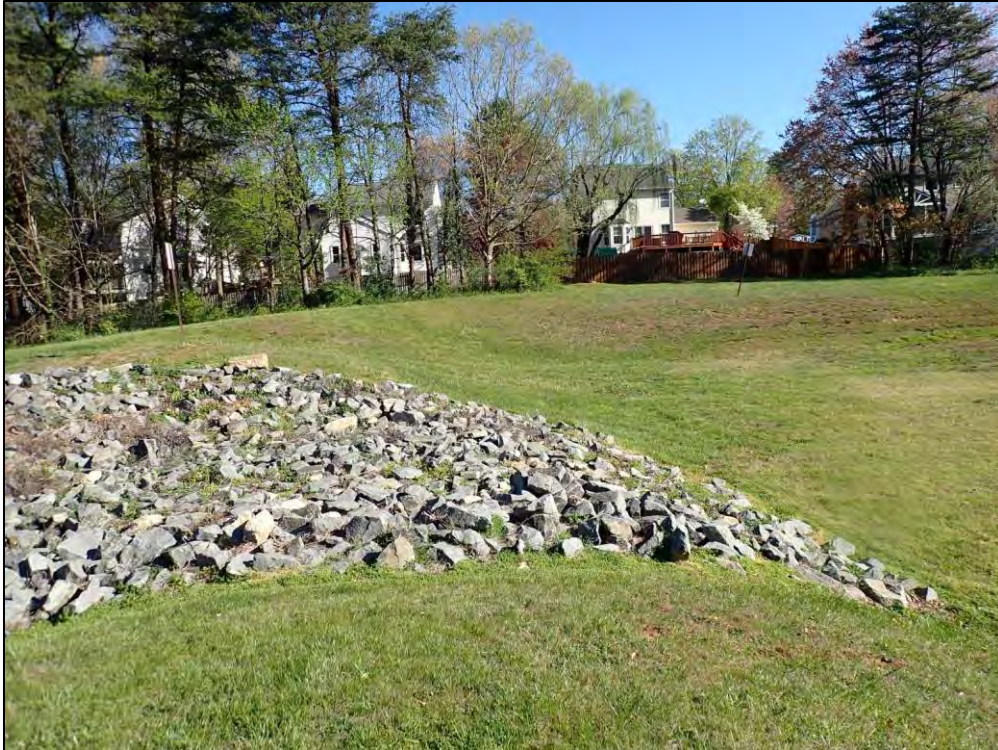
9310: Emergency Spillway, Overall. Shrubby, low-growing vegetation, and/or vine material growing on the embankment (Monitor).

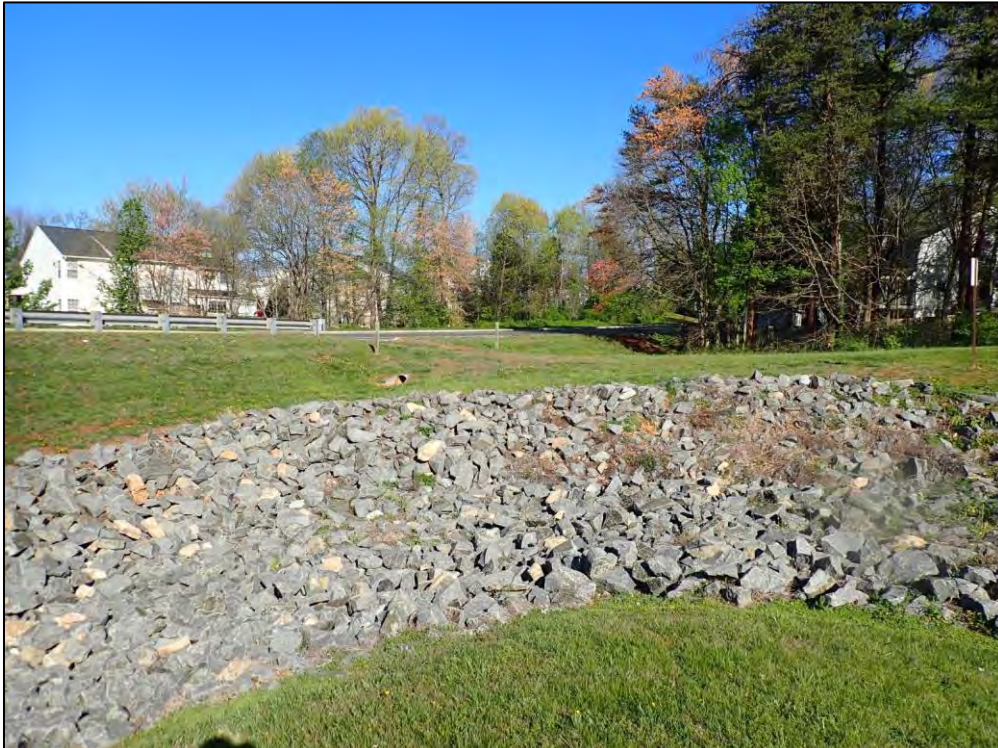
9311: From the Emergency Spillway, looking upstream. Shrubbery, low-growing vegetation, and/or vine material growing on the embankment (Monitor).

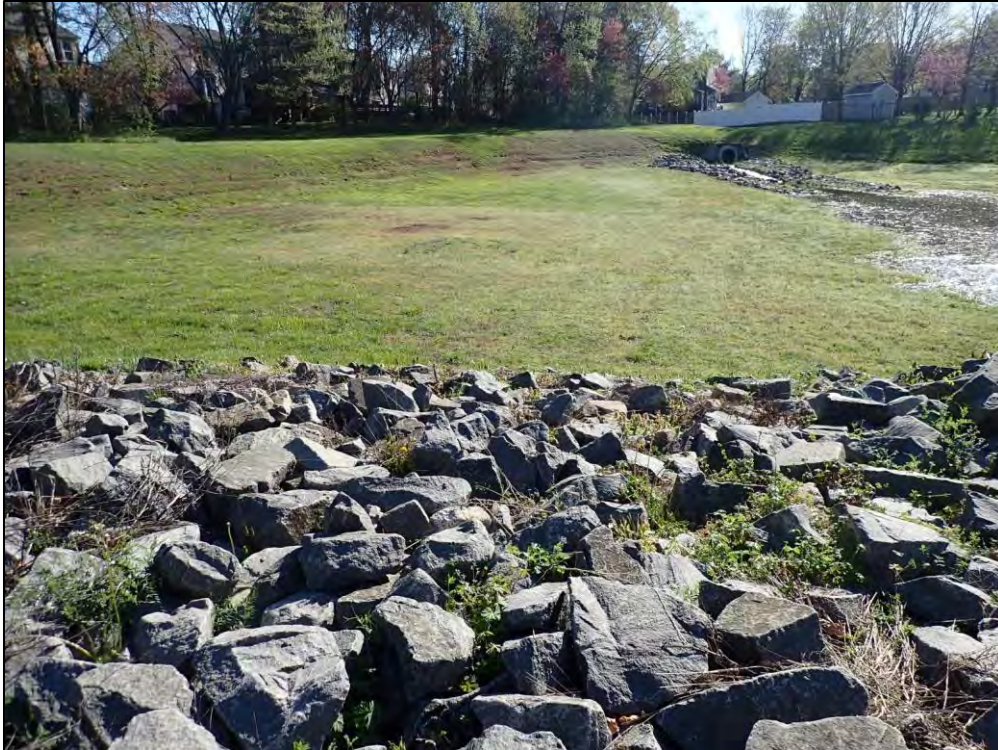
9312: Looking downstream along the Emergency Spillway. Shrubbery, low-growing vegetation, and/or vine material growing on the embankment (Monitor).

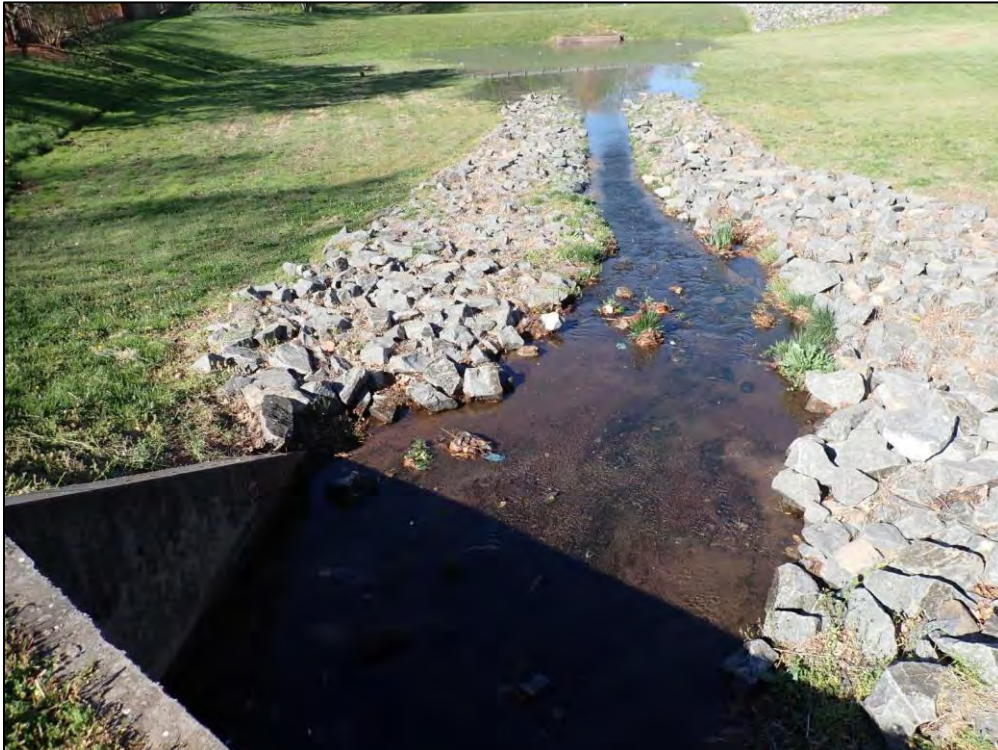
9322: From Inflow Structure D5, looking downstream. Buildup of trash, debris, and sediment (Monitor).

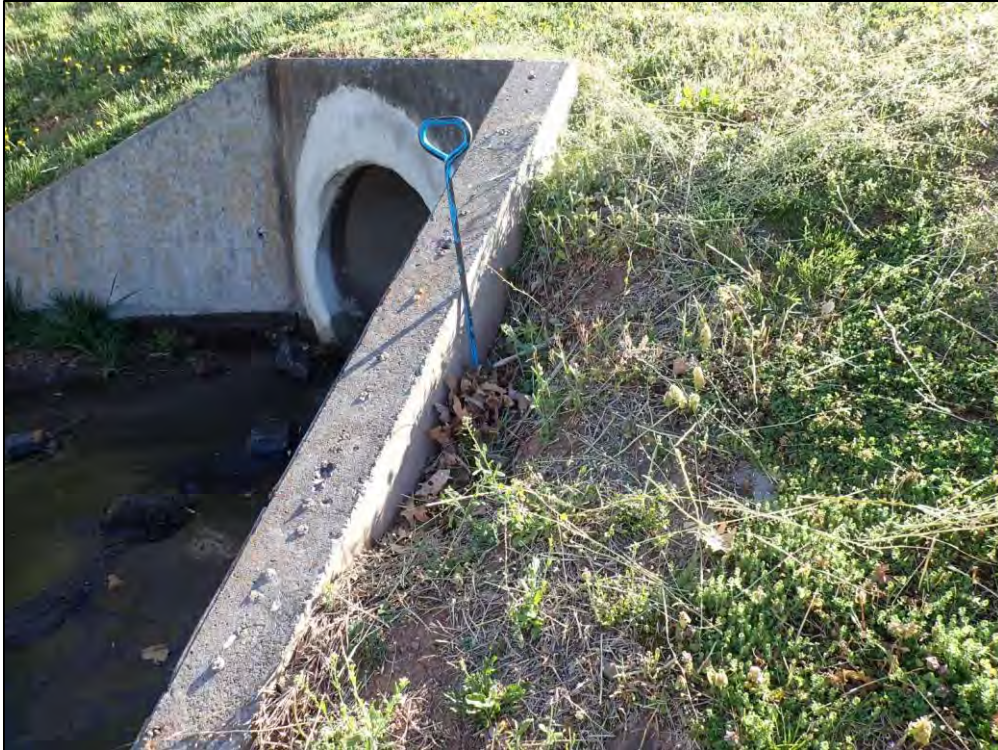
9323: Inflow Structure D5, overall. Evidence of erosion or undermining around inlet (Routine Maintenance Needed).

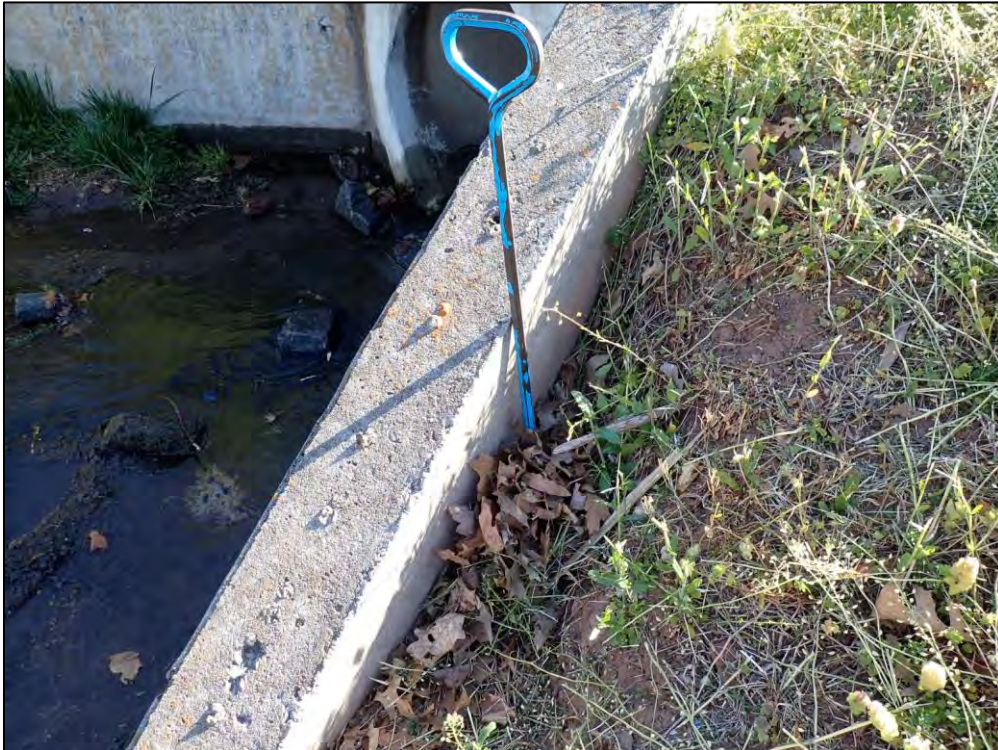
9324: Inflow Structure D5, closeup. Evidence of erosion or undermining around inlet (Routine Maintenance Needed).

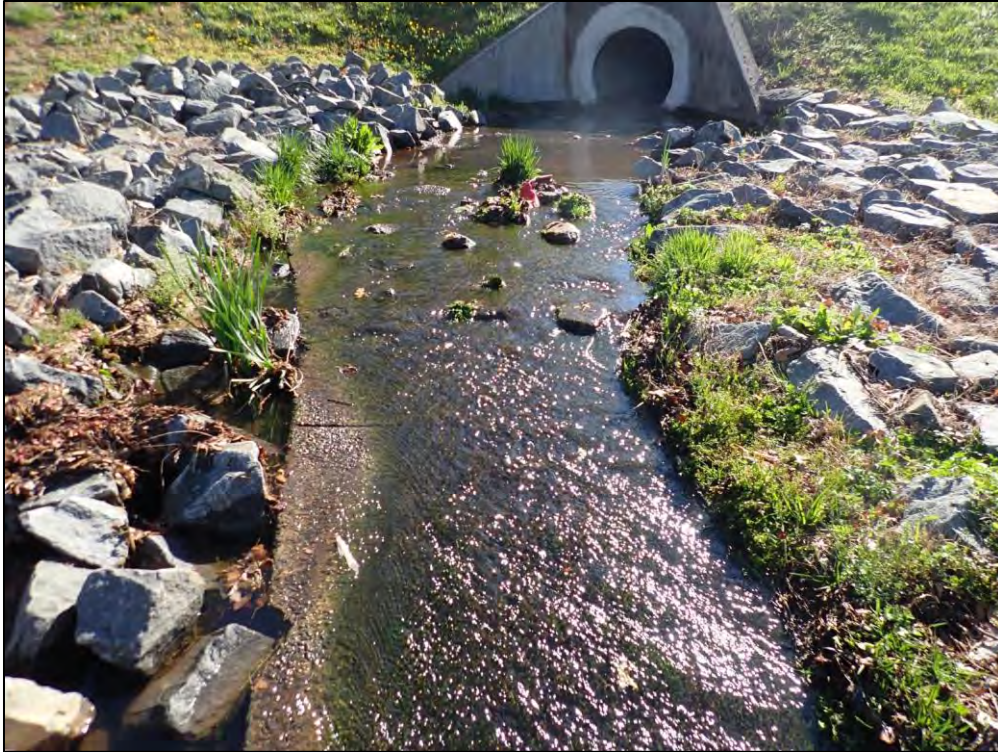
9326: From the Trickle Ditch, looking upstream toward Inflow Structure D5. The low-flow ditch is clogged with sediment/debris (Monitor).

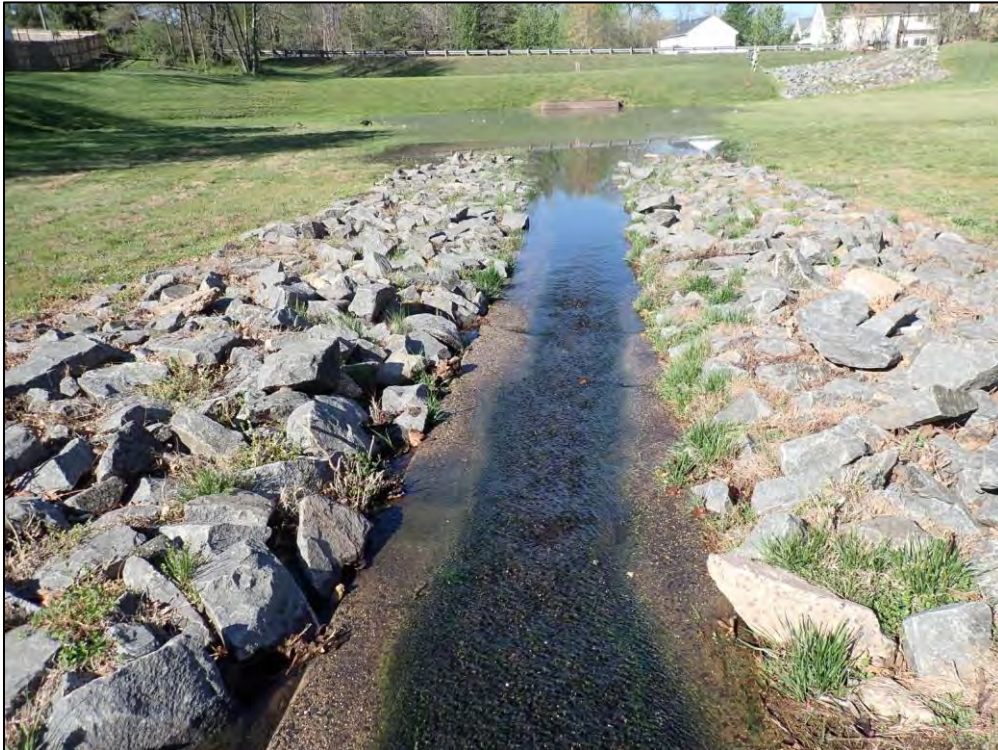
9327: Looking downstream along the Trickle Ditch. The low-flow ditch is clogged with sediment/debris (Monitor).
