Infiltration Trench Inspection Report					
Facility Name	Fairview Riverdale	Facility ID	STMF0090080	Type of Inspection: Initial Inspection	
Location	Lat: 38.747968 Long: -77.460524	Watershed	Lower Bull Run	Previous 48 Hour Precipitation Total	0.35"
Materials available for inspection	N/A	Owner Notification Date	N/A	Owners/ Owner's Representative	City of Manassas
Inspectors	gky_mfreeman	Date of Inspection	6/28/2023	Date of Last Inspection	3/29/2022
Overall Condition Score					
	1	Adequate	No deficiencies identified.		
	2	Monitor	No maintenance may be needed at the time, but might become an issue in the future. Will revisit next inspection. Examples include minor erosion, small sediment accumulation, or small structural issues of facility components.		
	3	Routine Maintenance Needed	Facility is functional but preventative maintenance is required. Examples includes vegetation management, minor erosion, or trash/debris removal.

Facility ID: STMF0090080
Facility Name: Fairview Riverdale

Inspection Date: 06/28/2023

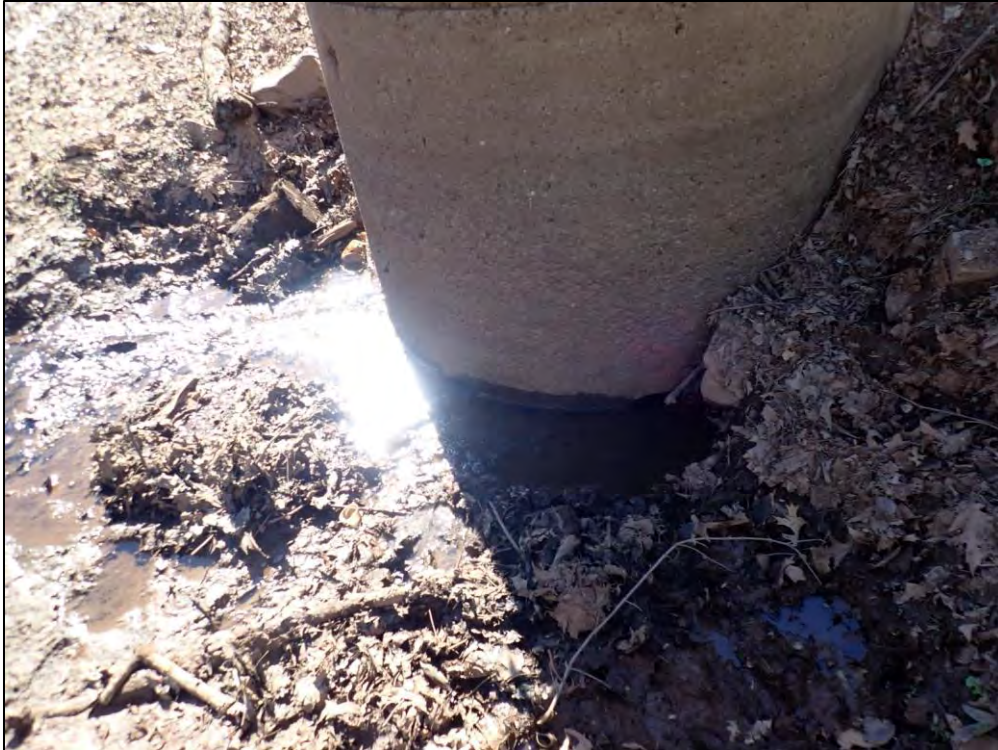
9337: Control Structure, low-flow orifice close-up. The low-flow orifices are blocked (Immediate Repair Needed).

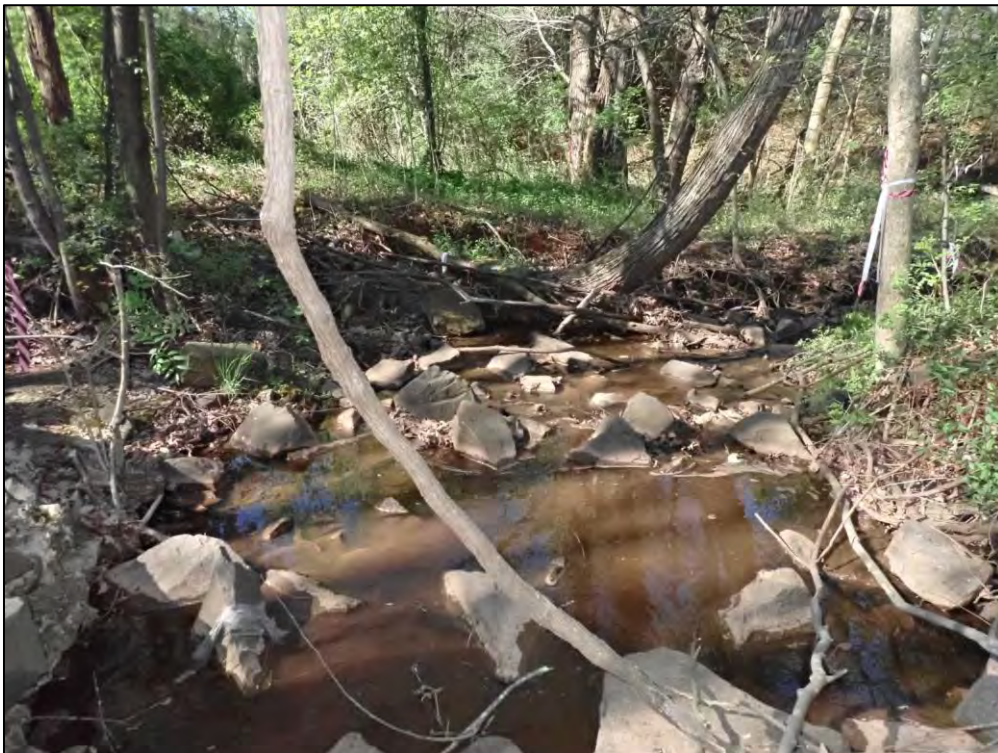
1	Outflow is causing undercutting or erosion		
3	Outfall structure has separated more than three inches from principal spillway barrel	The outfall structure is beginning to separate from the PSP (9.42 Linear Feet).	9347
1	Outfall structure is damaged or rusting		
3	Woody vegetation growing within 5' of outlet and barrel	A tree was observed growing adjacent to the outfall structure (1, 7-12" tree).	9349
1	Buildup of trash, debris, and sediment around outfall or in channel		
1	Signs of erosion around outfall or channel

9347: Inside the Outfall. The outfall structure has separated from the principal spillway barrel (Routine Maintenance Needed).

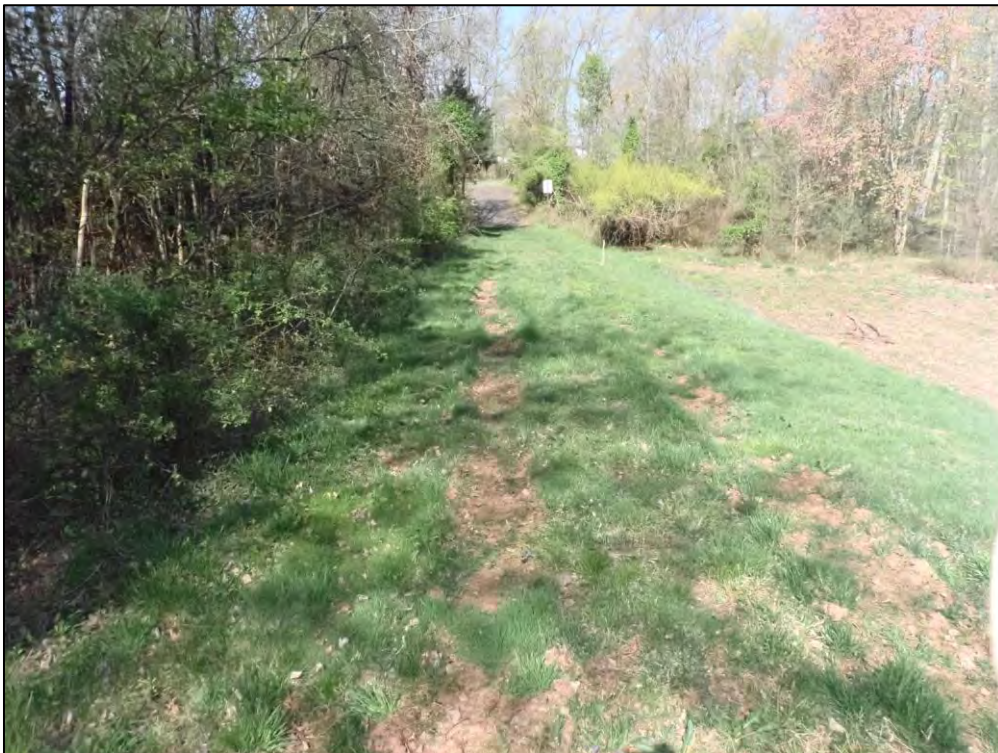
9349: Outfall, Overall. Woody vegetation growing within 5' of outlet and barrel (Routine Maintenance Needed).

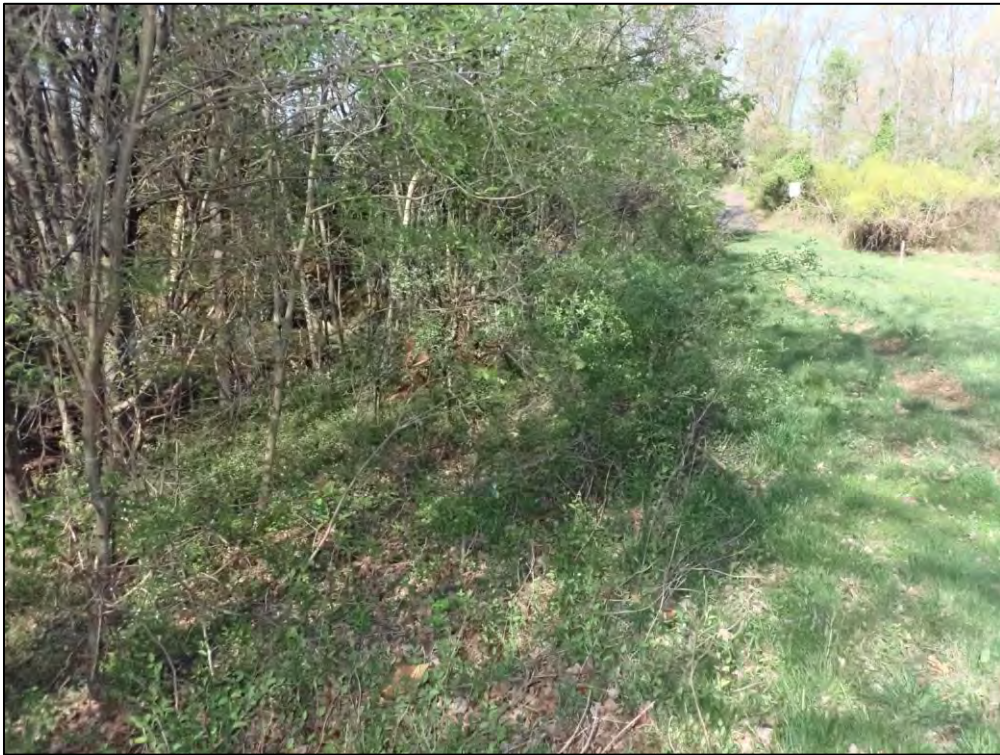
9350: Dam, Overall. Sparse vegetative coverage (Monitor).

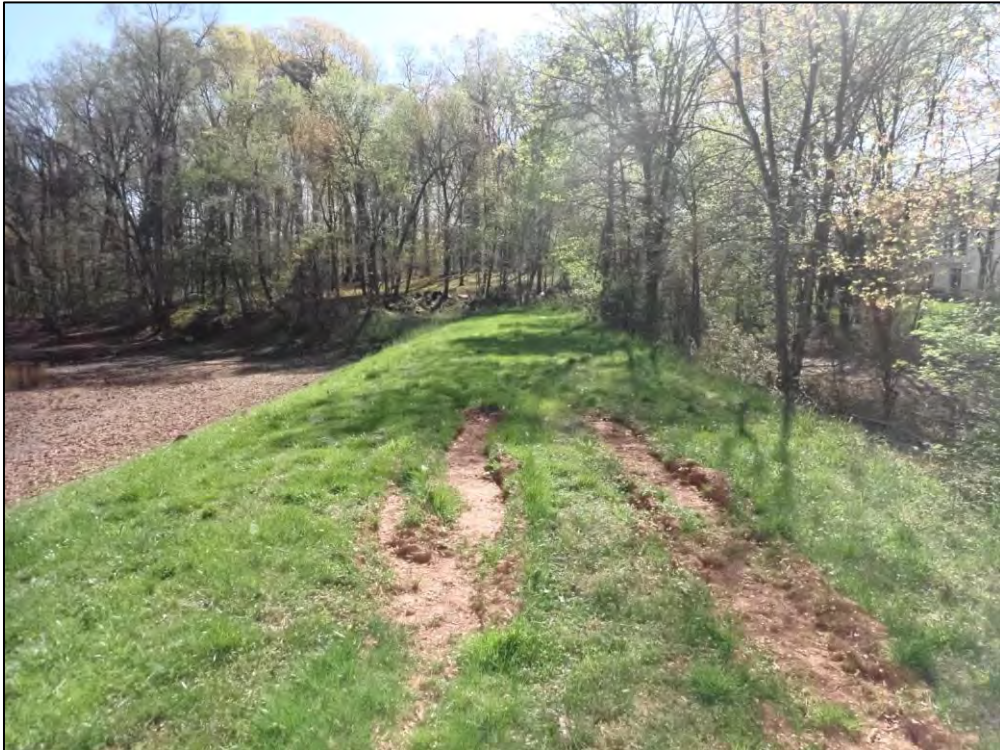
9351: Dam, Overall. Woody vegetation on the embankment (Routine Maintenance Needed).

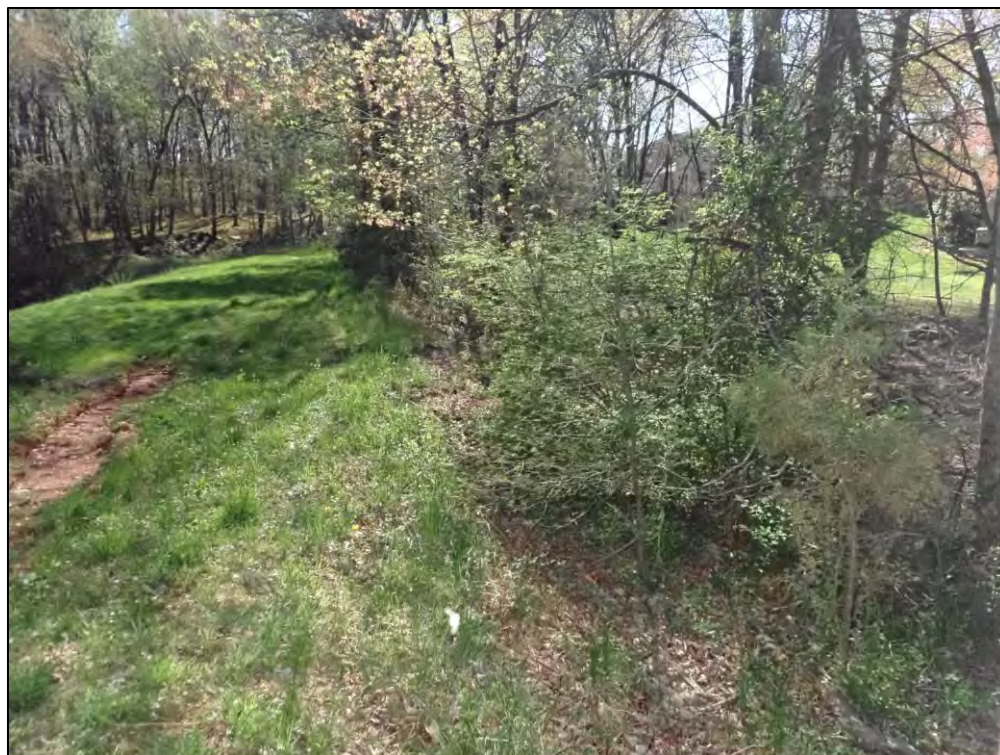
9352: Dam, Overall. Sparse vegetative coverage (Monitor).

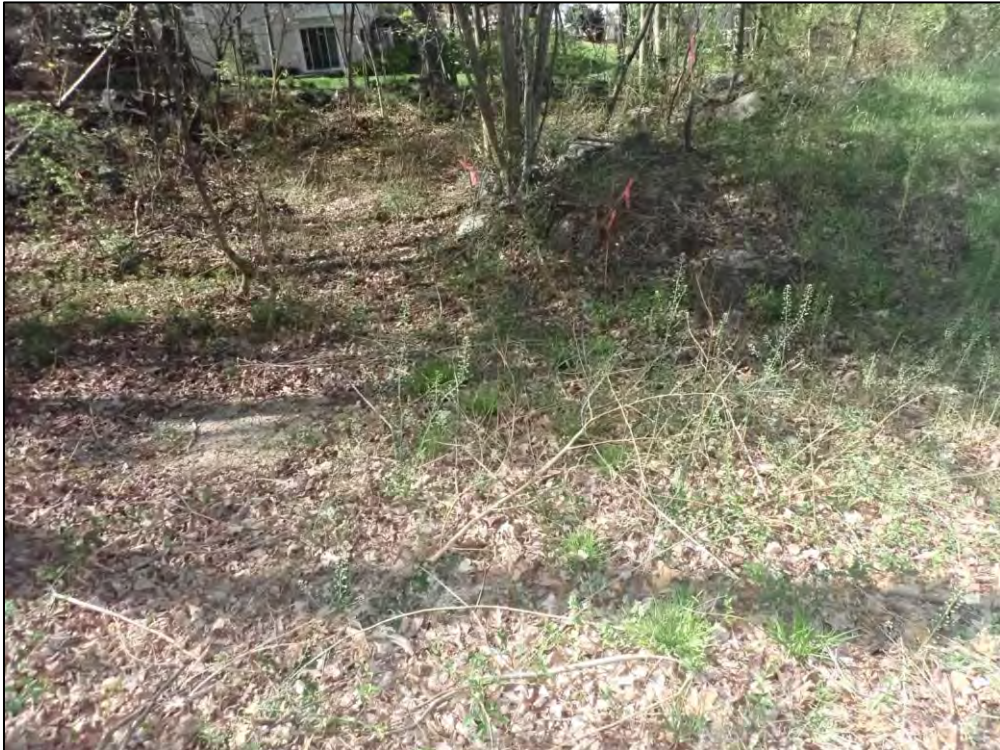
9355: Emergency Spillway, Overall. Woody vegetation on the embankment (Routine Maintenance Needed).

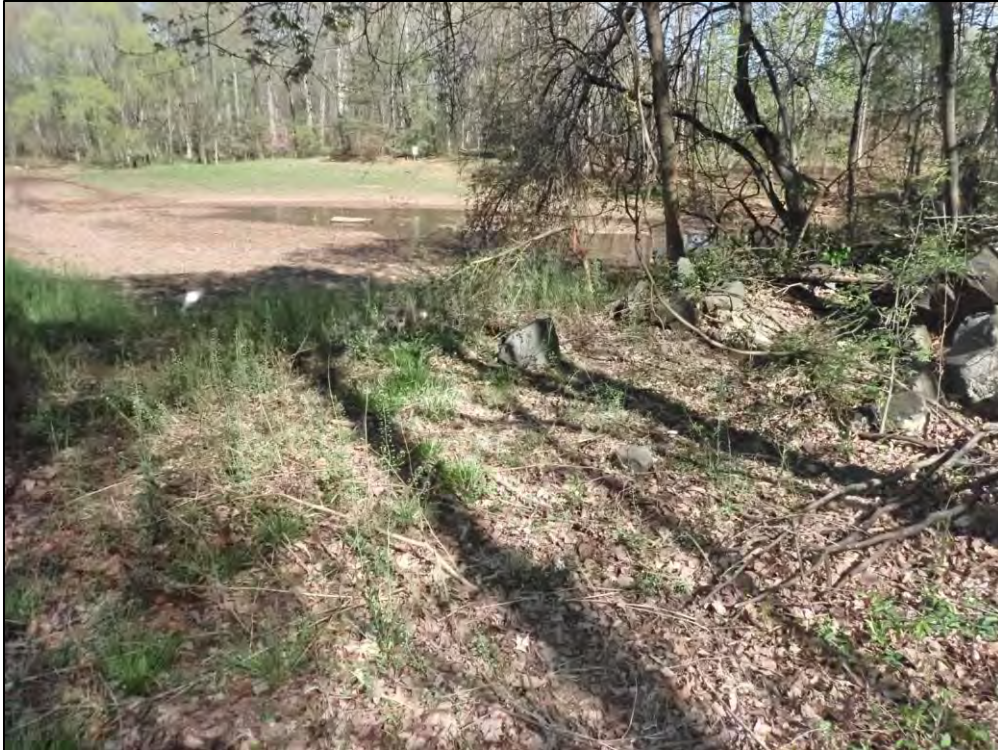
9356: Emergency Spillway, Overall. Woody vegetation on the embankment (Routine Maintenance Needed).

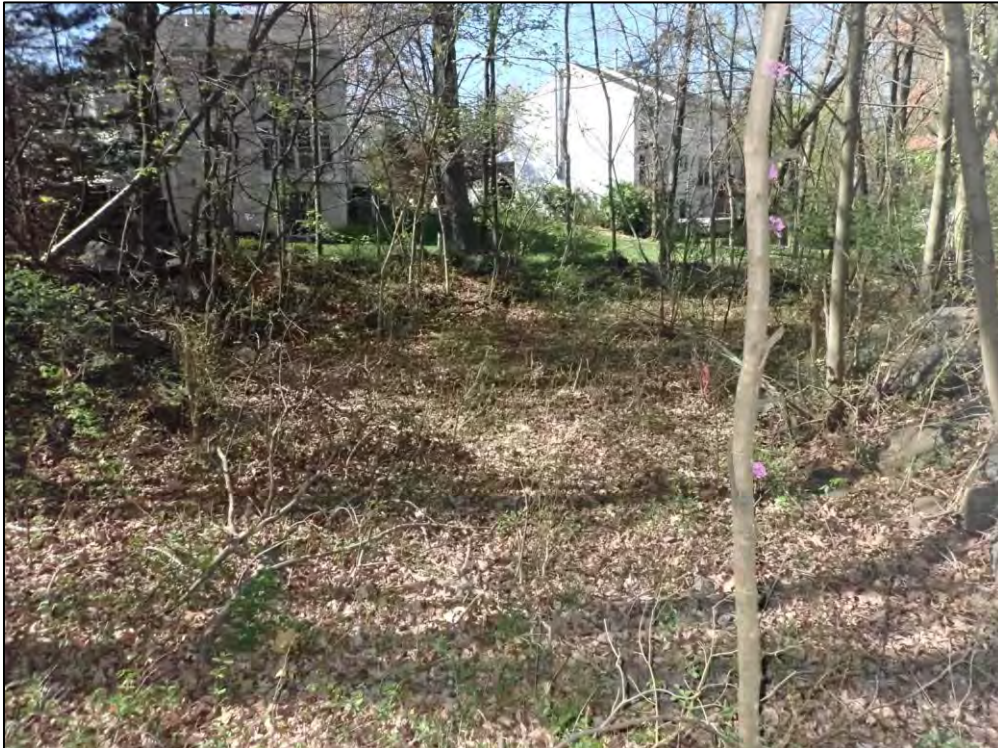
9357: Looking upstream from the Emergency Spillway. Woody vegetation on the embankment (Routine Maintenance Needed).

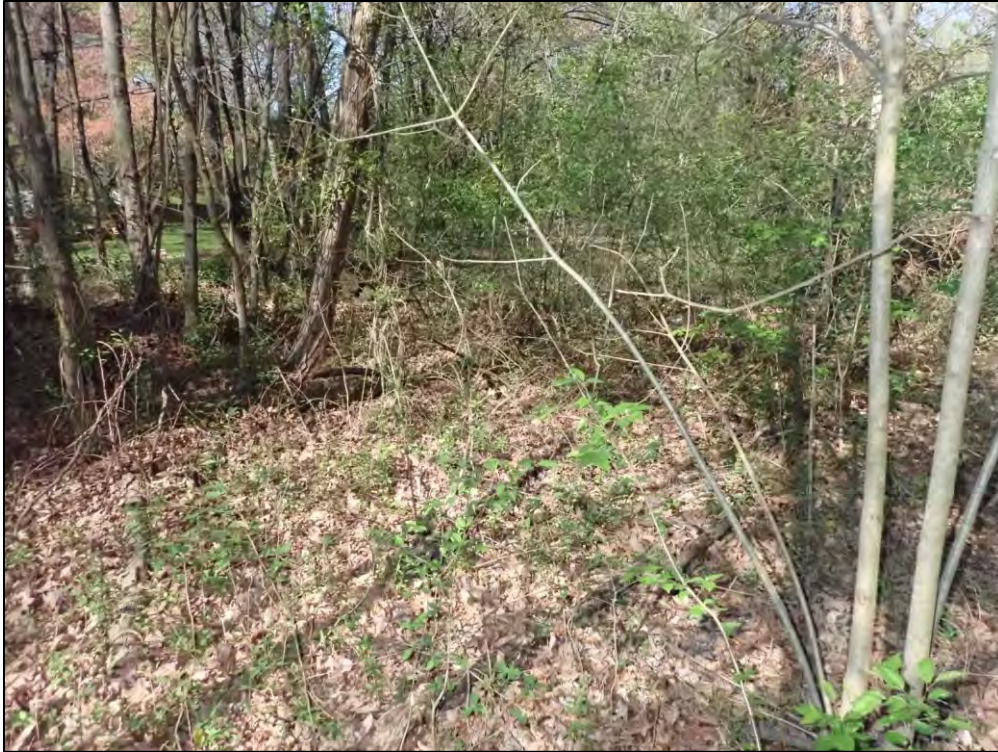
9359: Emergency Spillway, Overall. Woody vegetation on the embankment (Routine Maintenance Needed).

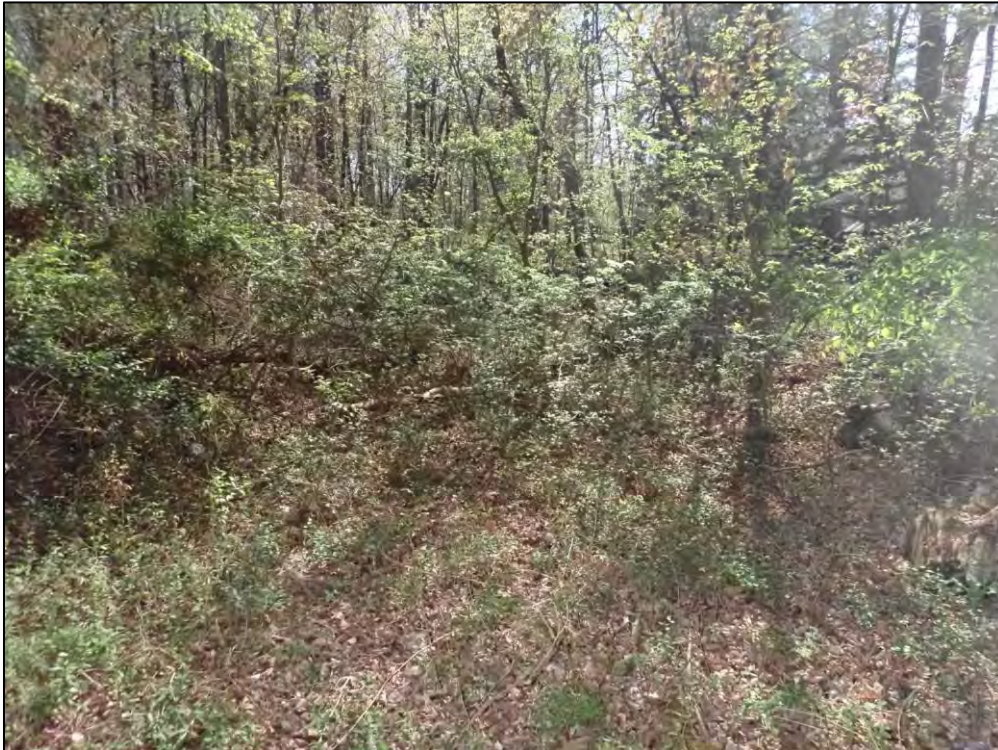
9360: Emergency Spillway, Overall. Woody vegetation on the embankment (Routine Maintenance Needed).

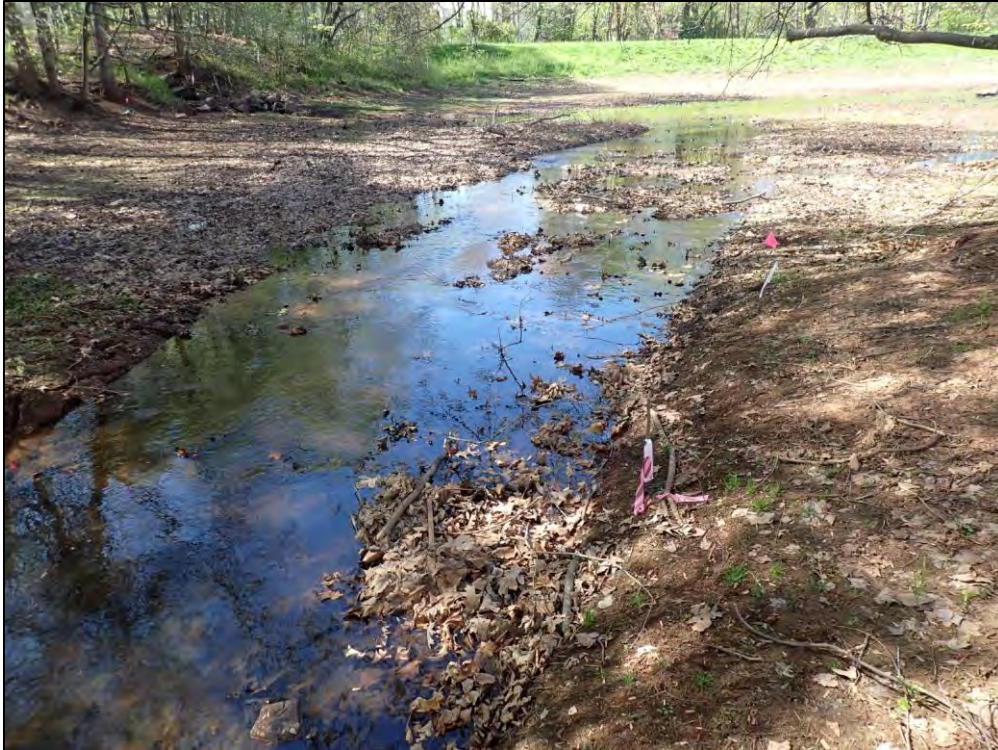
9371: From Inflow 2, looking downstream. Buildup of trash, debris, and sediment (Monitor).

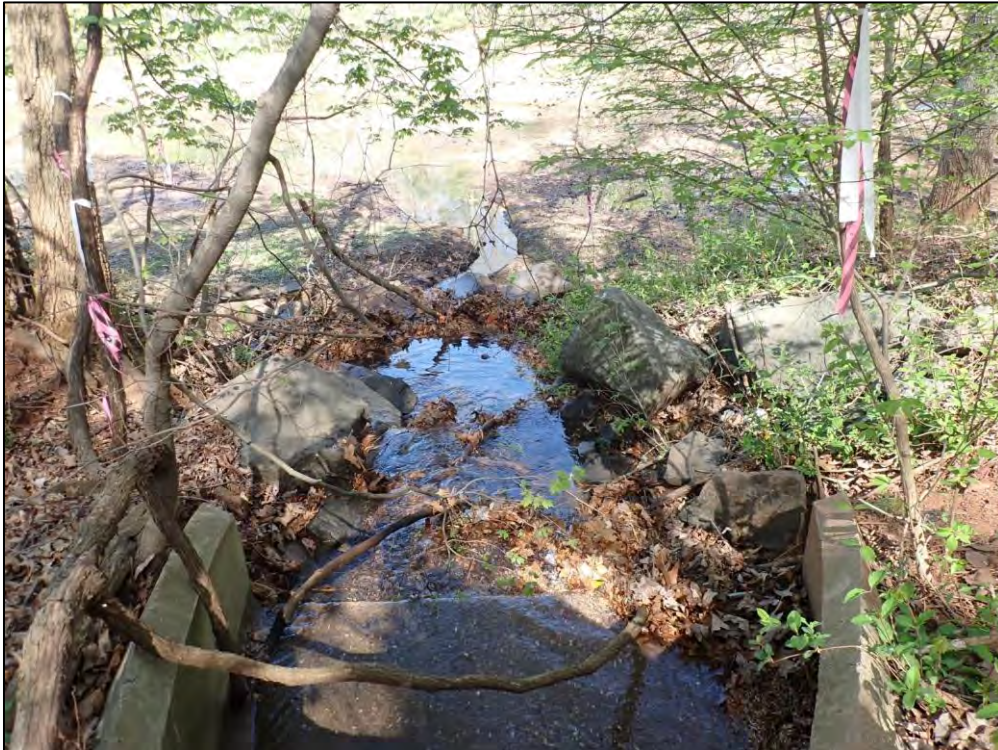
9374: From Inflow Structure D1, looking downstream. Buildup of trash, debris, and sediment (Monitor).

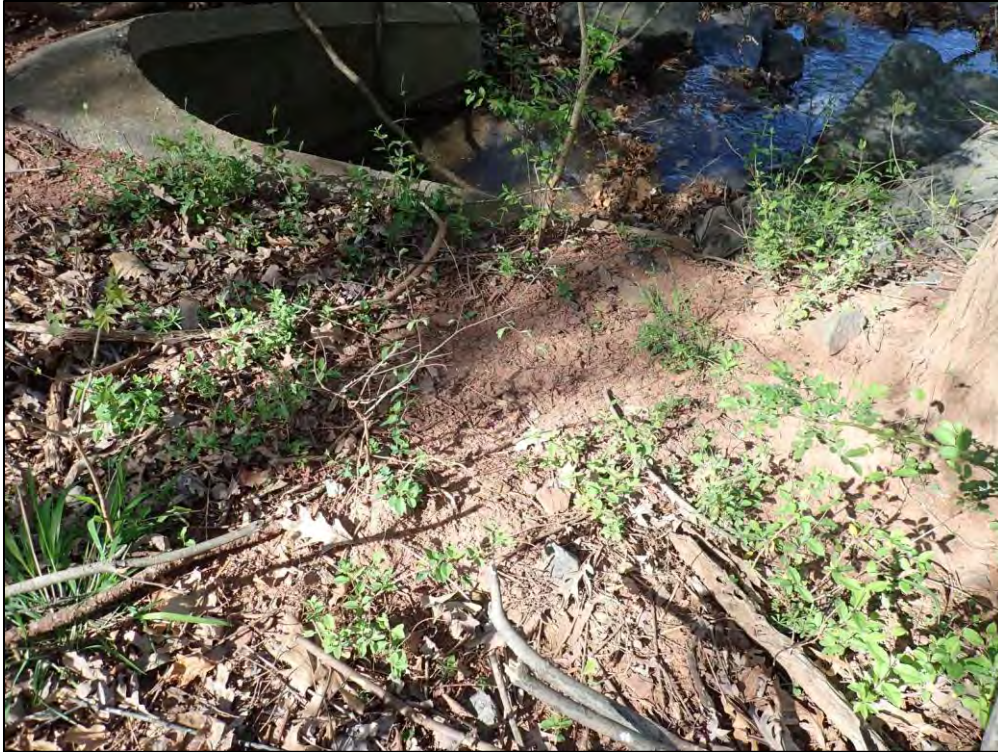
9375: Inflow Structure D1, closeup. Woody growth around the inlet structure (Routine Maintenance Needed).

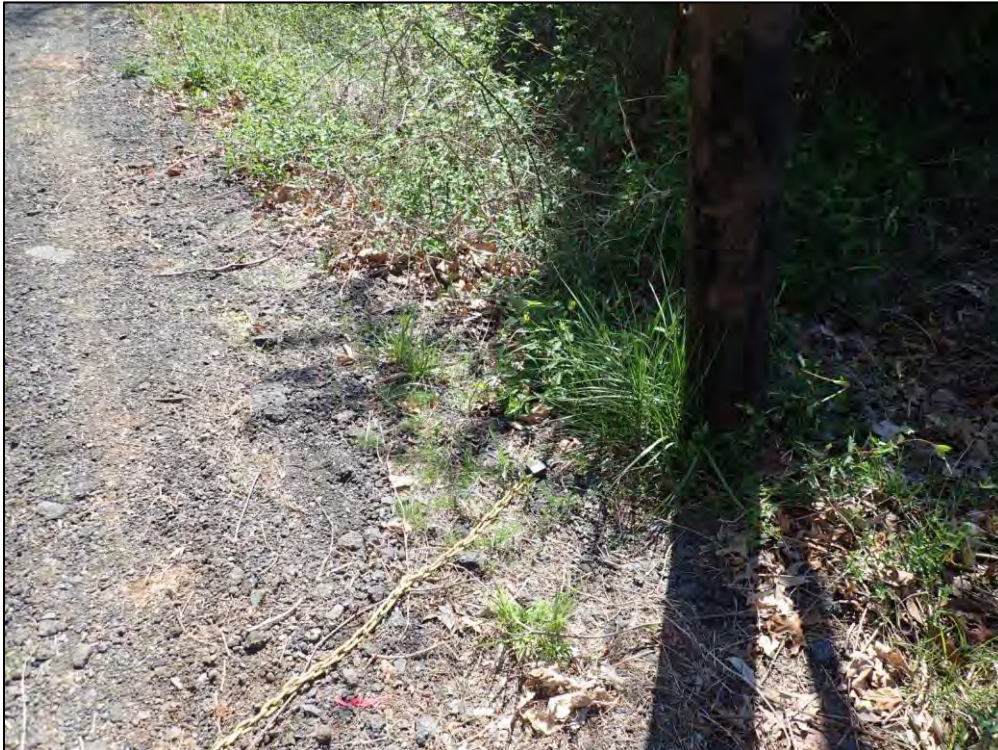
9380: Close-up of the Access road entrance, Padlock not attached to the bollard.

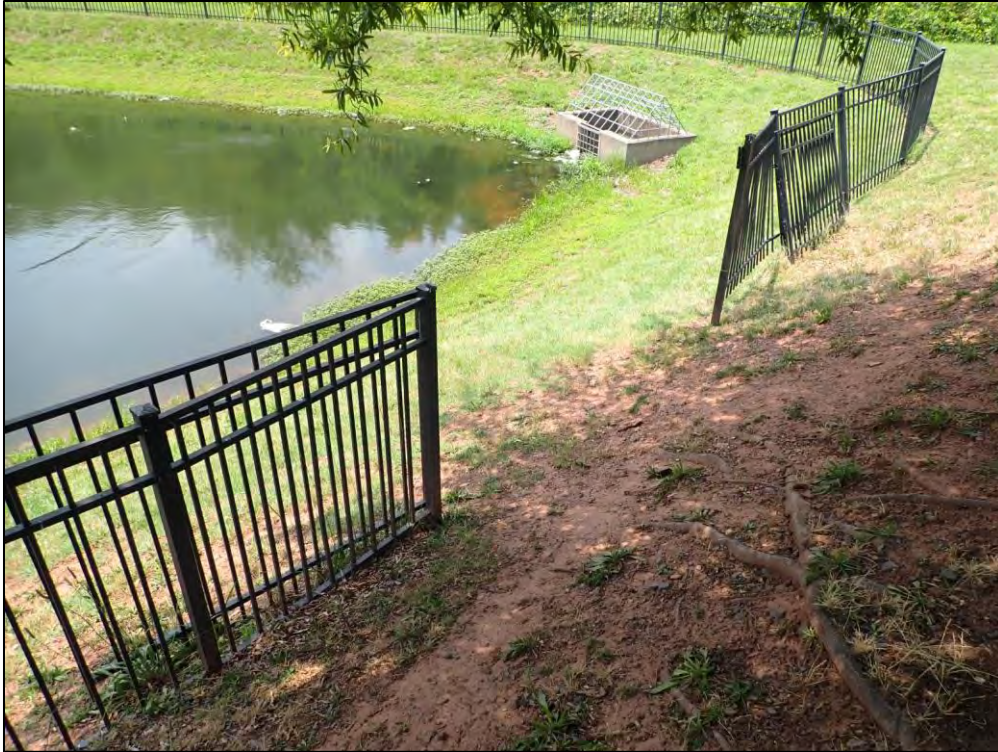
4768: Access, Overall. Fence is damaged (Routine Maintenance Needed).

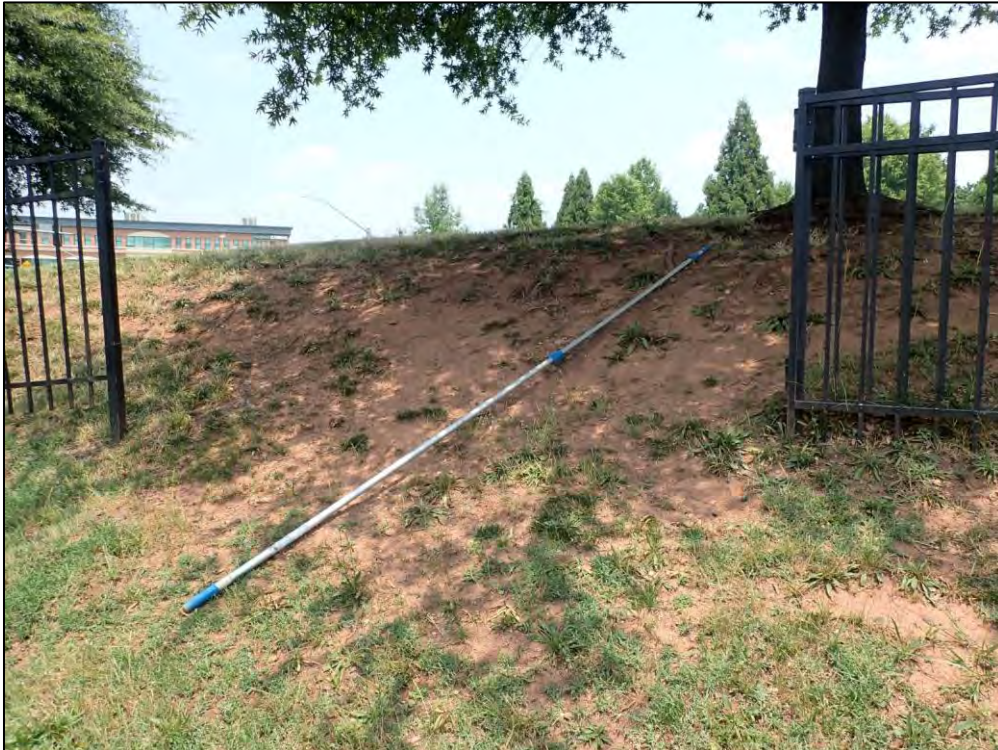
4771: Impoundment Area, Overall. Sparse vegetation or erosion (Routine Maintenance Needed).

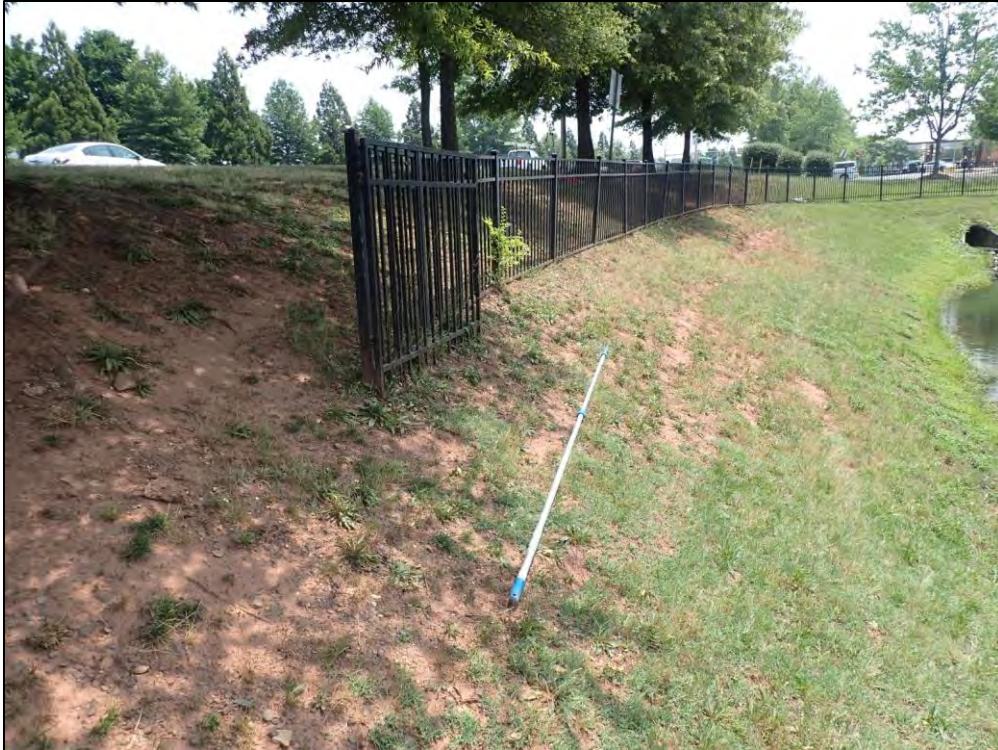
4772: Impoundment Area, Overall. Sparse vegetation or erosion (Routine Maintenance Needed).

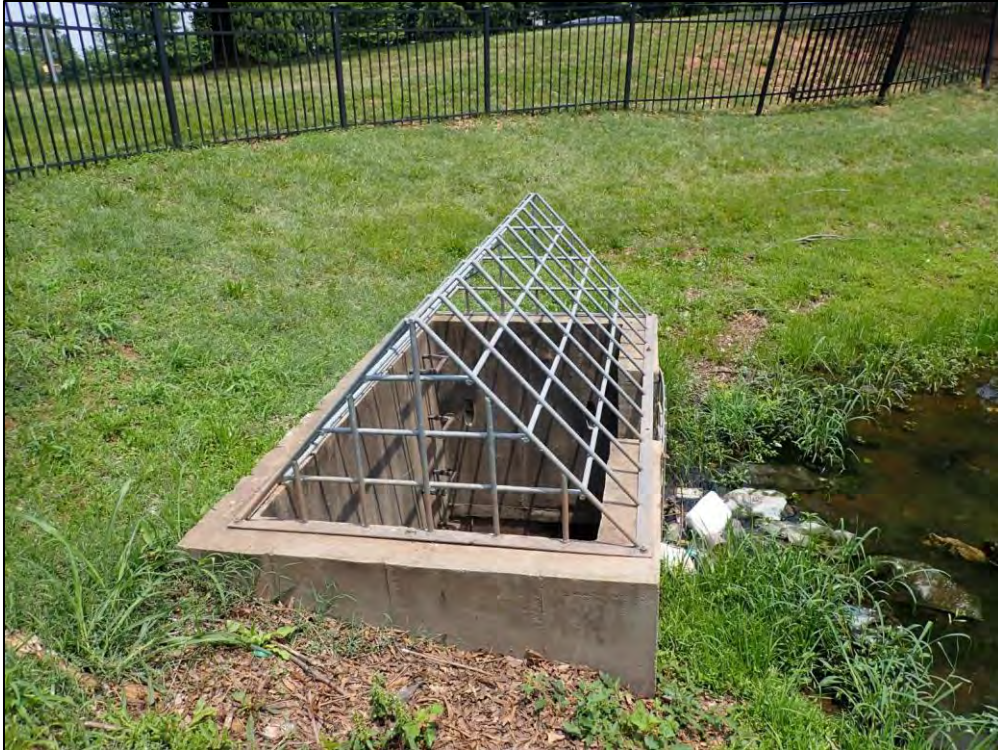
Score	Description	Comment(s) / Corrective Action(s)	Reference Image
Dam Embankment (Includes emergency spillway if applicable)			
1	Woody vegetation on embankment		
1	Shrubby, low growing vegetation, and/or vine material growing on embankment		
1	Sparse vegetative coverage		
1	Signs of erosion, settlement, piping, or slope slippage		
1	Signs of seepage, soft spots, and sinkhole formation		
4	Evidence of nuisance animals	An animal hole was observed adjacent to the control structure.	4788, 4789
1	Buildup of trash or debris on embankment		
1	Trash, debris, or obstructions in emergency spillway		
Outlet/Riser Structure			
1	Low-flow orifice is blocked		
1	BMP device is deteriorated, misaligned, and/or damaged		
1	BMP device is missing		
1	Low-level gate drain is accessible and operational. Drain has been exercised in last three years.		
3	Trash, debris, or other material in BMP device	Trash and debris observed adjacent to the control structure (2 Cubic Feet).	4775, 4776, 4778

4776: Control Structure 37, top trash rack. Trash, debris, or other material in BMP device (Routine Maintenance Needed).

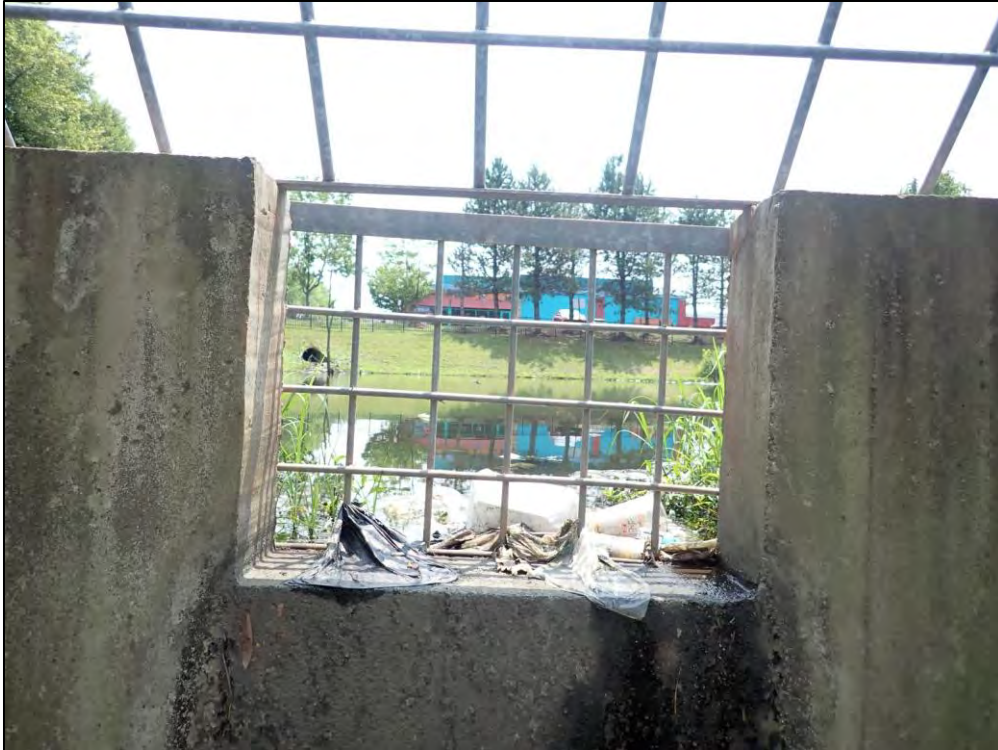
4778: Inside Control Structure 37, looking upstream toward the upper orifice. Trash, debris, or other material in BMP device (Routine Maintenance Needed).

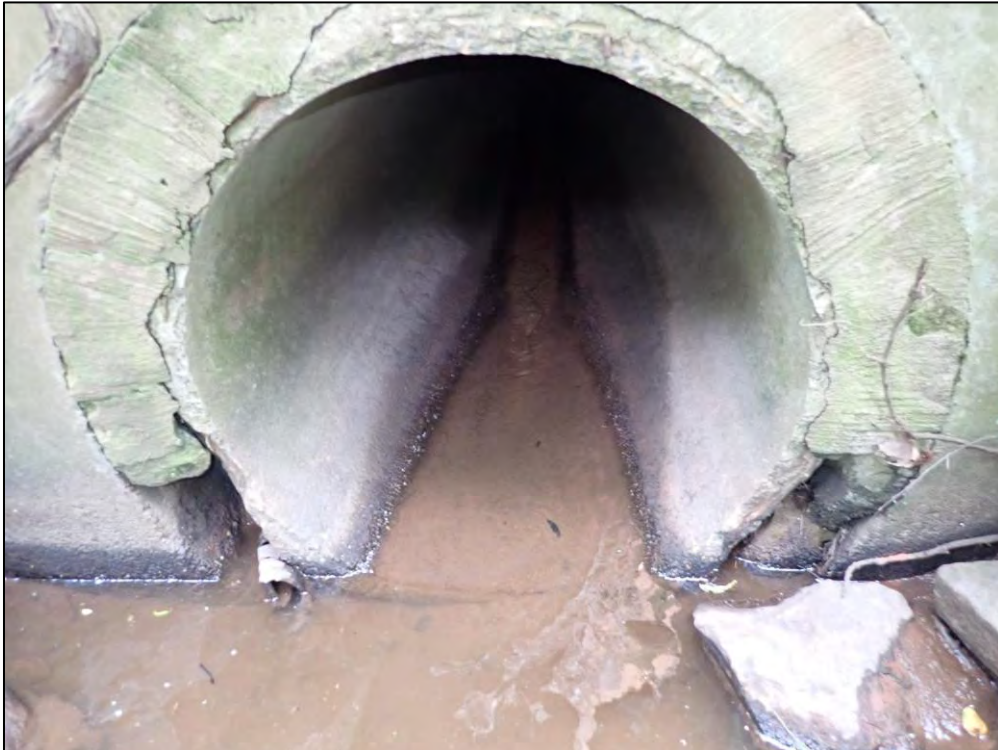
Principal Spillway Pipe			
1	Spillway is blocked by debris or sediment		
1	Evidence of leaking joints		
1	One or more sections of the pipe have settled to the point that it threatens the integrity of the dam		
Impoundment Area and Side Slopes			
1	Buildup of trash and debris		
1	Silt and sedimentation buildup		
1	Ponding area is showing signs of poor health (i.e. nutrient overload, excess aquatic vegetation, or turbidity)		
1	Signs of erosion along shoreline		
1	Low-flow ditch is clogged with sediment/debris		
1	Sections of low-flow ditch are cracked or showing signs of undercutting		
3	Sparse vegetation or erosion	Bare spots observed on the eastern bank of the facility (480 Square Feet).	4771, 4772
1	Evidence of nuisance animals		
Outfall Structure and Channel			
1	Outflow is causing undercutting or erosion		
1	Outfall structure has separated more than three inches from principal spillway barrel		
3	Outfall structure is damaged or rusting	Spalling observed on the outfall pipe face (1 bag of concrete).	4783

4783: Outfall Structure 36, close-up. The outfall structure is damaged, Spalling(Routine Maintenance Needed).

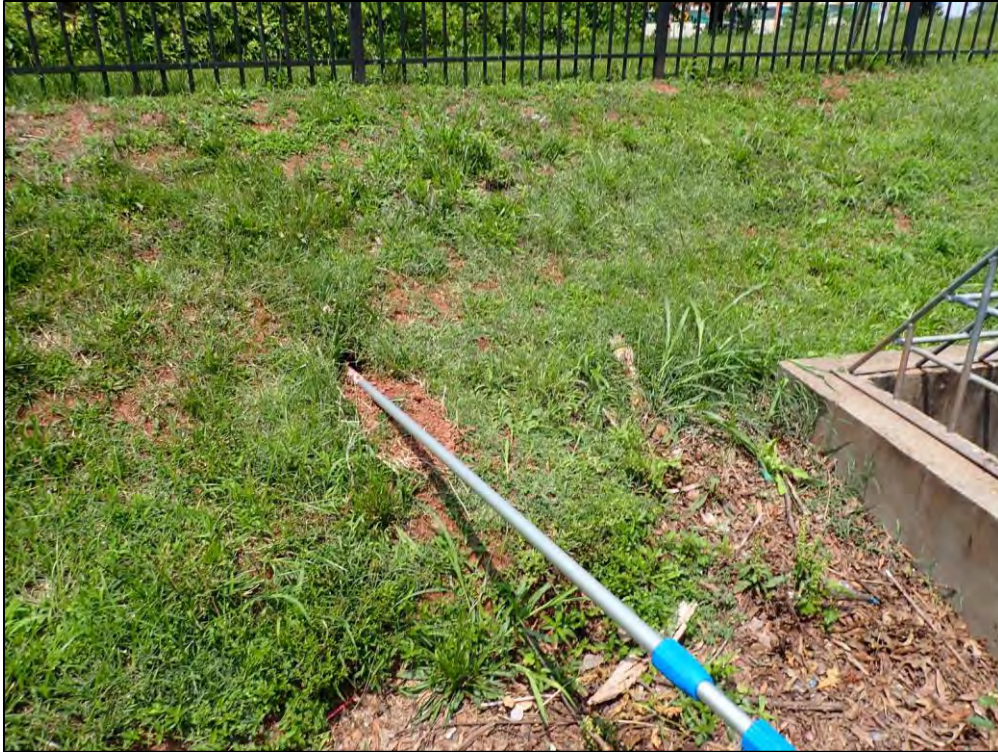
4788: Animal hole, overall. Evidence of nuisance animals (Immediate Repair Needed).

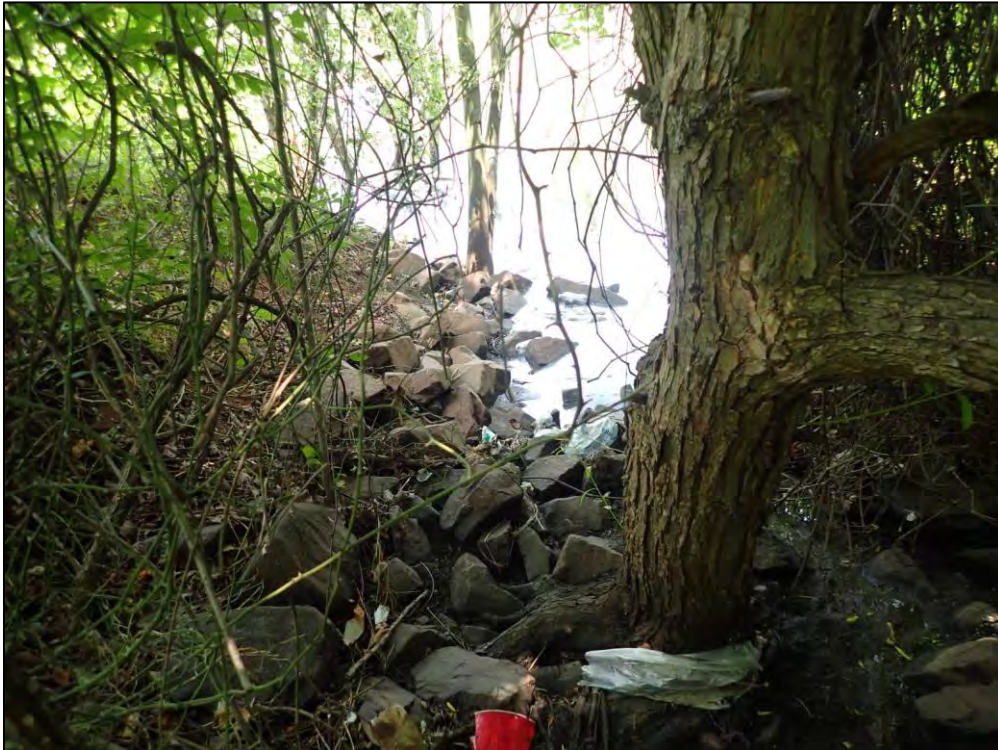
4793: From Inflow Structure 1, looking downstream. Woody growth around inlet structure (Routine Maintenance Needed).

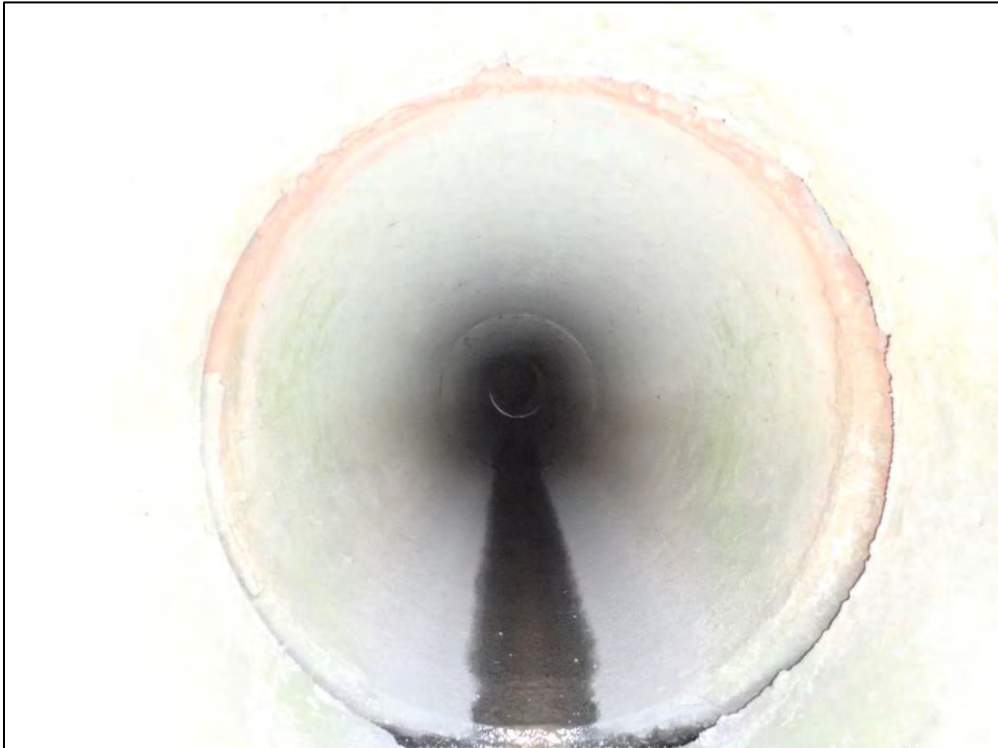
Pre-Treatment					
1	Buildup of trash or debris				
1	Signs of erosion or exposed soil				
1	Sediment in forebay has reached 50% or more of capacity				
1	Evidence of clogging				
1	Vegetation does not match original design				
Inlet					
1	Buildup of trash, debris, and sediment				
1	Evidence of erosion or undermining around inlet				
4	Woody growth around inlet structure		1, 13-24" tree was observed adjacent to Inflow Structure 1. Remove woody vegetation and vines adjacent to inflow structure (200 Square Feet).	4793	
1	Evidence of nuisance animals				
3	Damage to inlet pipe or structure		A joint separation was noted in Inflow	4797

4797: Inside Inflow Structure 21. Joint misalignment and separation. (Routine Maintenance Needed).

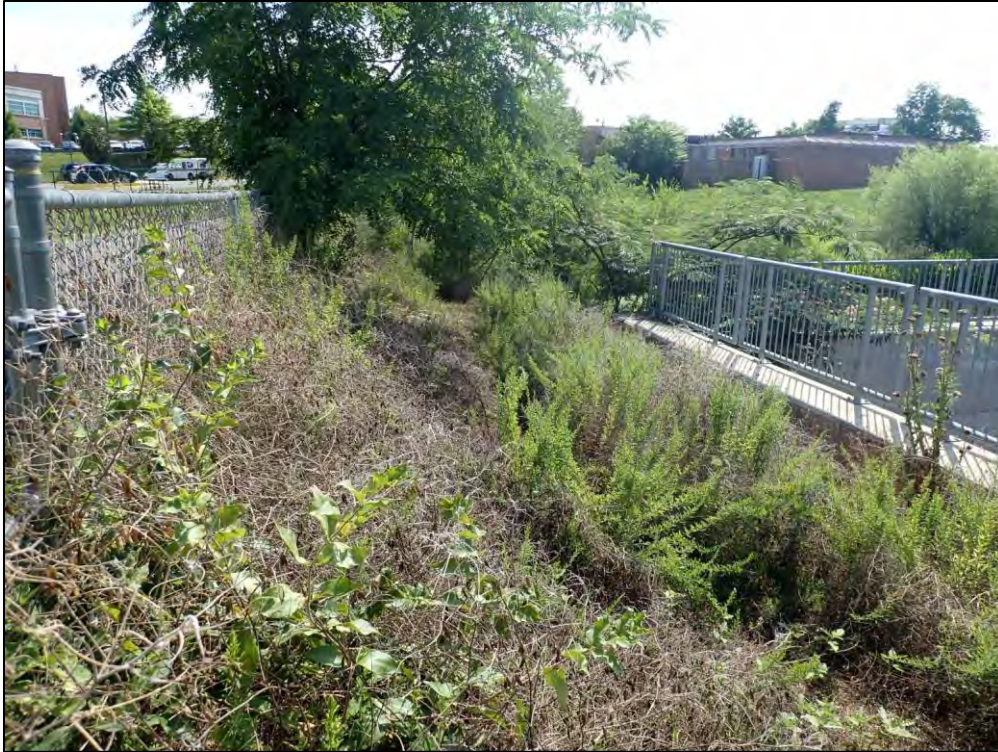
4430: Dam Overall, front slope. Shrubbery, low-growing vegetation, and/or vine material growing on the embankment (Routine Maintenance Needed).

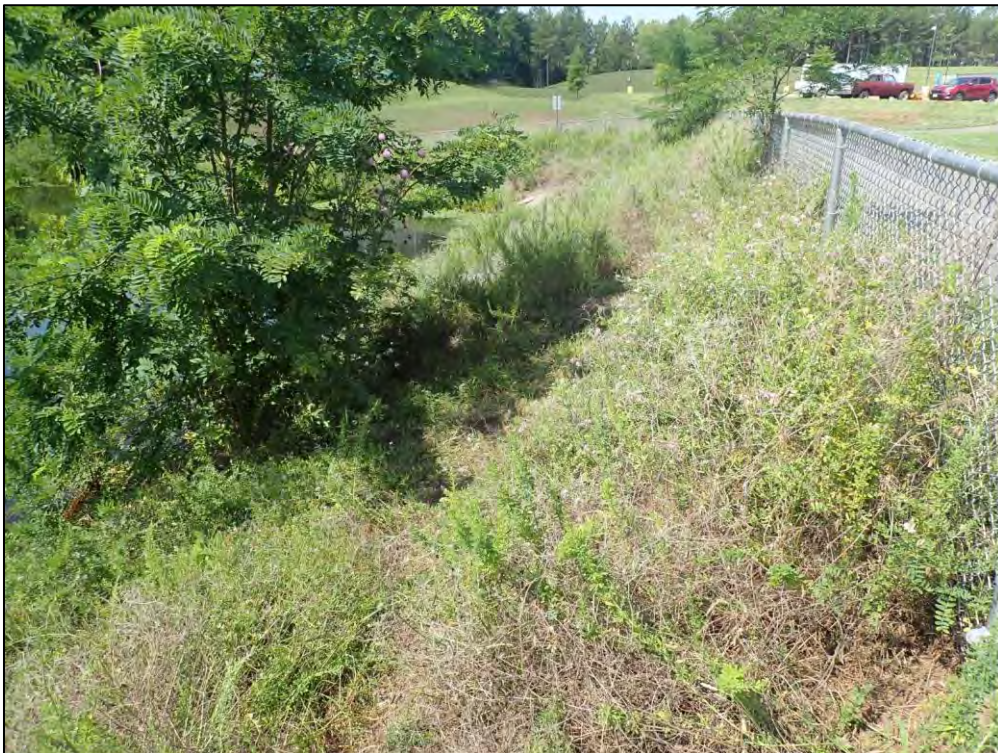
4431: Dam Overall, front slope. Shrubbery, low-growing vegetation, and/or vine material growing on the embankment (Routine Maintenance Needed).

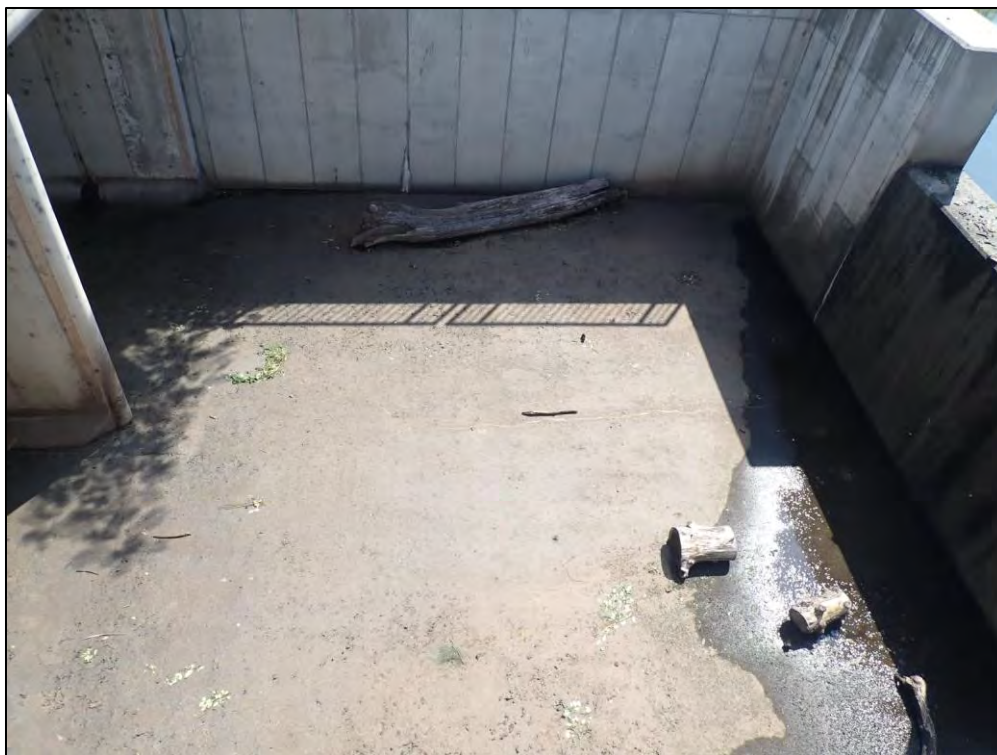
2	Trash, debris, or other material in BMP device	Debris is beginning to accumulate inside Control Structure 11 (0.30 Cubic Yards).	4434
Principal Spillway Pipe			
1	Spillway is blocked by debris or sediment		
1	Evidence of leaking joints		
1	One or more sections of the pipe have settled to the point that it threatens the integrity of the dam		
Impoundment Area and Side Slopes			
1	Buildup of trash and debris		
1	Silt and sedimentation buildup		
1	Ponding area is showing signs of poor health (i.e. nutrient overload, excess aquatic vegetation, or turbidity)		
1	Signs of erosion along shoreline		
1	Sparse vegetation or erosion		
1	Evidence of nuisance animals		
Outfall Structure and Channel			
1	Outflow is causing undercutting or erosion		
1	Outfall structure has separated more than three inches from principal spillway barrel		
1	Outfall structure is damaged or rusting		
1	Woody vegetation growing within 5' of outlet and barrel

4434: Inside Control Structure 11. Trash, debris, or other material in BMP device (Monitor).
