Infiltration Trench Inspection Report					
Facility Name	Fairview Riverdale	Facility ID	STMF0090080	Type of Inspection: Initial Inspection	
Location	Lat: 38.747968 Long: -77.460524	Watershed	Lower Bull Run	Previous 48 Hour Precipitation Total	0.35"
Materials available for inspection	N/A	Owner Notification Date	N/A	Owners/ Owner's Representative	City of Manassas
Inspectors	gky_mfreeman	Date of Inspection	6/28/2023	Date of Last Inspection	3/29/2022
Overall Condition Score					
	1	Adequate	No deficiencies identified.		
	2	Monitor	No maintenance may be needed at the time, but might become an issue in the future. Will revisit next inspection. Examples include minor erosion, small sediment accumulation, or small structural issues of facility components.		
	3	Routine Maintenance Needed	Facility is functional but preventative maintenance is required. Examples includes vegetation management, minor erosion, or trash/debris removal.

Facility ID: STMF0090080
Facility Name: Fairview Riverdale

Inspection Date: 06/28/2023

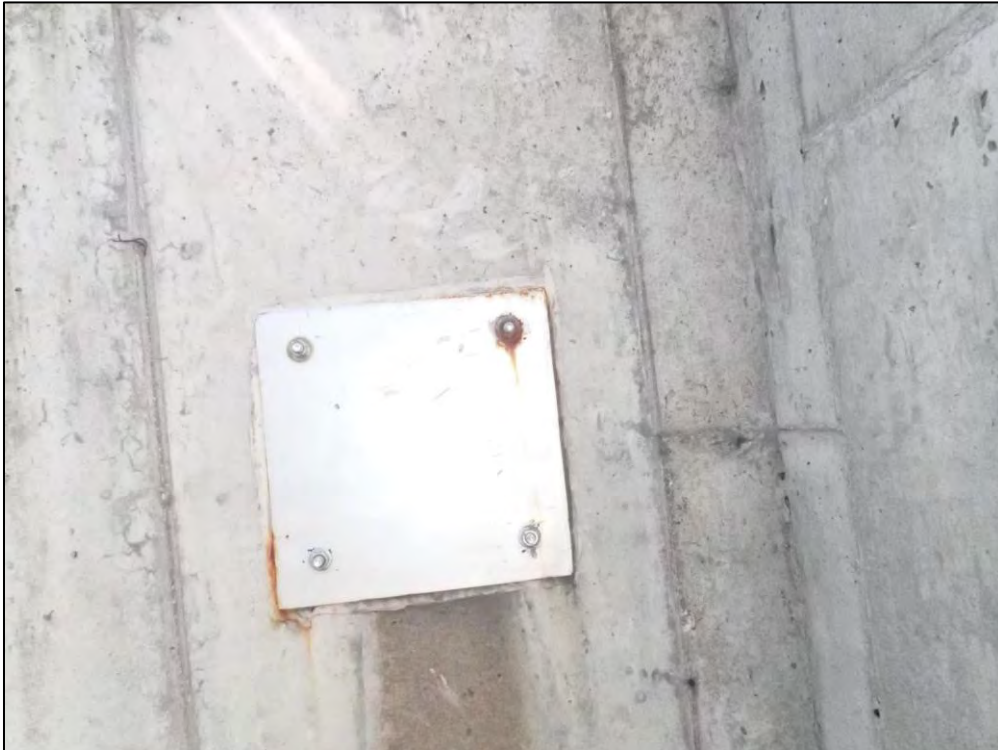
4442: Inside Control Structure 11, looking upstream toward the Dewatering Orifice. The BMP Orifice Plate device is missing (Immediate Repair Needed).

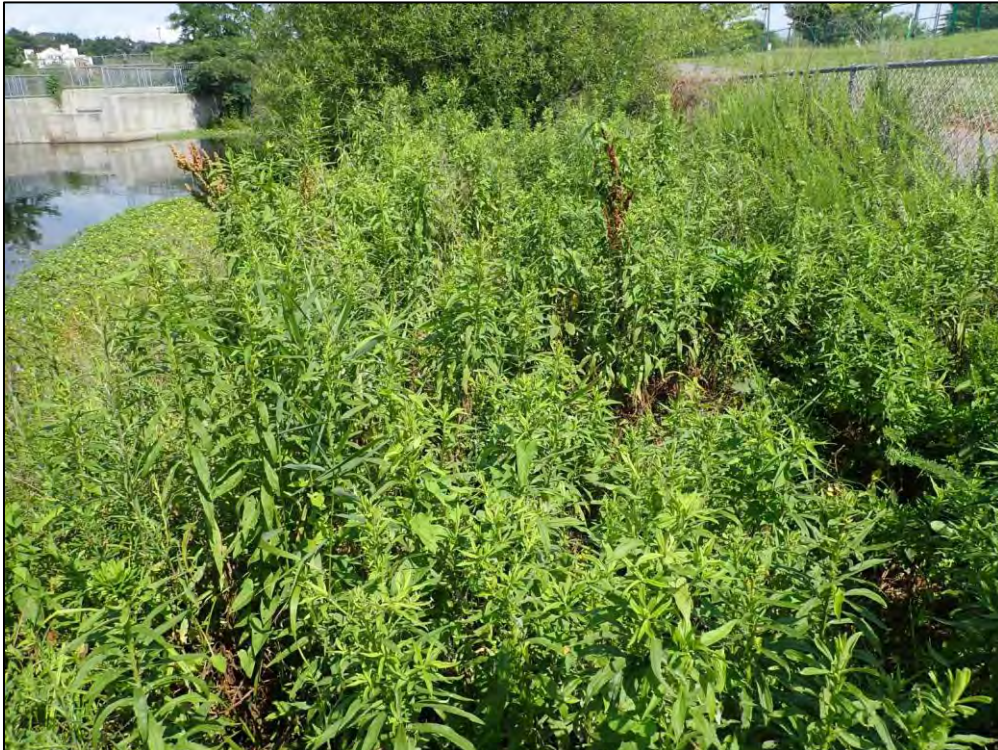
4448: Inflow 1, Overall. Woody growth around inflow structure (Immediate Repair Needed).

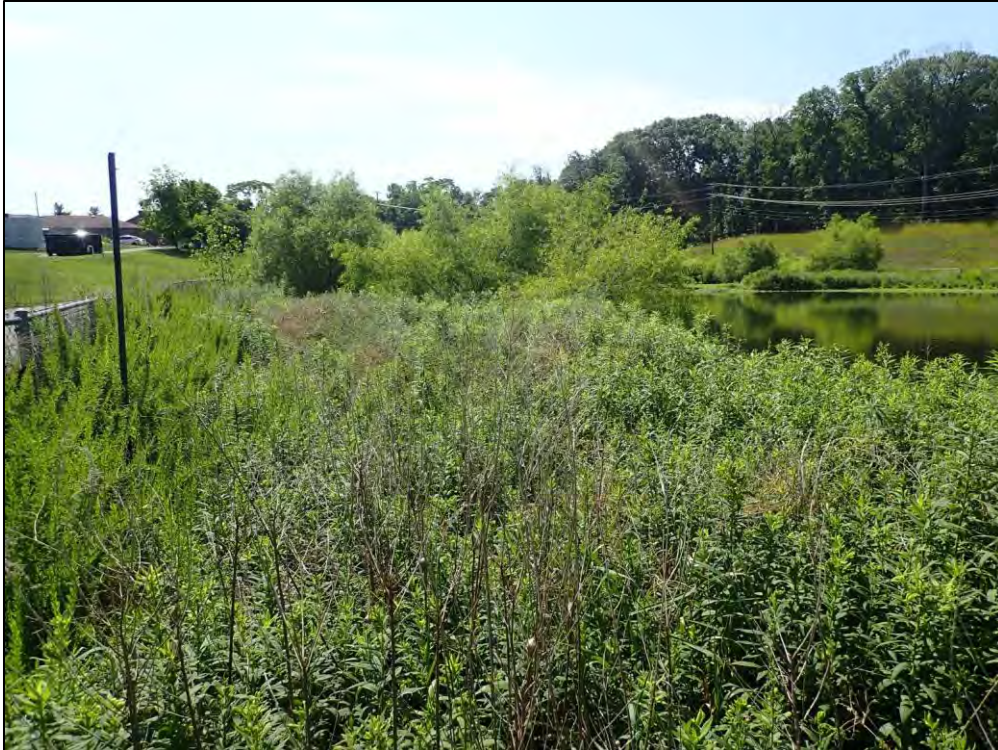
4451: Inflow 2, Overall. Woody growth around inflow structure (Immediate Repair Needed).

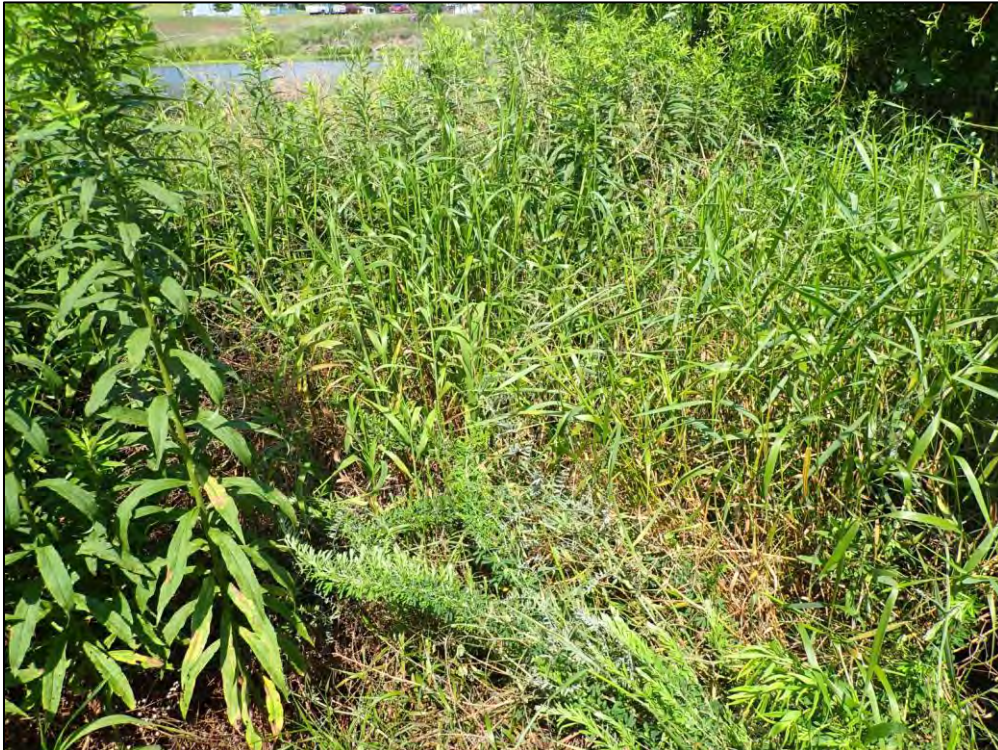
4452: Inflow 2, Overall. Woody growth around inflow structure (Immediate Repair Needed).

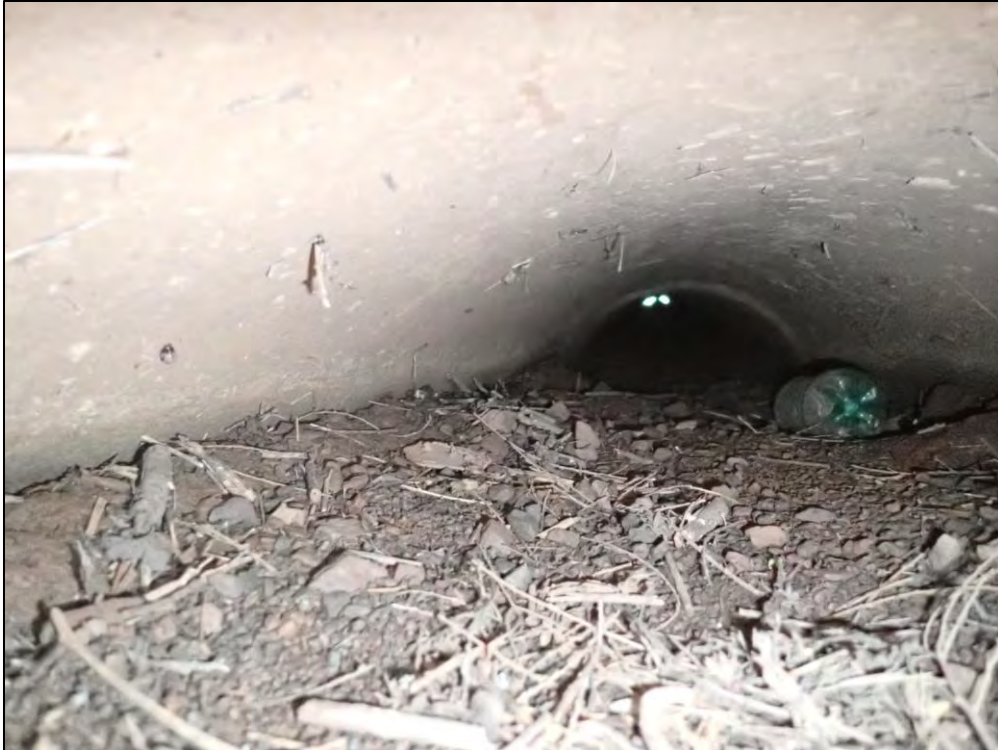
4464: Inflow Structure 3A, closeup. Buildup of trash, debris, and sediment (Immediate Repair Needed).

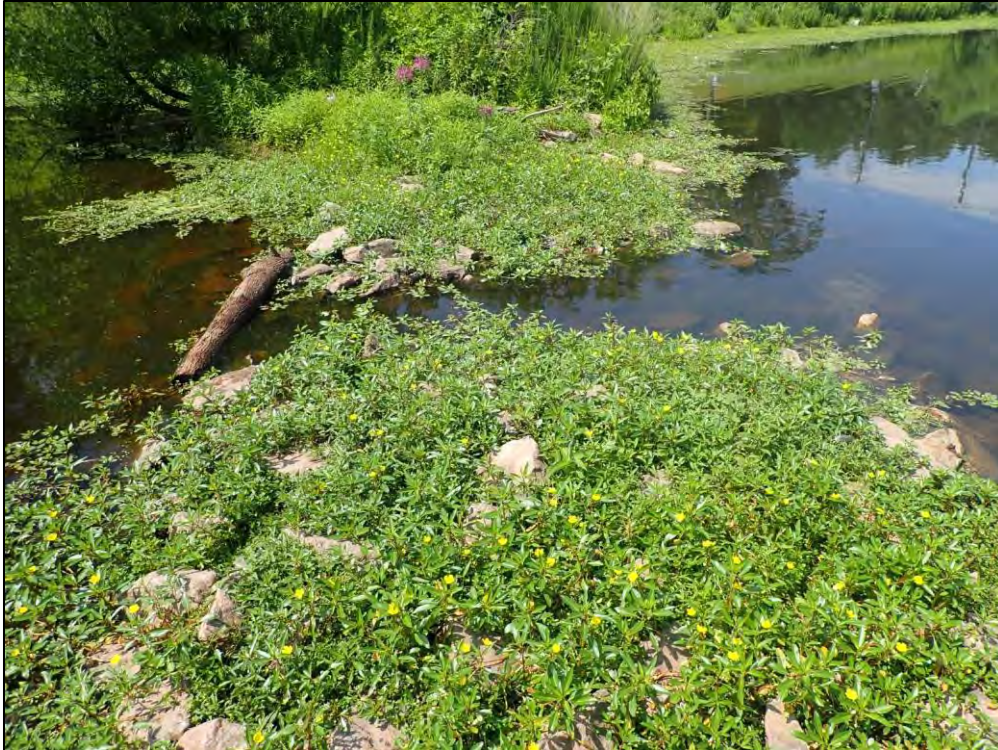
4474: Weir Overall. Buildup of trash or debris (Routine Maintenance Needed).

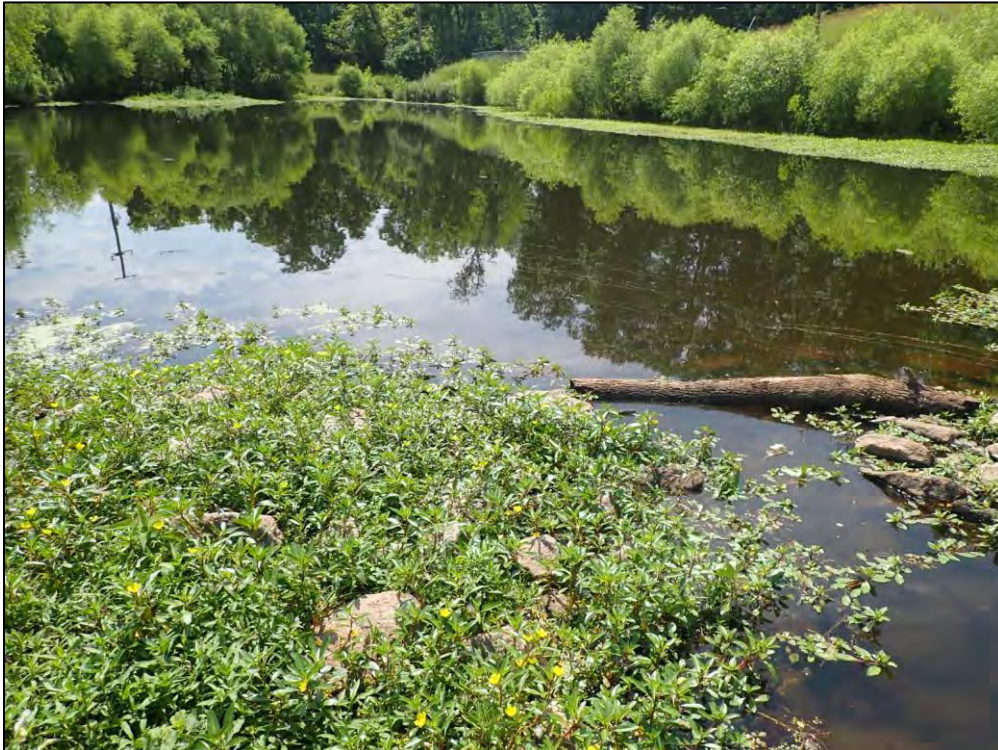
4475: Weir Overall. Buildup of trash or debris (Routine Maintenance Needed).

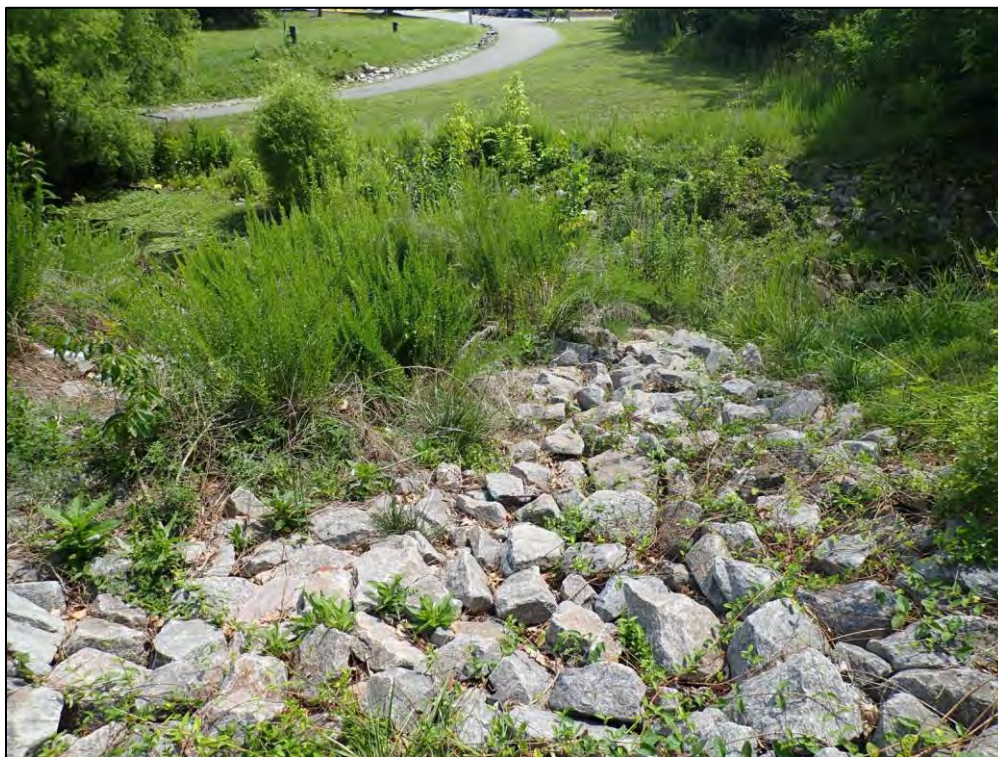
4486: Looking upstream along Inflow 8. Woody growth around inflow structure (Routine Maintenance Needed).

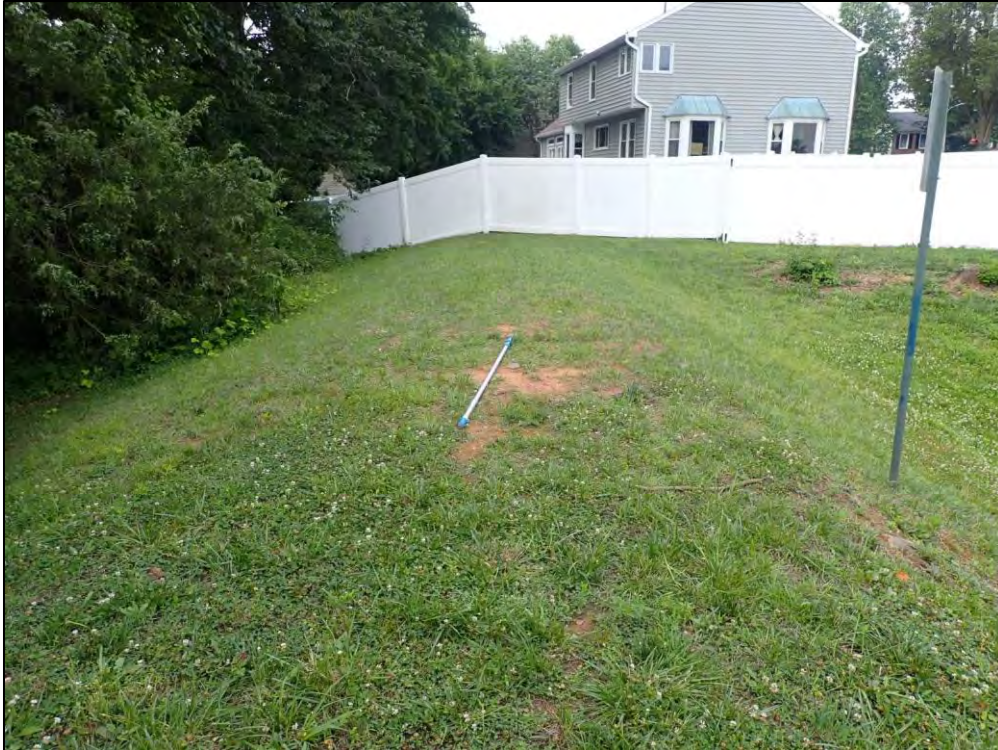
4732: Dam Overall. Sparse vegetative coverage (Monitor).

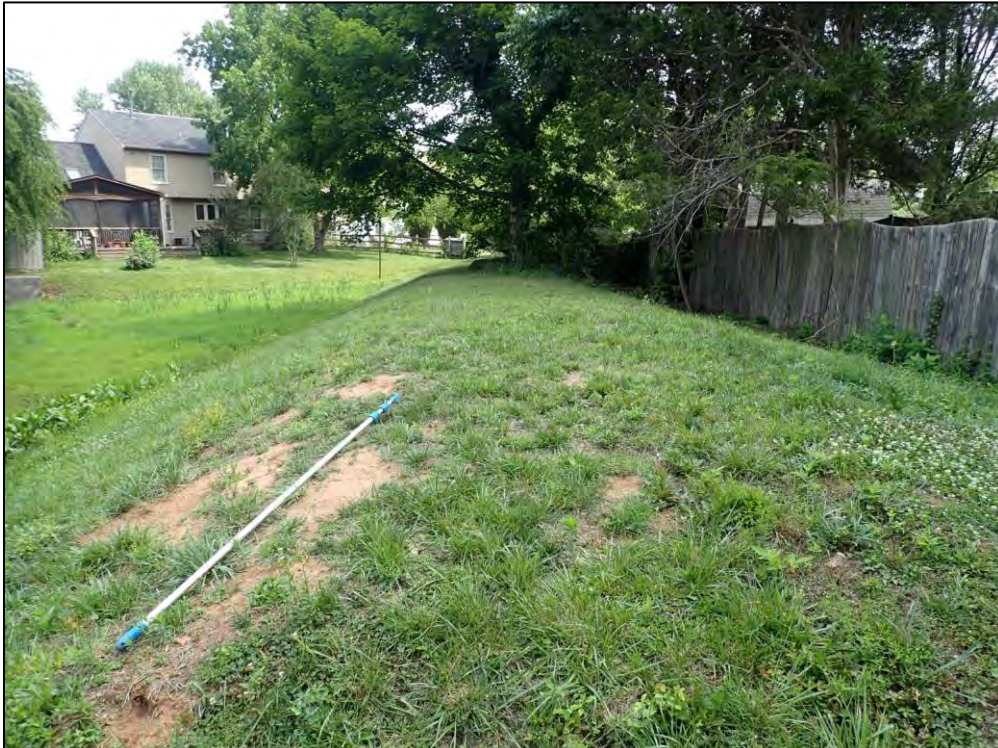
4733: Dam Overall. Sparse vegetative coverage (Monitor).

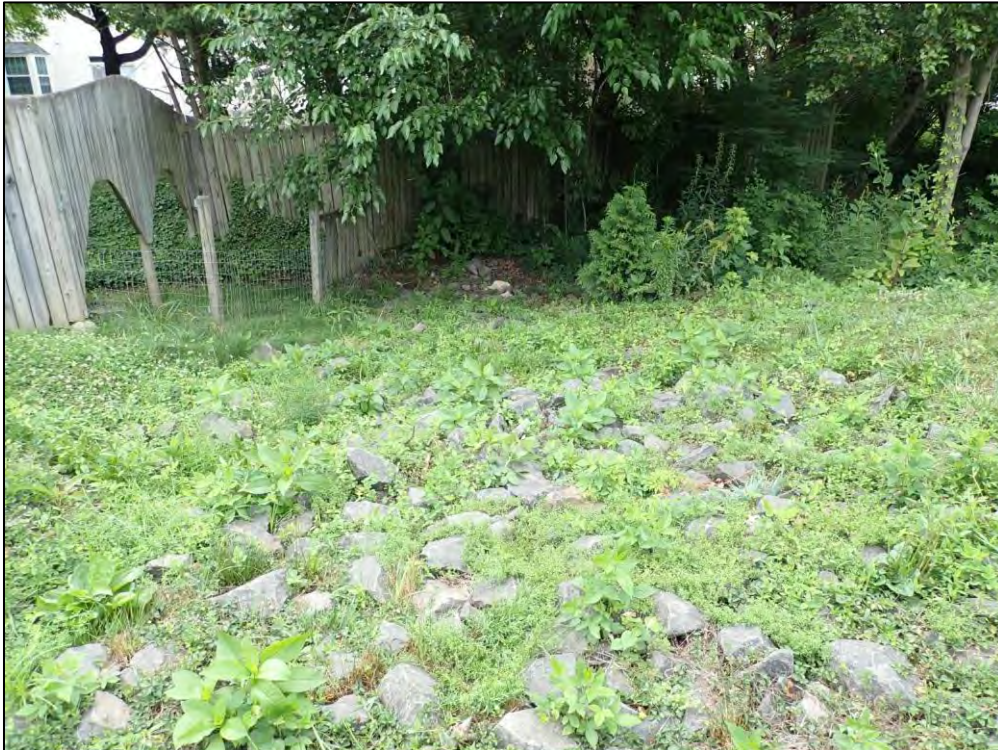
4735: Looking downstream along the Emergency Spillway. Shrubbery, low-growing vegetation, and/or vine material growing on the embankment (Routine Maintenance Needed).

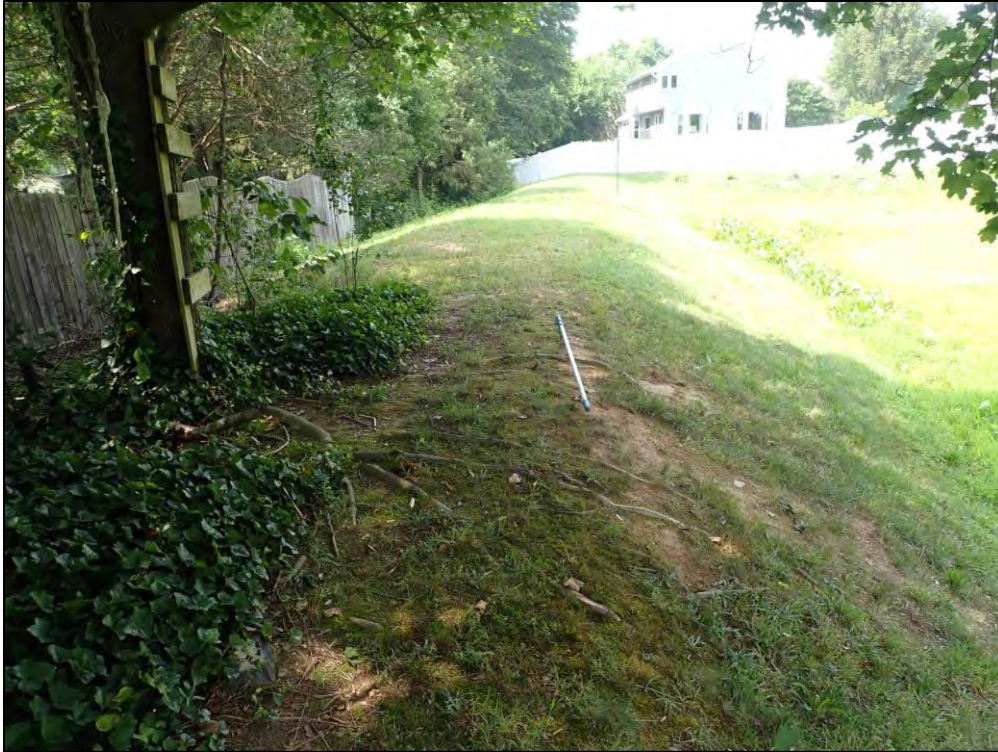
4736: Dam Overall. Sparse vegetative coverage (Monitor).

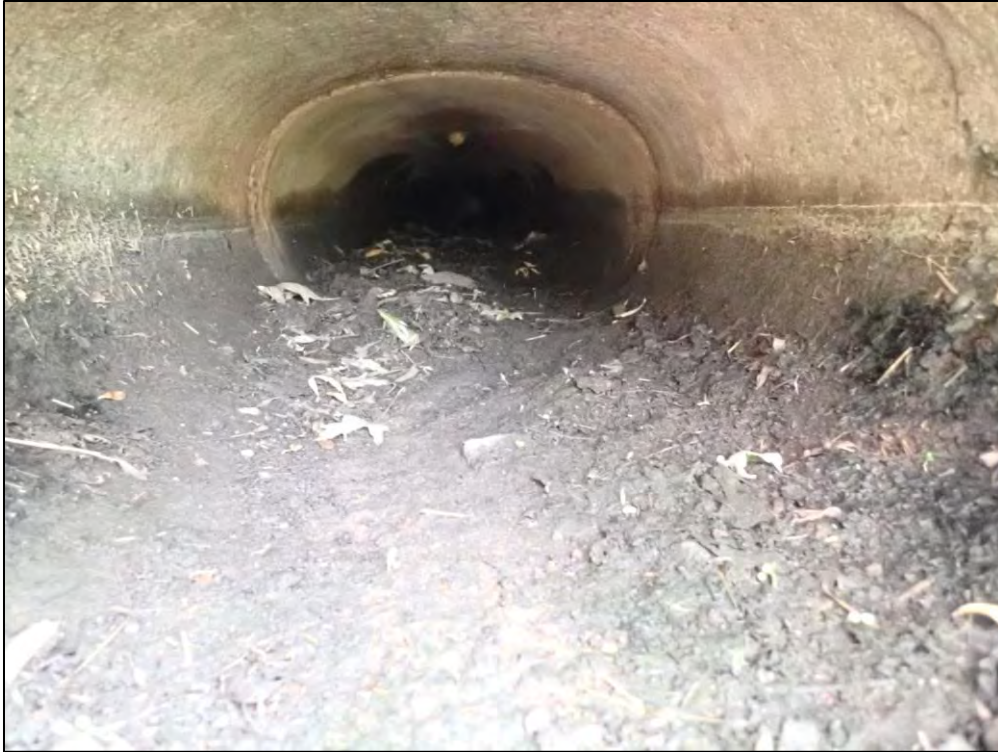
4738: Inside Inflow Structure D1. Buildup of trash, debris, and sediment (Routine Maintenance Needed).

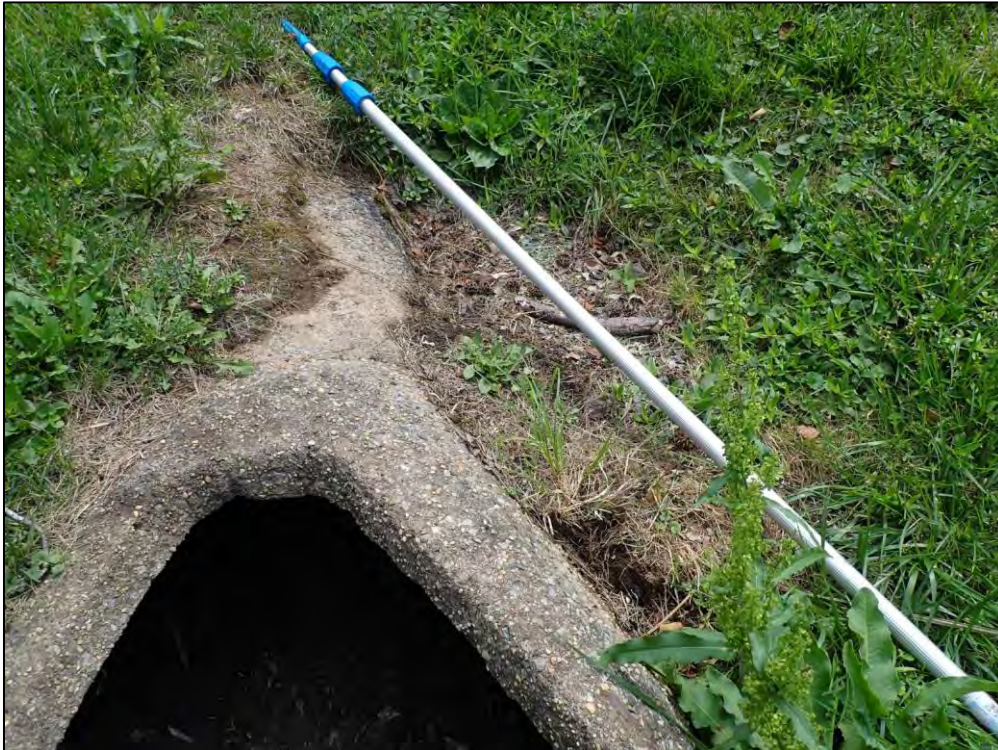
4739: Inflow Structure D1, closeup. Evidence of erosion or undermining around inlet (Routine Maintenance Needed).

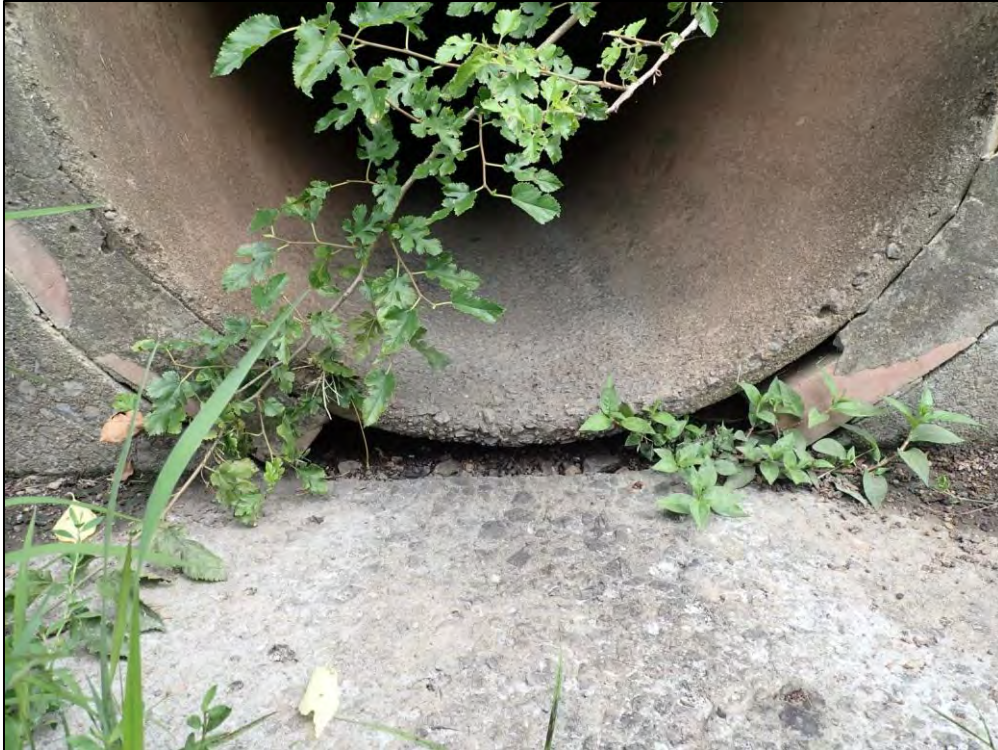
1	Sediment in forebay has reached 50% or more of capacity				
1	Evidence of clogging				
1	Vegetation does not match original design				
Inlet					
3	Buildup of trash, debris, and sediment	Debris and sediment accumulating in and downstream of Inflow Structure D1 (8 Cubic Feet) and Inflow Structure A1 (6 Cubic Feet).		4738, 4752	
3	Evidence of erosion or undermining around inlet	Erosion was observed adjacent to Inflow Structure D1 (4 Cubic Feet).		4739	
1	Woody growth around inlet structure				
1	Evidence of nuisance animals				
3	Damage to inlet pipe or structure	Spalling was observed on the front of Inflow Structure B1 (1 bag of concrete).		4744

4744: Inflow Structure B1, closeup. Damage to inlet pipe or structure (Routine Maintenance Needed).

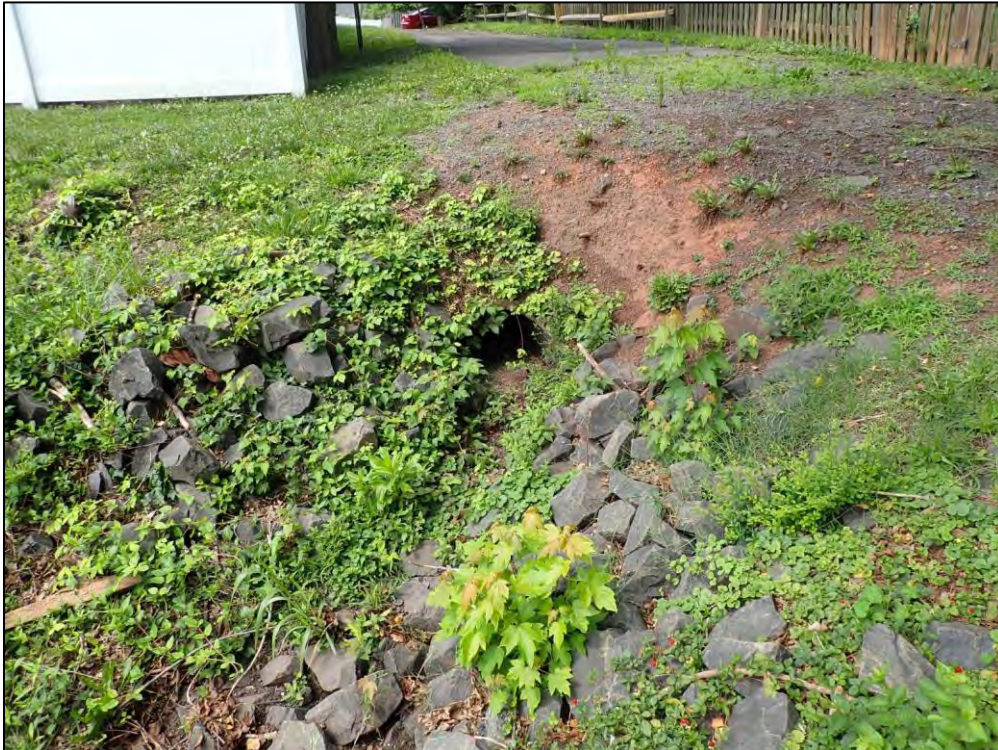
4750: Inflow Structure A1, front. Sparse vegetative coverage (Monitor).

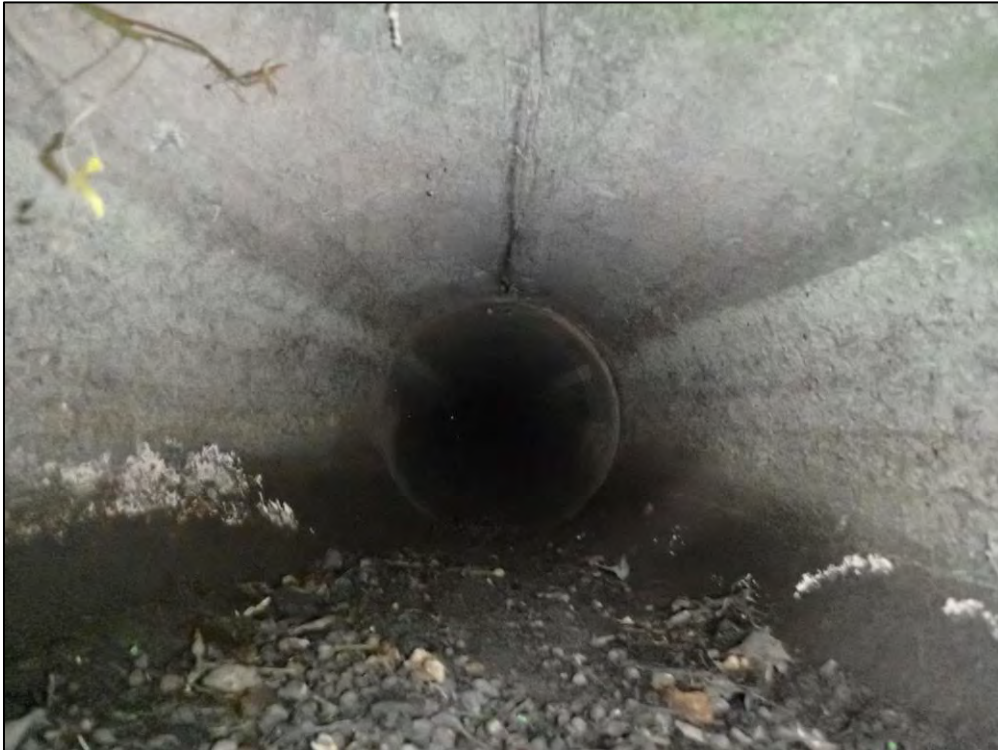
4752: Inside Inflow Structure A1. Buildup of trash, debris, and sediment (Routine Maintenance Needed).

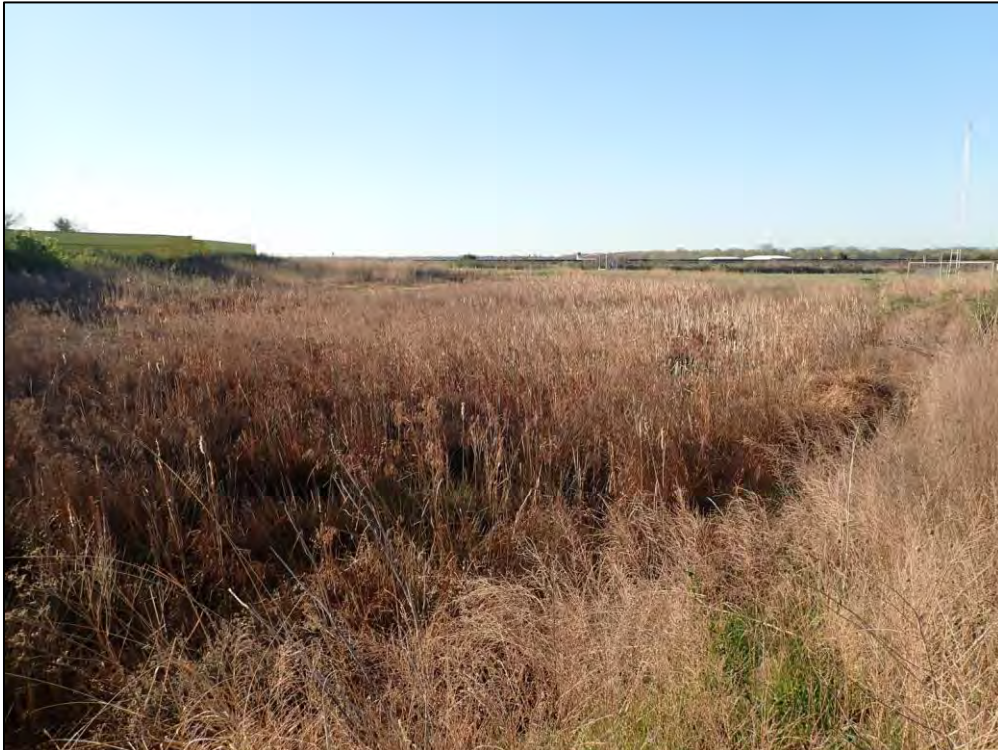
2691: Facility Overall. Overgrown vegetation was observed on the pond floor (Routine Maintenance Needed).

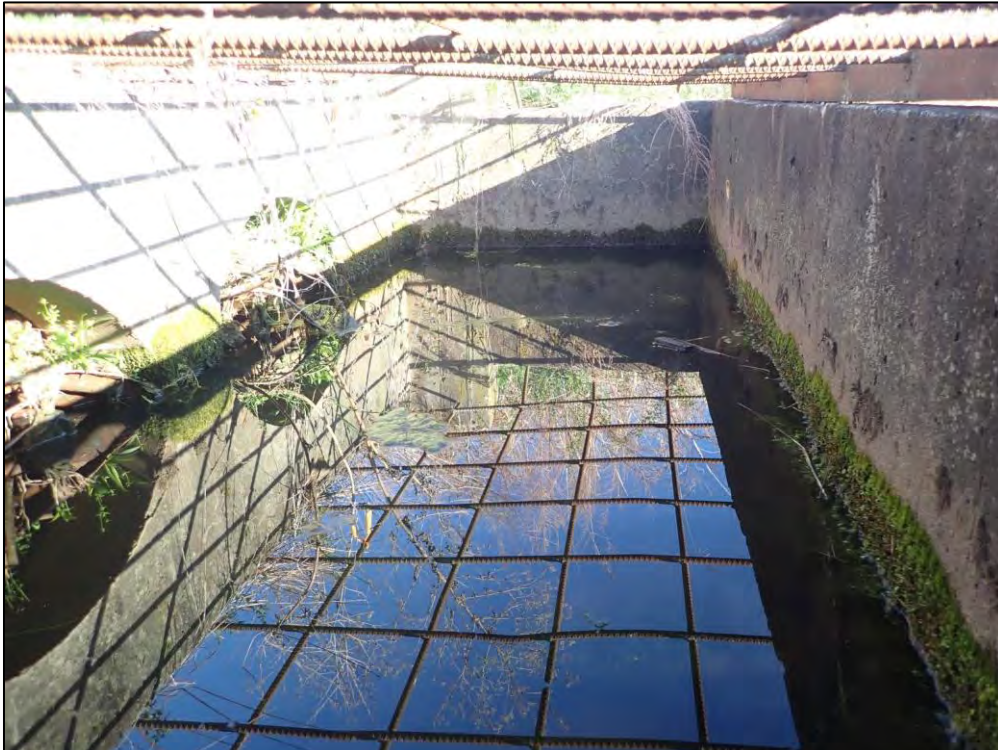
Score	Description	Comment(s) / Corrective Action(s)	Reference Image
Dam Embankment (Includes emergency spillway if applicable)			
3	Woody vegetation on embankment	Trees were observed growing in and adjacent to the Emergency Spillway (13, 2-6" trees).	2704, 2705
1	Shrubbery, low growing vegetation, and/or vine material growing on embankment		
1	Sparse vegetative coverage		
1	Signs of erosion, settlement, piping, or slope slippage		
1	Signs of seepage, soft spots, and sinkhole formation		
1	Evidence of nuisance animals		
1	Buildup of trash or debris on embankment		
1	Trash, debris, or obstructions in emergency spillway		
Outlet/Riser Structure			
1	Low-flow orifice is blocked		
1	BMP device is deteriorated, misaligned, and/or damaged		
1	BMP device is missing		
1	Low-level gate drain is accessible and operational. Drain has been exercised in last three years.		
3	Trash, debris, or other material in BMP device	Debris was observed in the Control Structure (0.25 Cubic Yards).	2695, 2696, 2697

2695: Inside the Control Structure. Trash, debris, or other material in the BMP device (Routine Maintenance Needed).

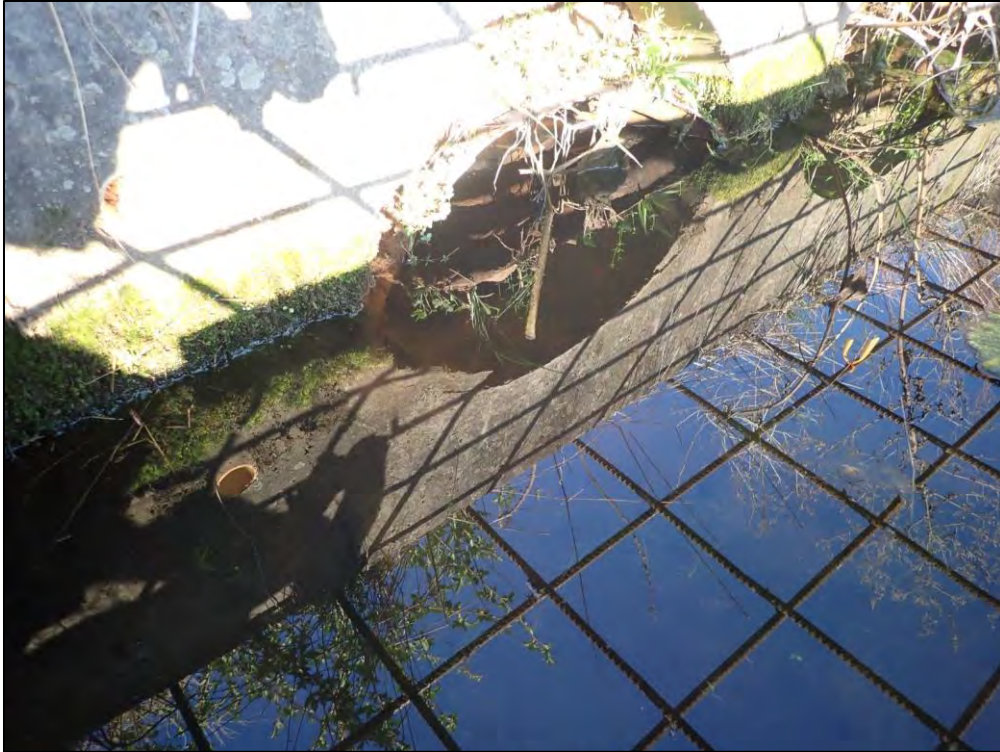
2696: Inside the Control Structure, looking downstream toward the Southern pipe. Trash, debris, or other material in the BMP device (Routine Maintenance Needed).

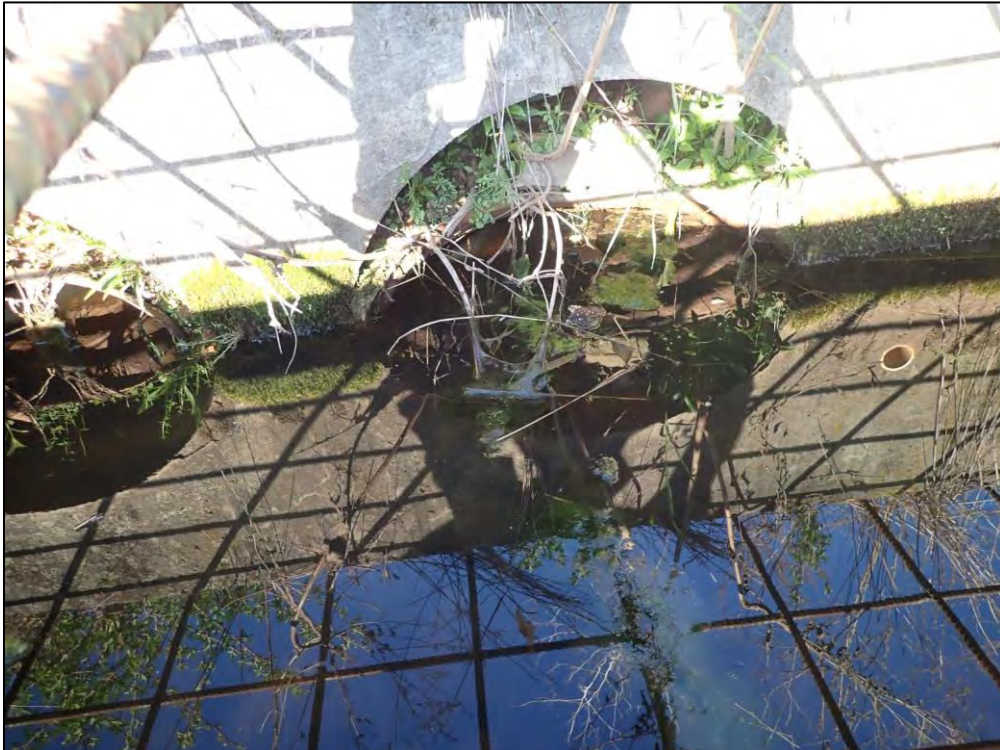
2697: Inside the Control Structure, looking downstream toward the Northern pipe. Trash, debris, or other material in the BMP device (Routine Maintenance Needed).

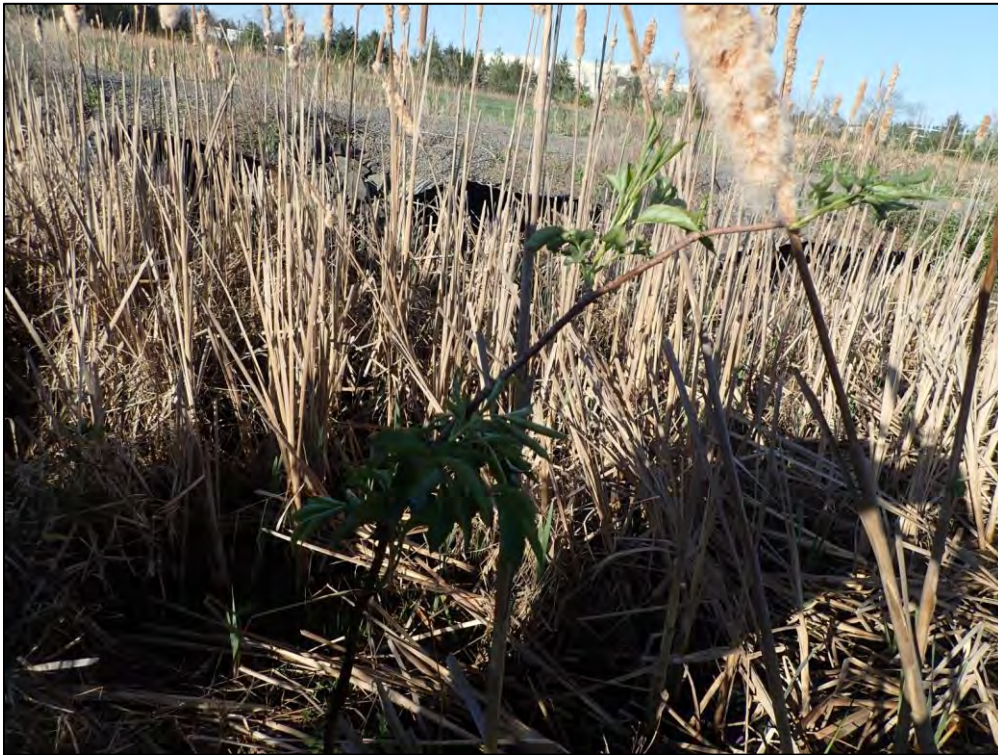
2700: From the Outfall, looking downstream. Overgrown vegetation was observed on the pond floor (Routine Maintenance Needed).

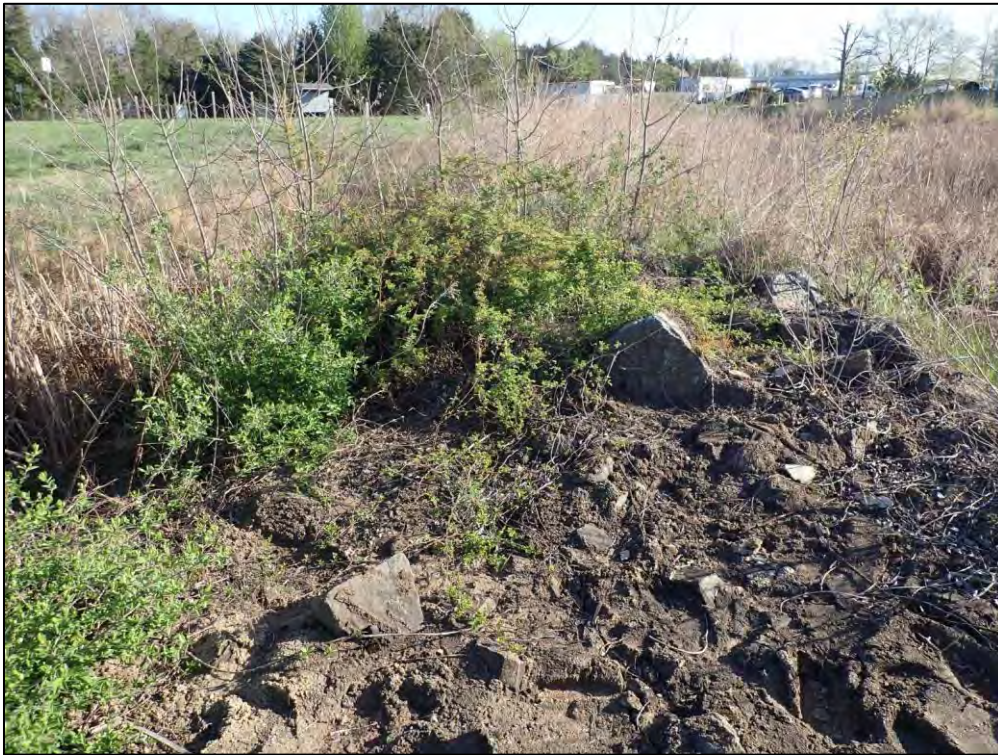
2704: Dam Overall. Woody vegetation on the embankment (Routine Maintenance Needed).

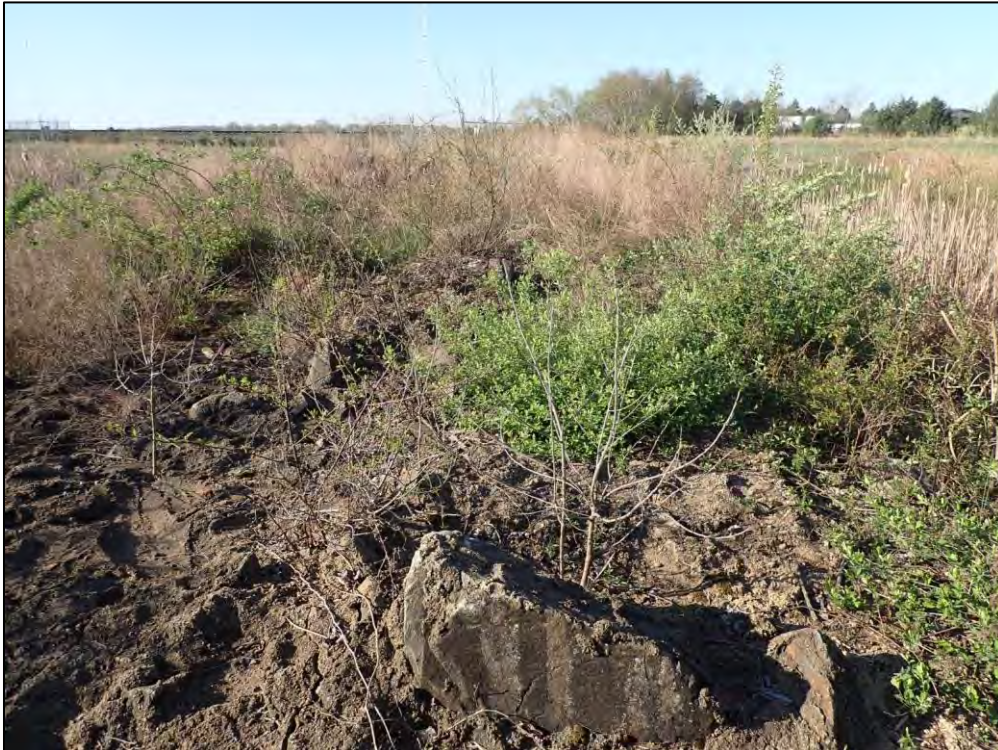
2705: Emergency Spillway, Overall. Woody vegetation on the embankment (Routine Maintenance Needed).

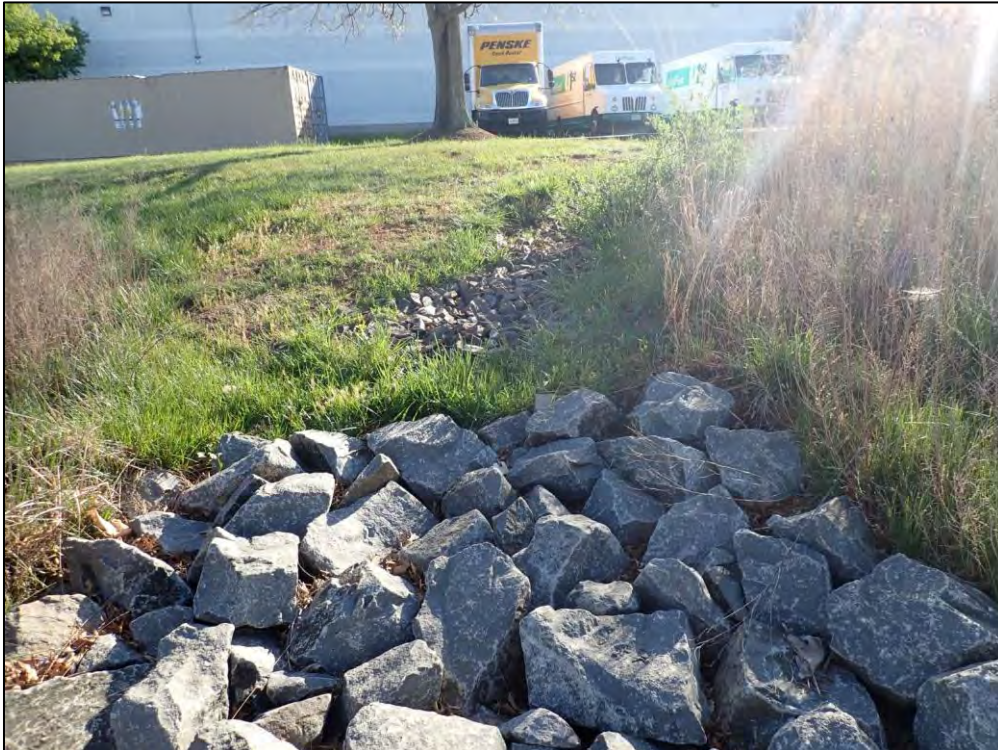
2708: Facility Overall. Overgrown vegetation was observed on the pond floor (Routine Maintenance Needed).

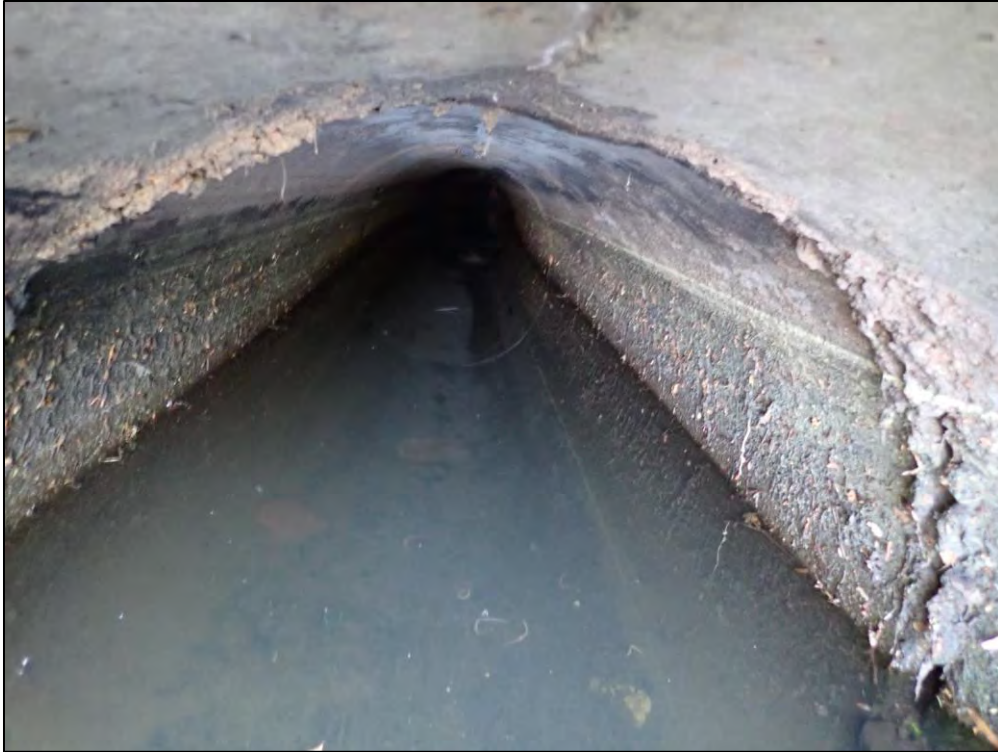
2717: Inflow Structure D9, front. Woody growth around inlet structure (Routine Maintenance Needed).

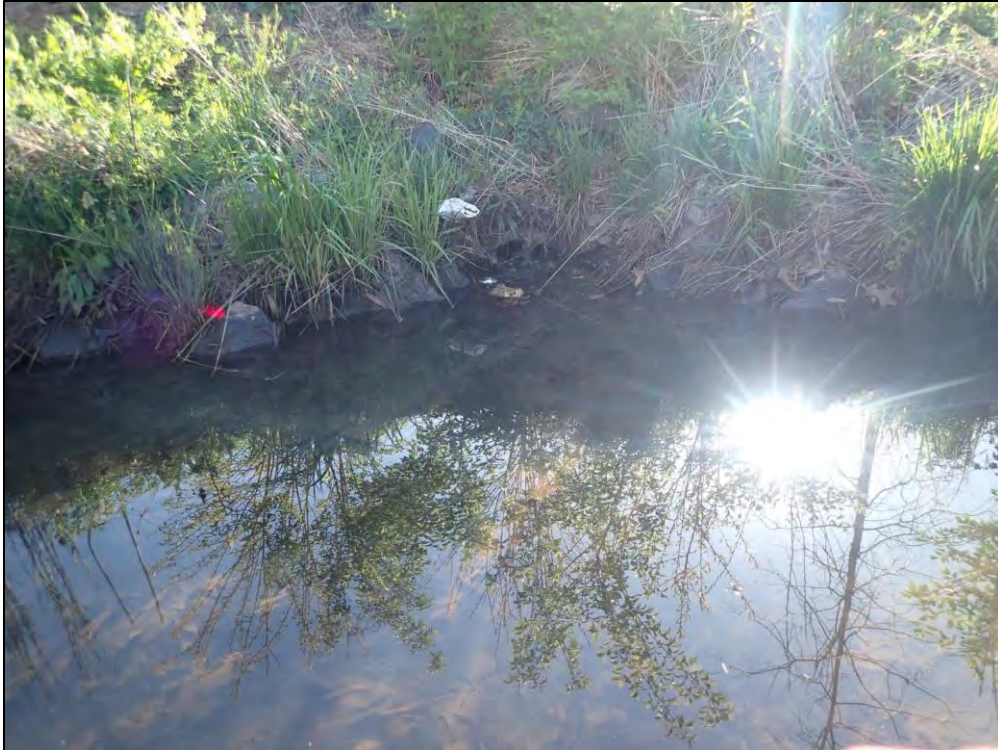
2719: From Inflow Structure D9, looking downstream. Overgrown vegetation was observed on the pond floor (Routine Maintenance Needed).

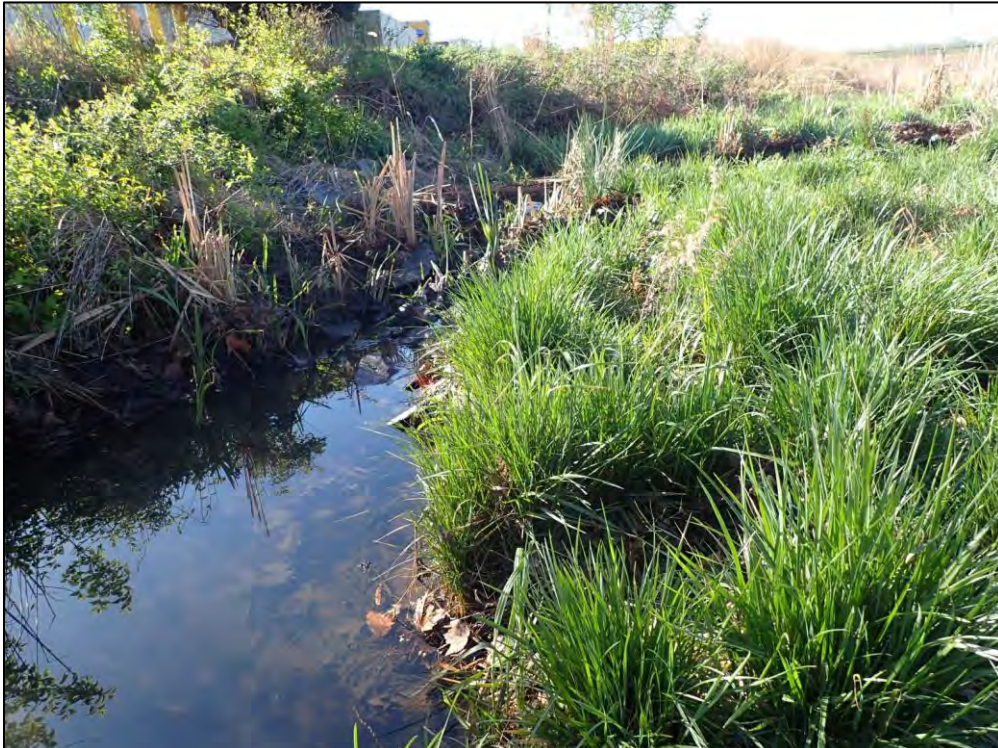
2720: Inflow Structure 4, front. Buildup of trash, debris, and sediment (Immediate Repair Needed).
