Infiltration Trench Inspection Report					
Facility Name	Fairview Riverdale	Facility ID	STMF0090080	Type of Inspection: Initial Inspection	
Location	Lat: 38.747968 Long: -77.460524	Watershed	Lower Bull Run	Previous 48 Hour Precipitation Total	0.35"
Materials available for inspection	N/A	Owner Notification Date	N/A	Owners/ Owner's Representative	City of Manassas
Inspectors	gky_mfreeman	Date of Inspection	6/28/2023	Date of Last Inspection	3/29/2022
Overall Condition Score					
	1	Adequate	No deficiencies identified.		
	2	Monitor	No maintenance may be needed at the time, but might become an issue in the future. Will revisit next inspection. Examples include minor erosion, small sediment accumulation, or small structural issues of facility components.		
	3	Routine Maintenance Needed	Facility is functional but preventative maintenance is required. Examples includes vegetation management, minor erosion, or trash/debris removal.

Facility ID: STMF0090080
Facility Name: Fairview Riverdale

Inspection Date: 06/28/2023

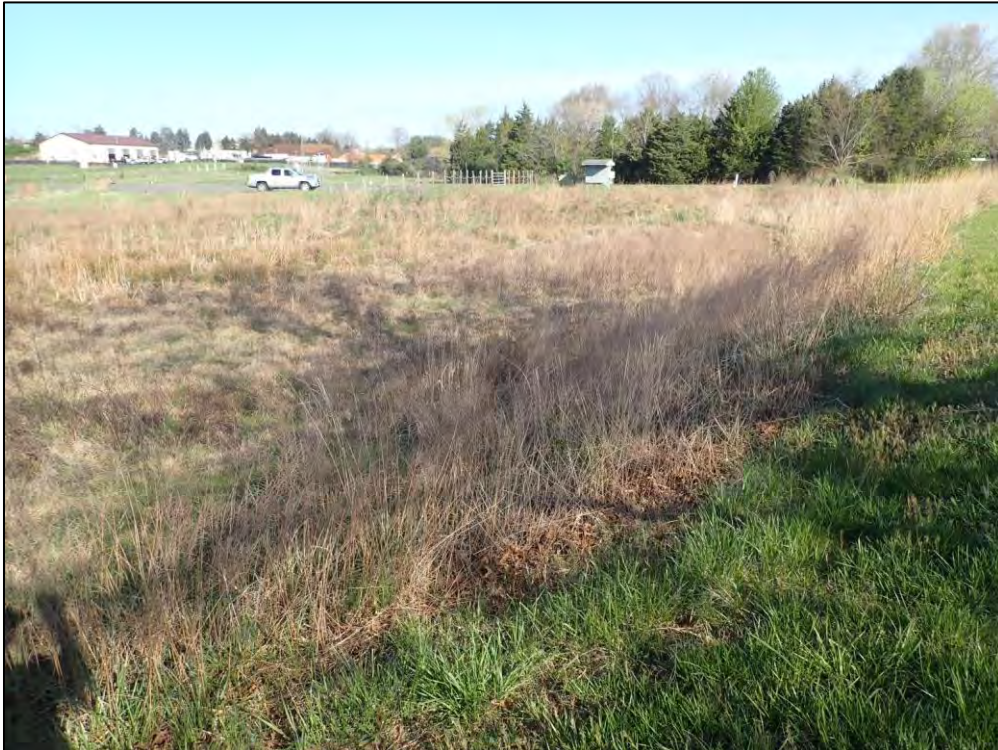
2723: Facility Overall. Overgrown vegetation was observed on the pond floor (Routine Maintenance Needed).

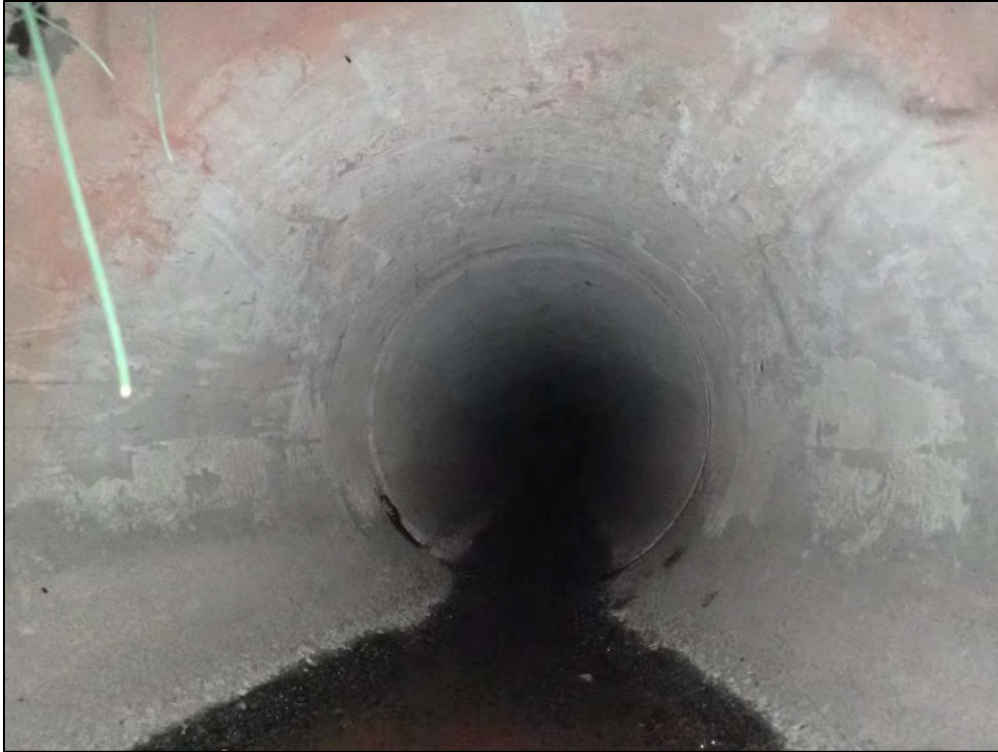
2818: Inside the Outfall. Damage to inlet pipe or structure (Routine Maintenance Needed).

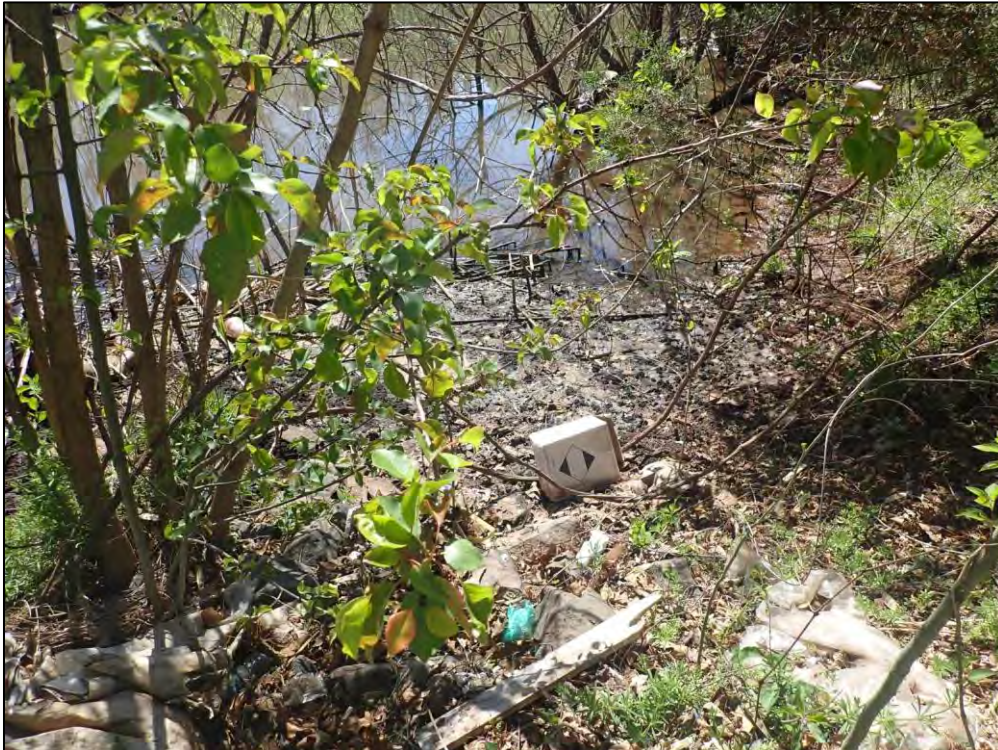
1	Vegetation does not match original design				
Inlet					
3	Buildup of trash, debris, and sediment	Trash, debris, and sediment were observed downstream of Inflow Structure 3A (8 Cubic Feet).		2827	
1	Evidence of erosion or undermining around inlet				
3	Woody growth around inlet structure	Trees were observed adjacent to Inflow Structure 2A (5, 2-6" trees), and Inflow Structure 1A (5, 2-6" trees).		2828, 2831, 2833	
1	Evidence of nuisance animals				
1	Damage to inlet pipe or structure

2827: From Inflow Structure 3A, looking downstream. Buildup of trash, debris, and sediment (Routine Maintenance Needed).

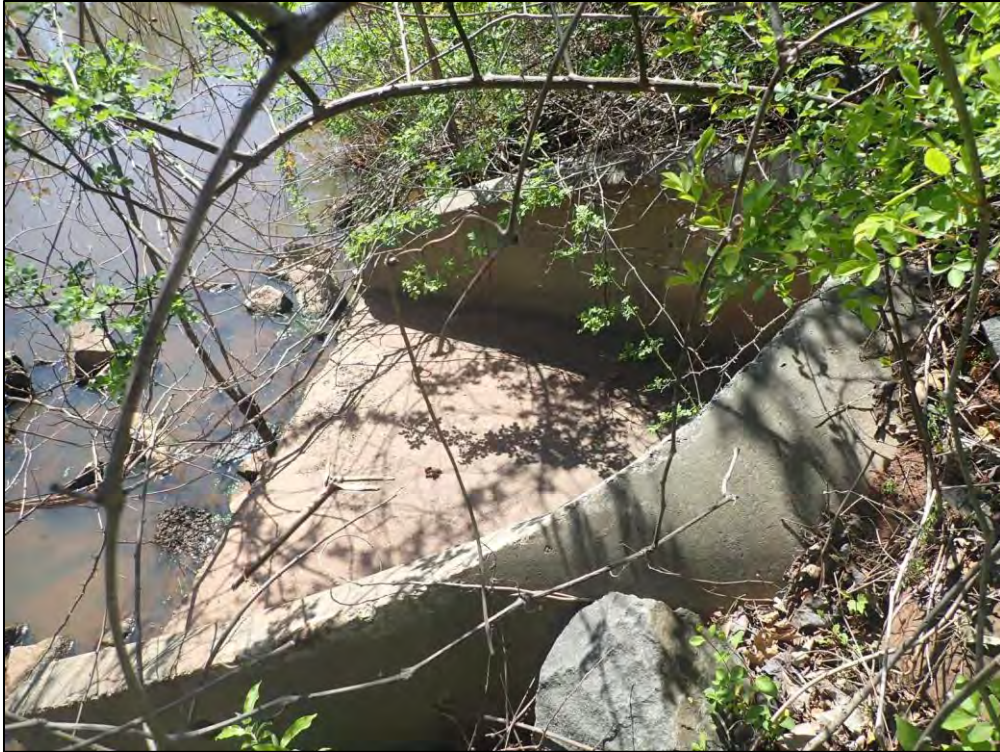
2828: Inflow Structure 2A, closeup. Woody growth around inflow structure (Routine Maintenance Needed).

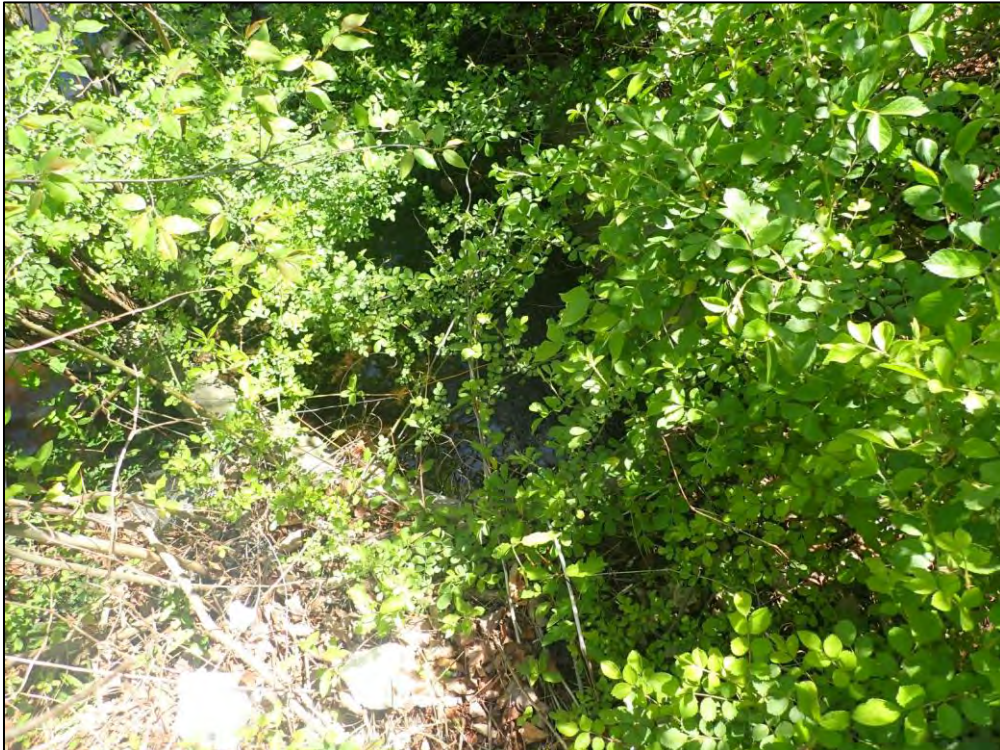
2831: Inflow Structure 1A, Overall. Woody growth around inflow structure (Routine Maintenance Needed).

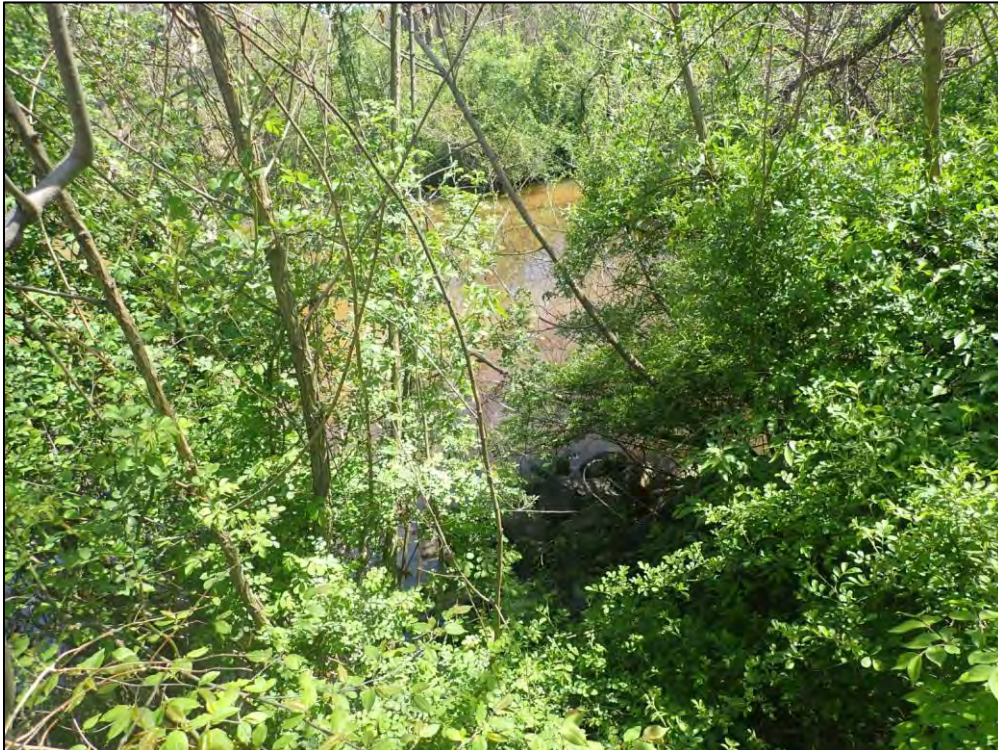
2833: From Inflow Structure 1A, looking downstream. Woody growth around inflow structure (Routine Maintenance Needed).

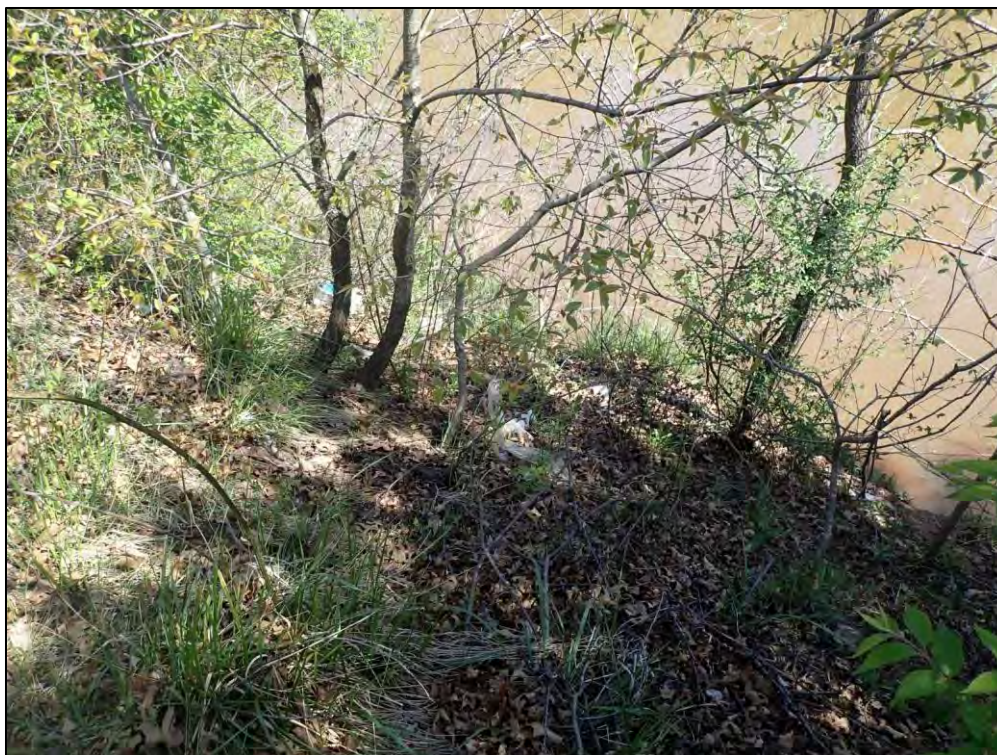
2834: Facility Overall. Buildup of trash and debris (Routine Maintenance Needed).

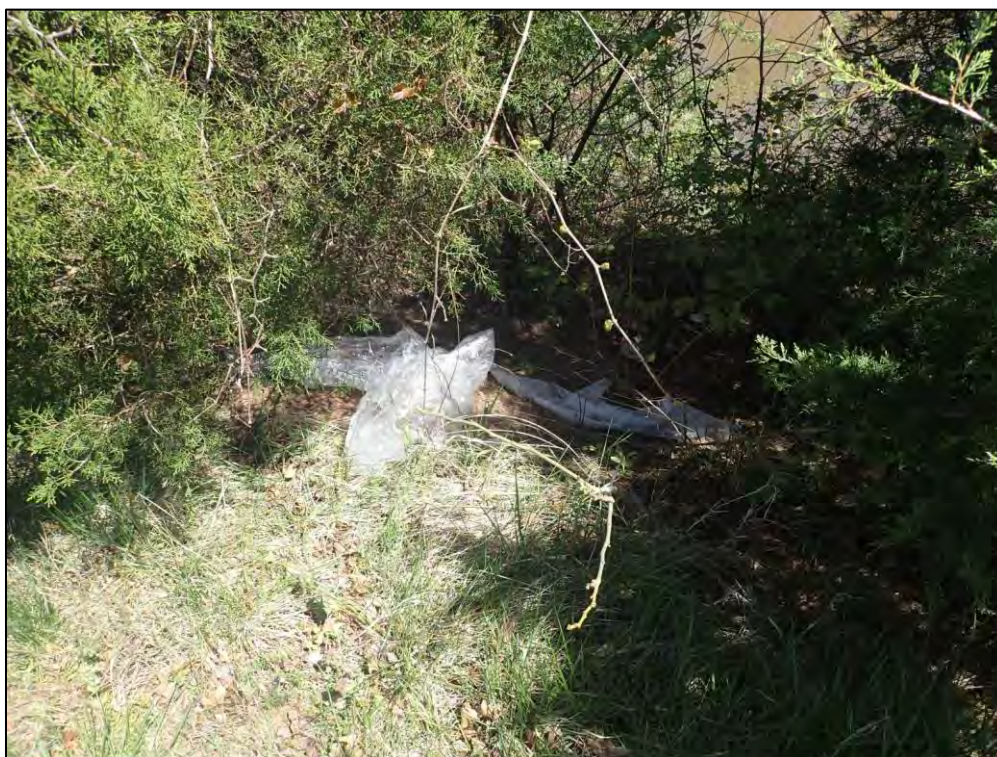
2835: Facility Overall. Buildup of trash and debris (Routine Maintenance Needed).

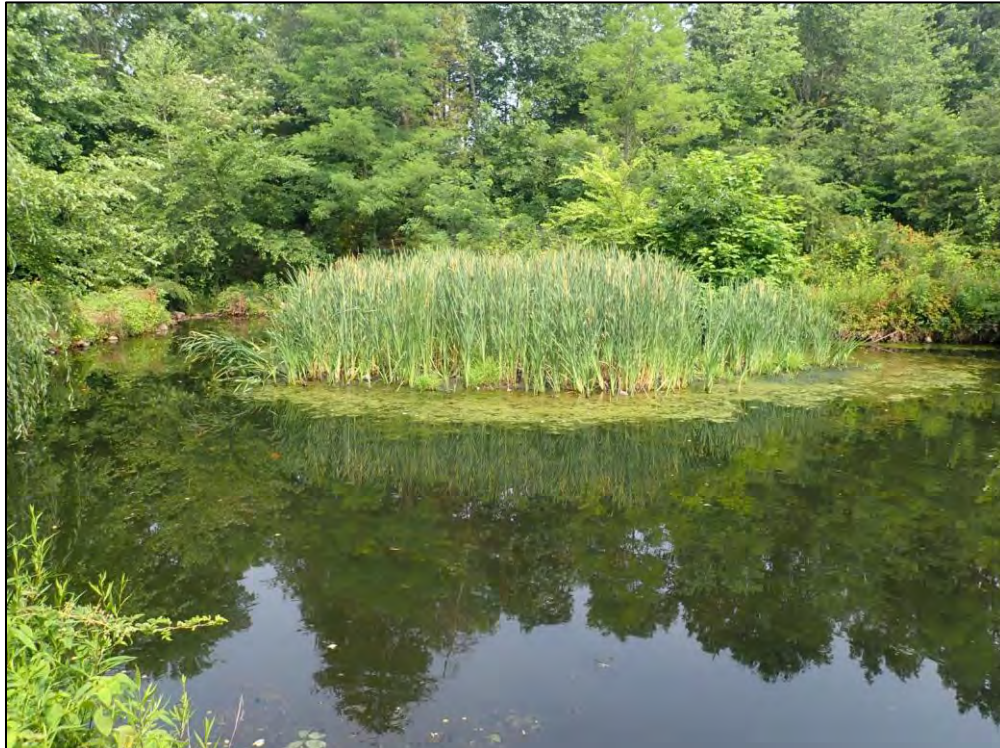
4973: Forebay Overall. Vegetation does not match the original design (Routine Maintenance Needed).

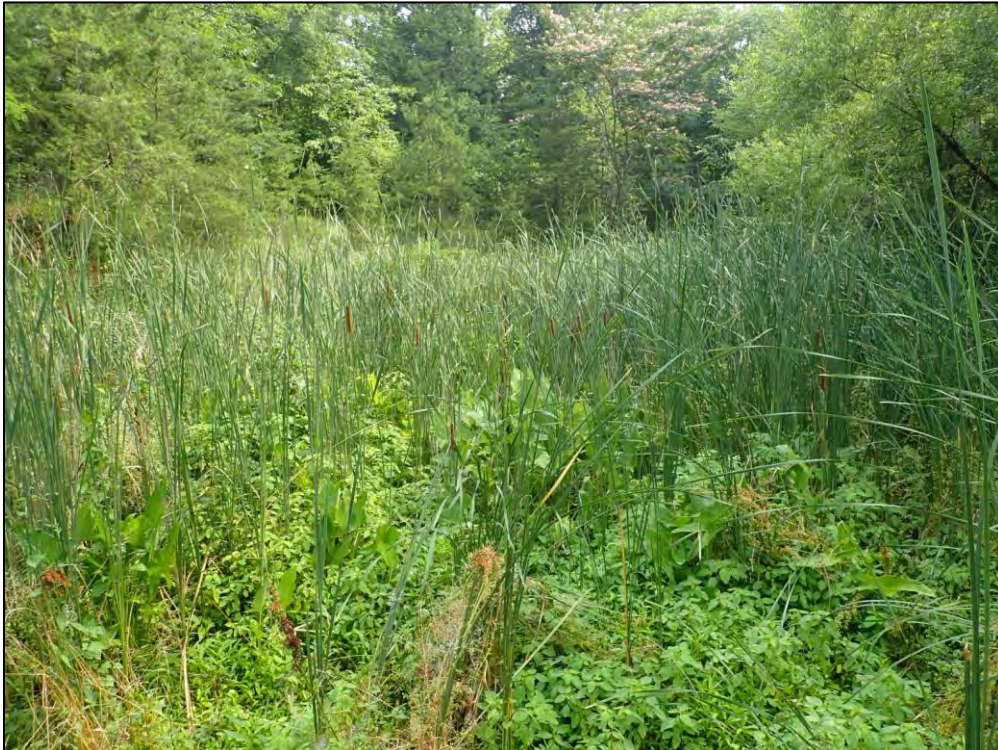
4983: Wetland habitat, Overall. Undesired Vegetation (Cattails/Phragmites) (Routine Maintenance Needed).

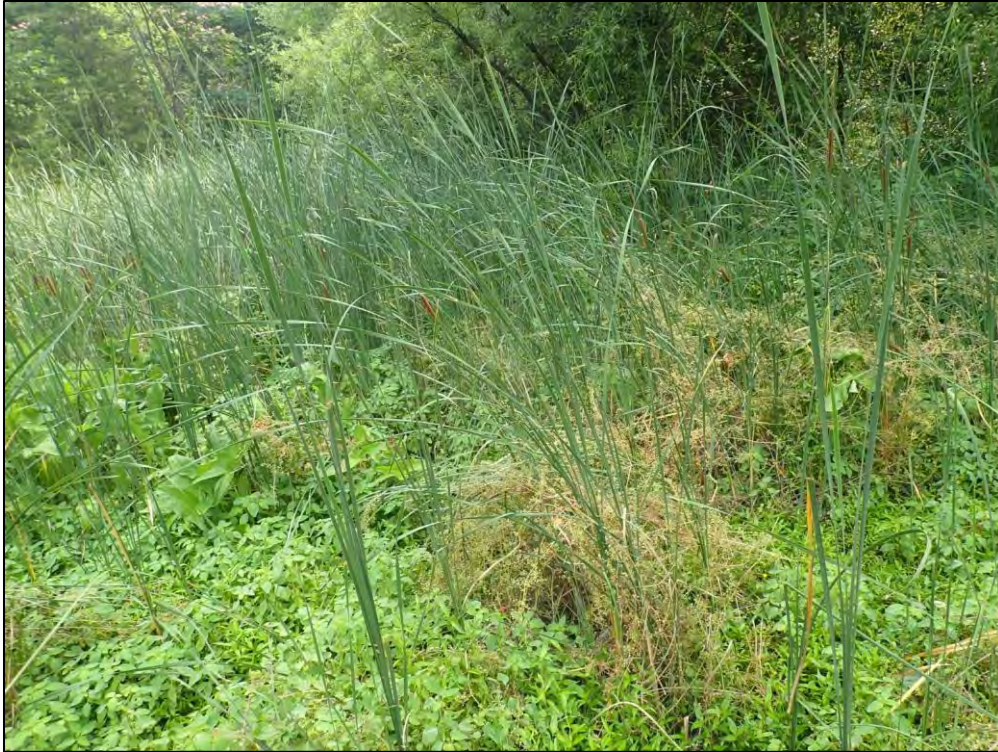
4984: Wetland habitat, Overall. Undesired Vegetation (Cattails/Phragmites) (Routine Maintenance Needed).

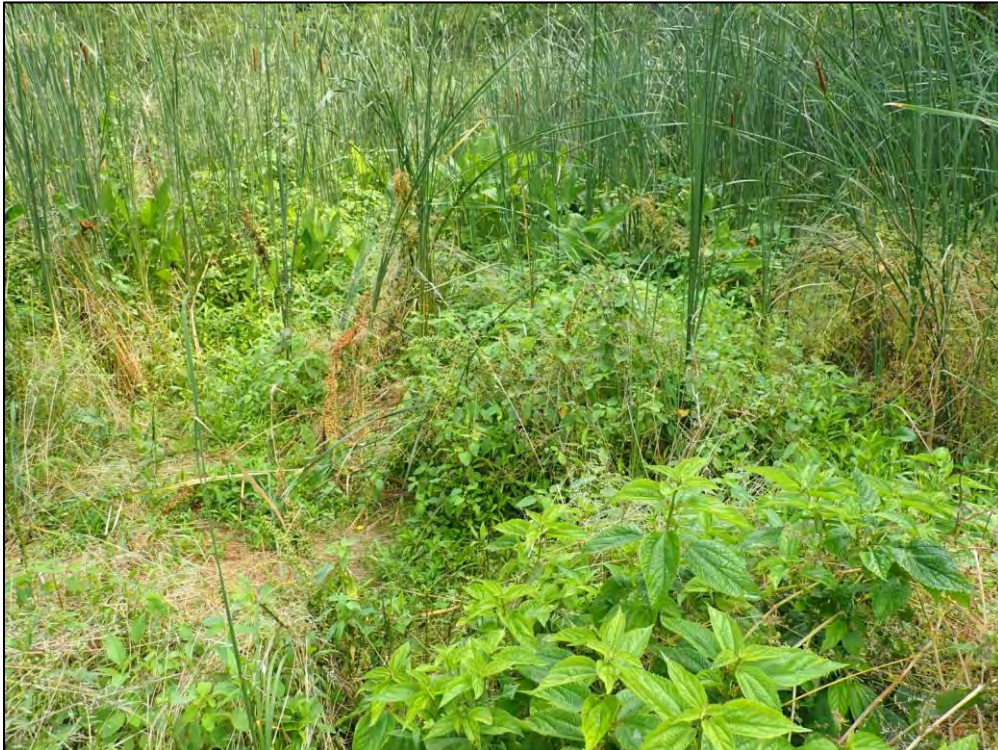
4985: Looking upstream into the Wetland Habitat. Undesired Vegetation (Cattails/Phragmites) (Routine Maintenance Needed).

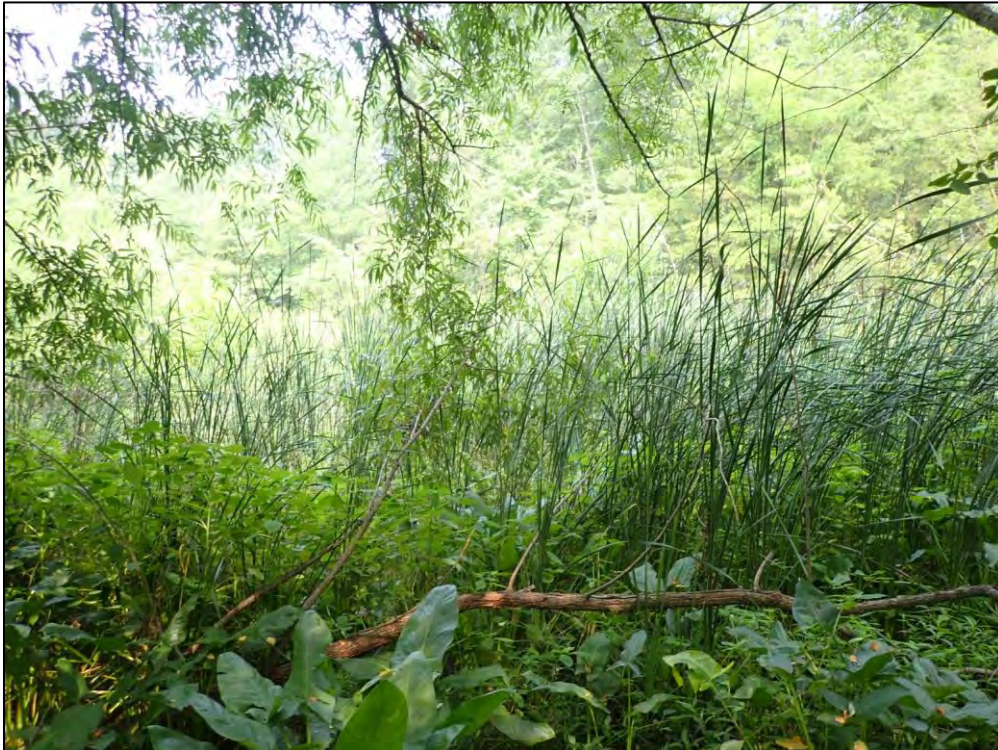
4987: Facility Overall. Undesired Vegetation (Cattails/Phragmites) (Routine Maintenance Needed).

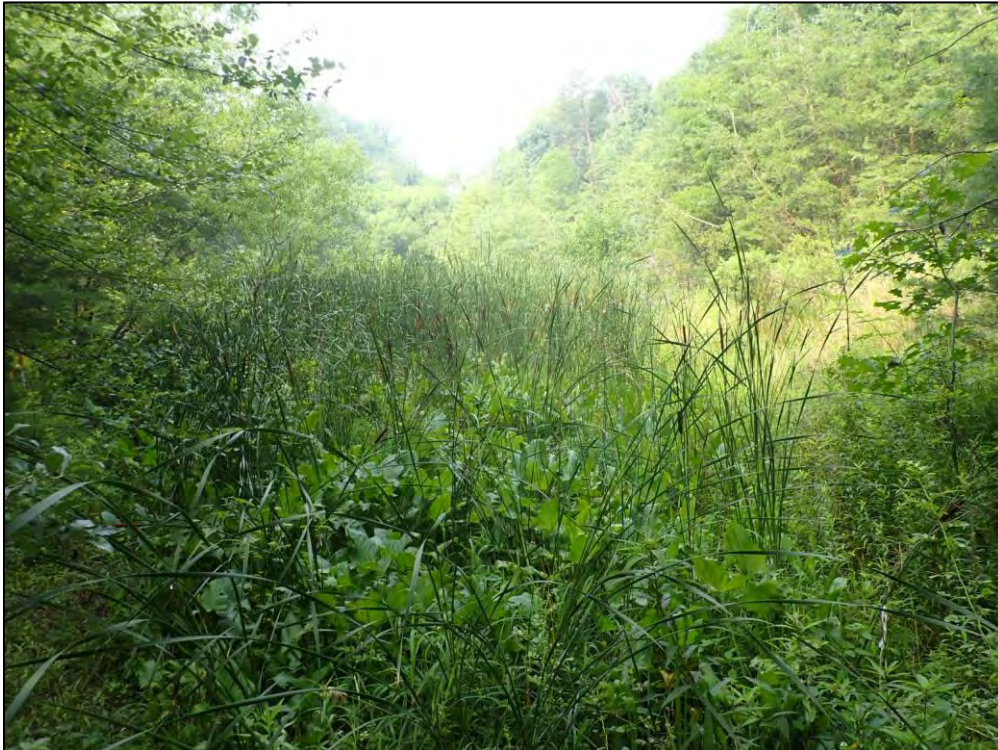
4989: Wetland habitat, Overall. Undesired Vegetation (Cattails/Phragmites) (Routine Maintenance Needed).

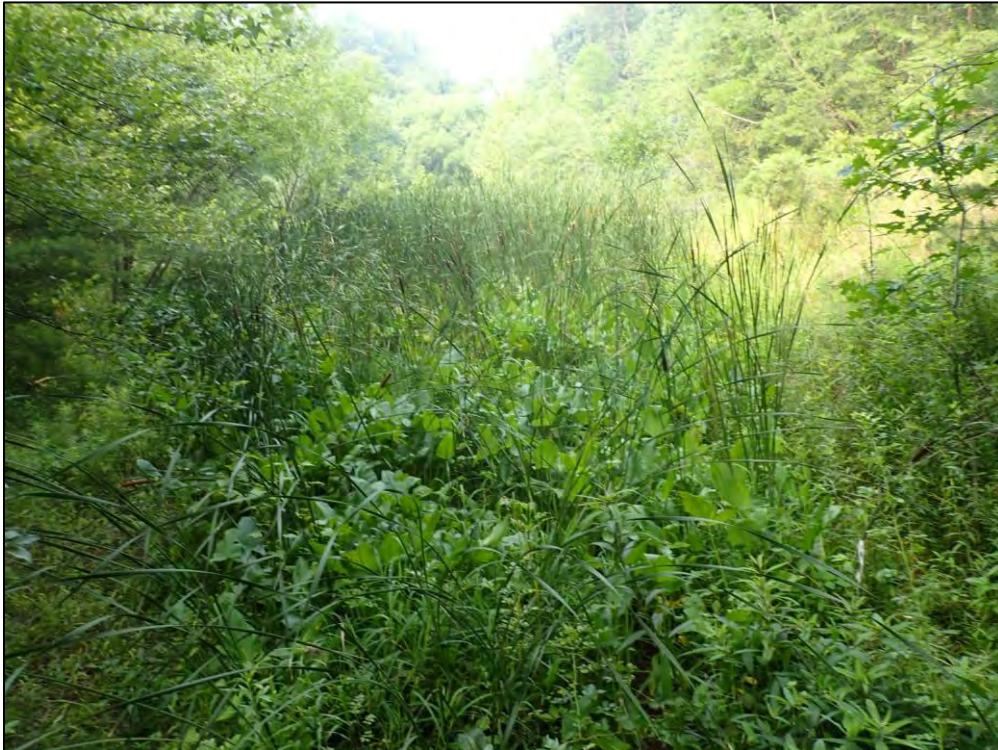
4993: Facility Overall. Undesired Vegetation (Cattails/Phragmites) (Routine Maintenance Needed).

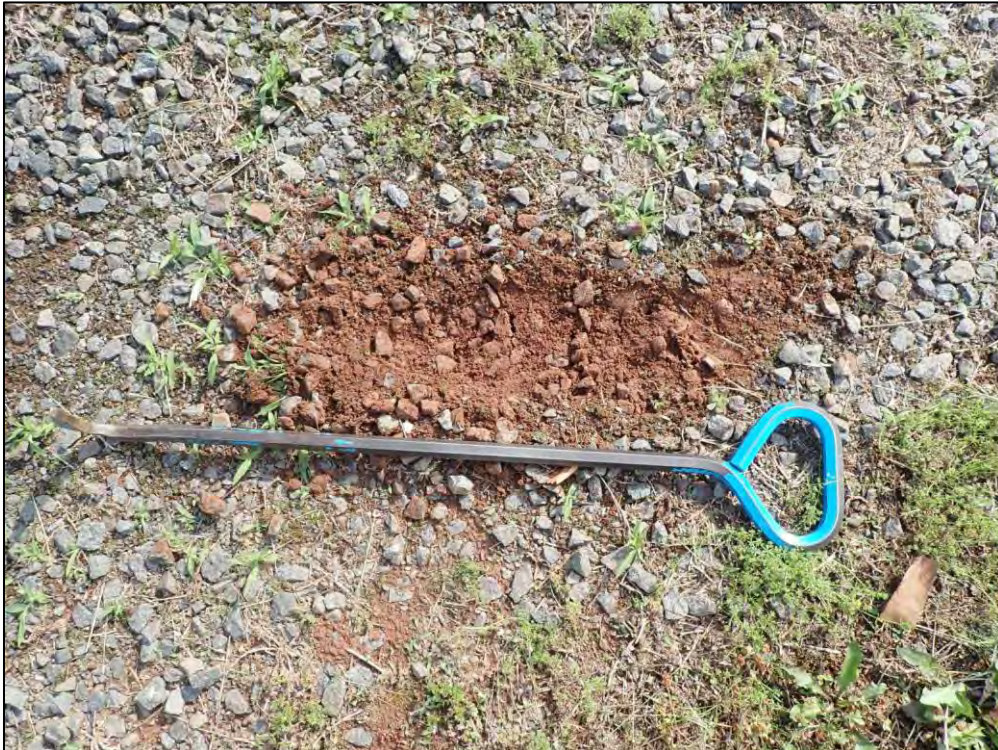
1	Condition of Grass or Fabric				
1	Signs of erosion or exposed soil				
4	Evidence of clogging		Sediment accumulation and vegetation were observed in the trench area.	4583, 4584, 4587, 4588, 4590	
1	Filter Fabric Needs Repair				
Observation Well/ Cleanout (s)					
1	Missing/ Not Found				
1	Cap Missing/ Stuck				
1	Water/ Sediment Observed in Well

4583: Close-up showing the Gravel Detail. Evidence of clogging (Immediate Repair Needed).

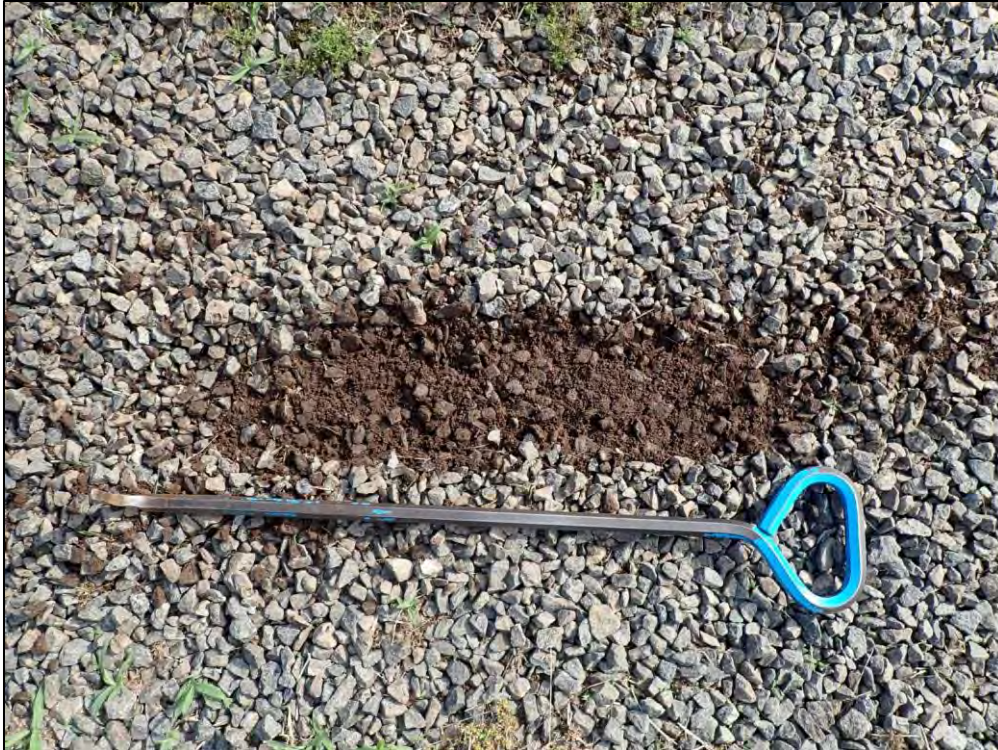
4584: Another close-up showing the Gravel Detail. Evidence of clogging (Immediate Repair Needed).

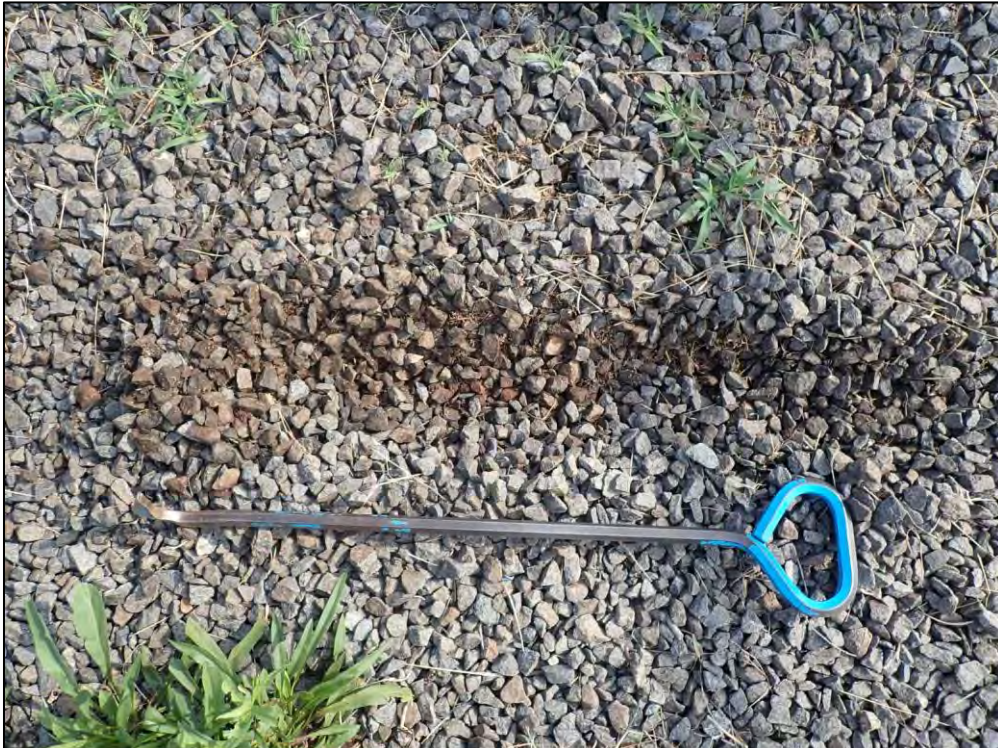
4587: Another close-up showing the Gravel Detail. Evidence of clogging (Immediate Repair Needed).

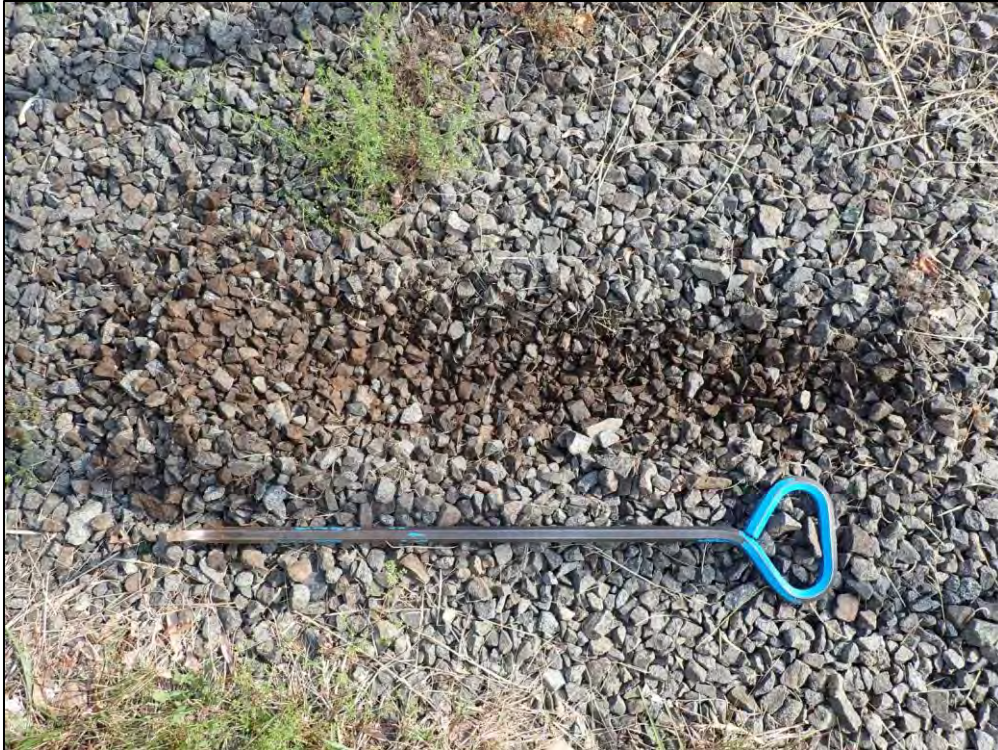
4588: Another close-up showing the Gravel Detail. Evidence of clogging (Immediate Repair Needed).

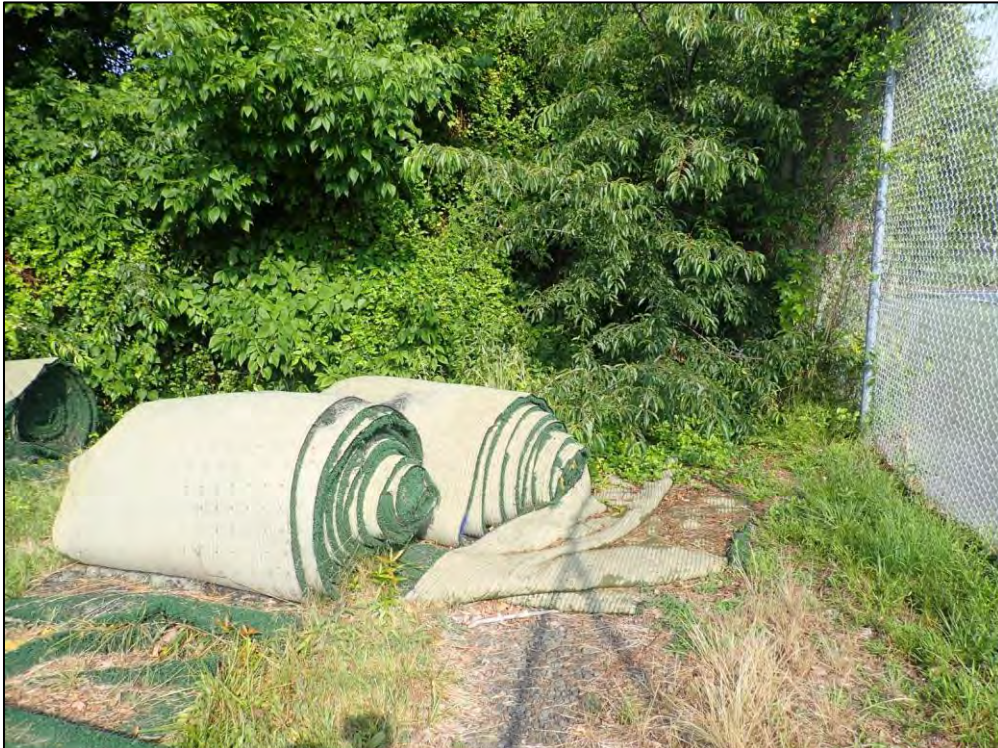
4589: Encroachment overall. Storage observed within the facility (Immediate Repair Needed).

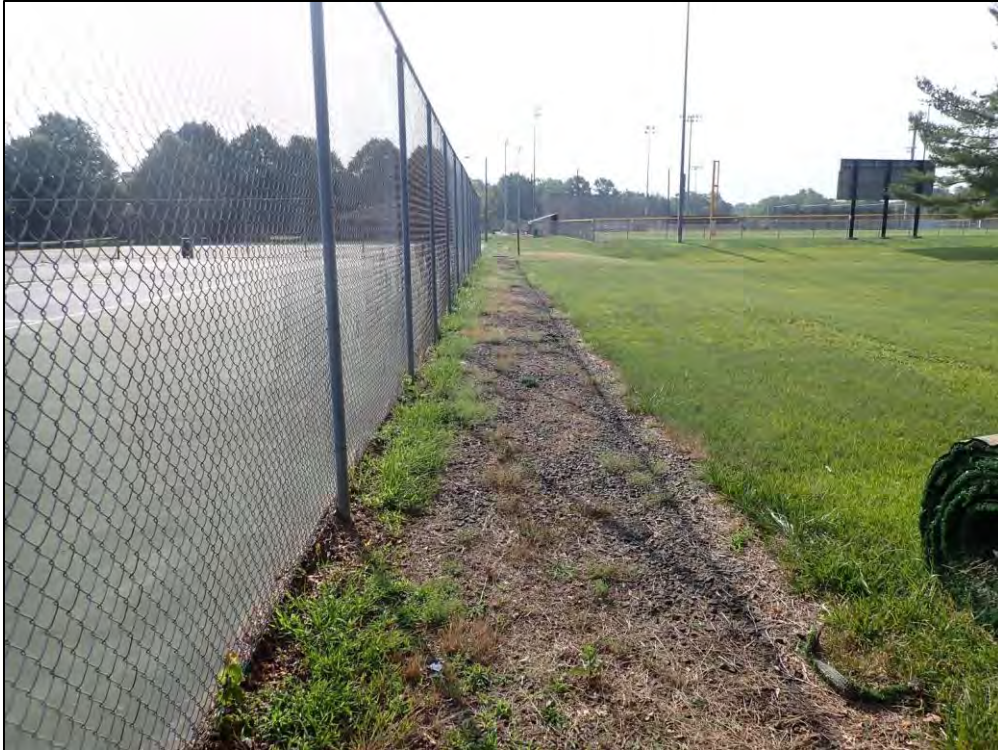
4590: Infiltration Trench Surface. Overgrown Vegetation Present (Immediate Repair Needed).

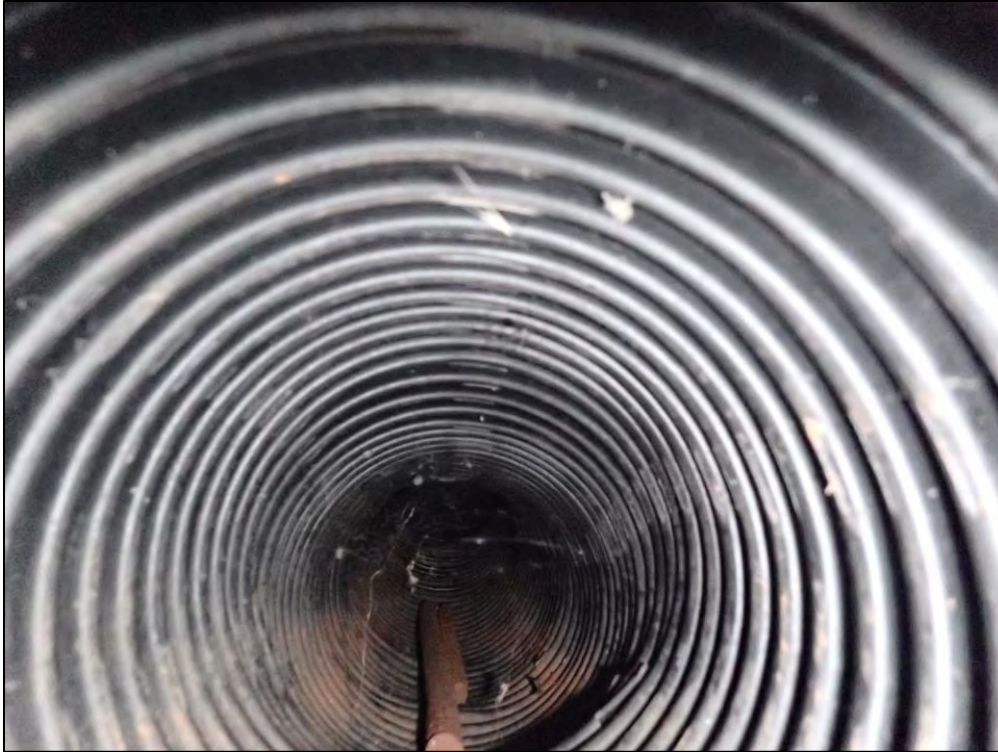
4600: Inside Control Structure I-29-017, looking upstream along the Northern underdrain. Debris observed within the underdrain (Immediate Repair Needed).
