ALDRICH PUBLIC LIBRARY

FEASIBILITY STUDY

Issued: October 21, 2021

CROSSKEY ARCHITECTS, LLC
750 Main Street, Suite 150
Hartford, CT 06103

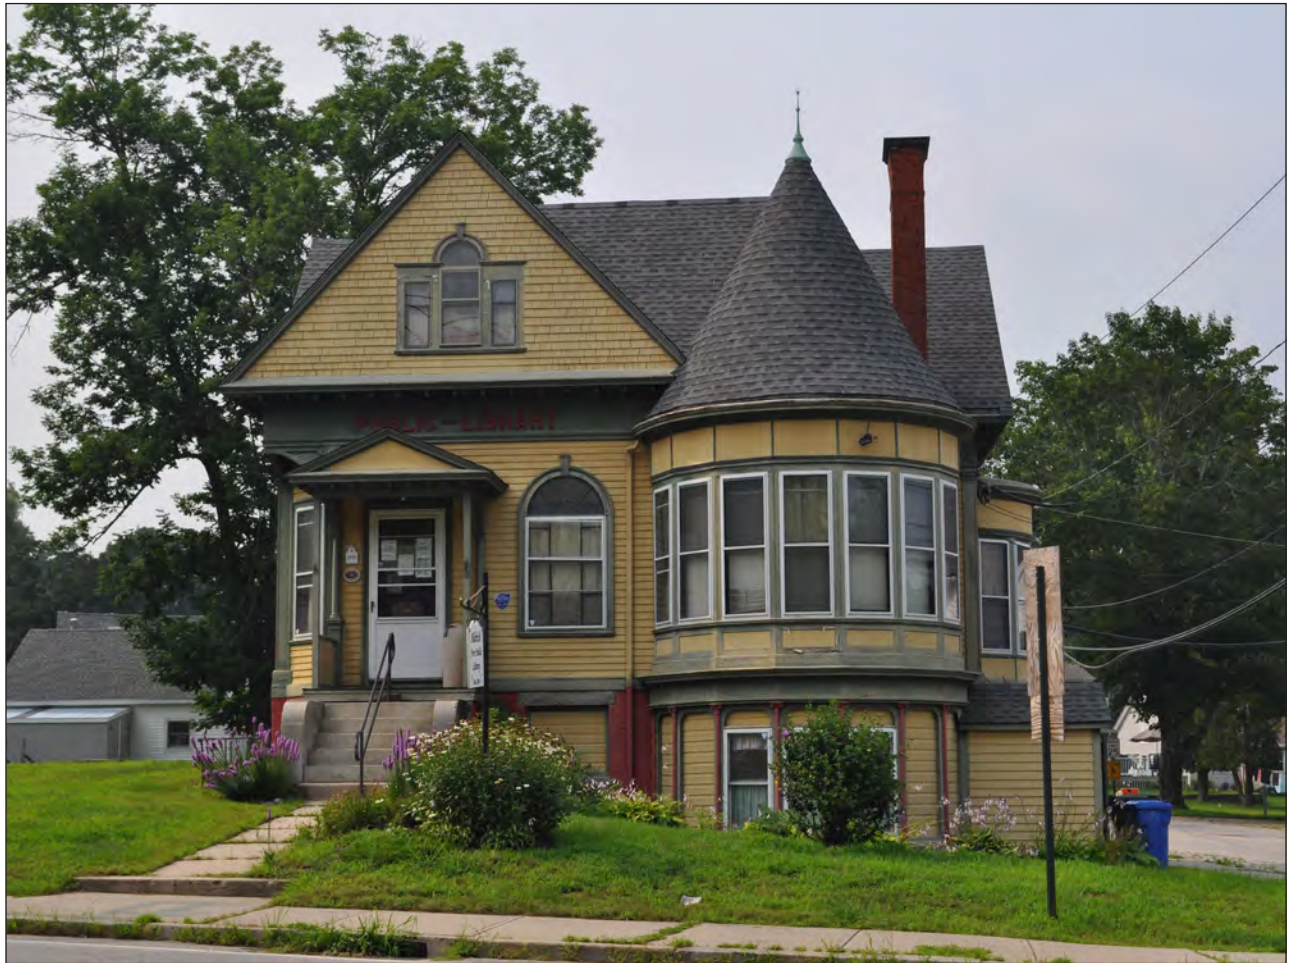
1. South elevation, camera facing north.

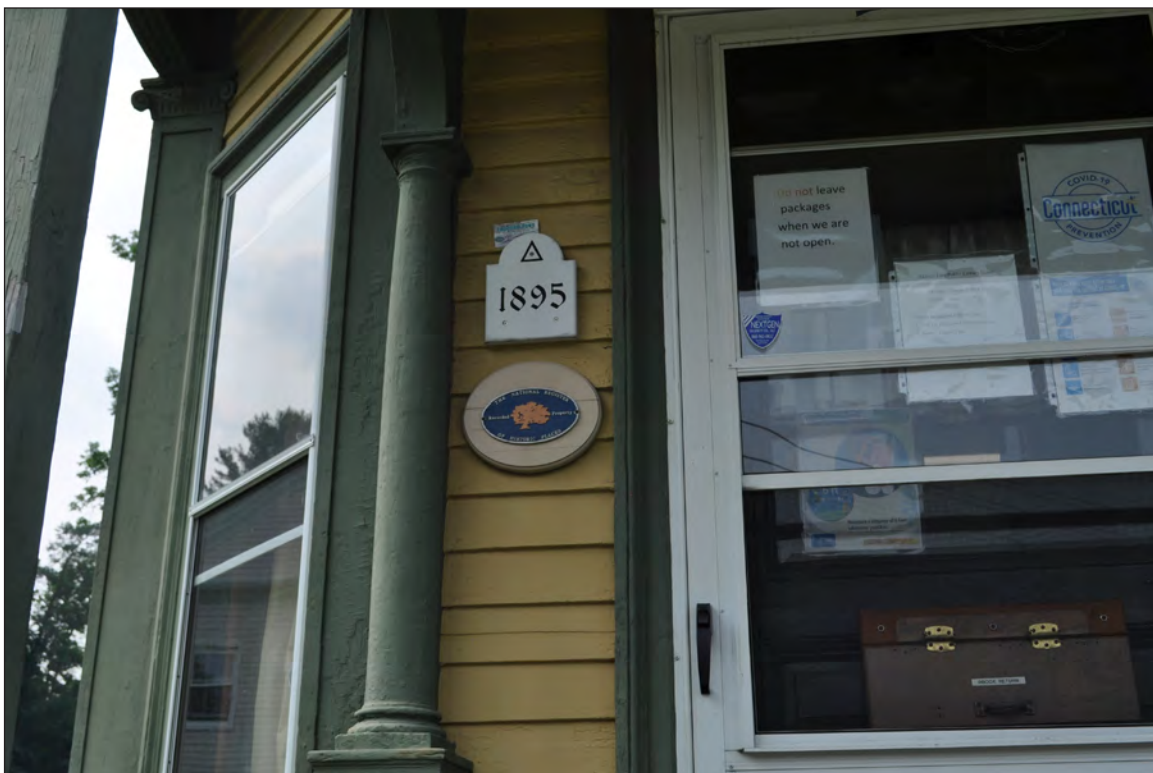
7. South elevation, porch column, camera facing north.

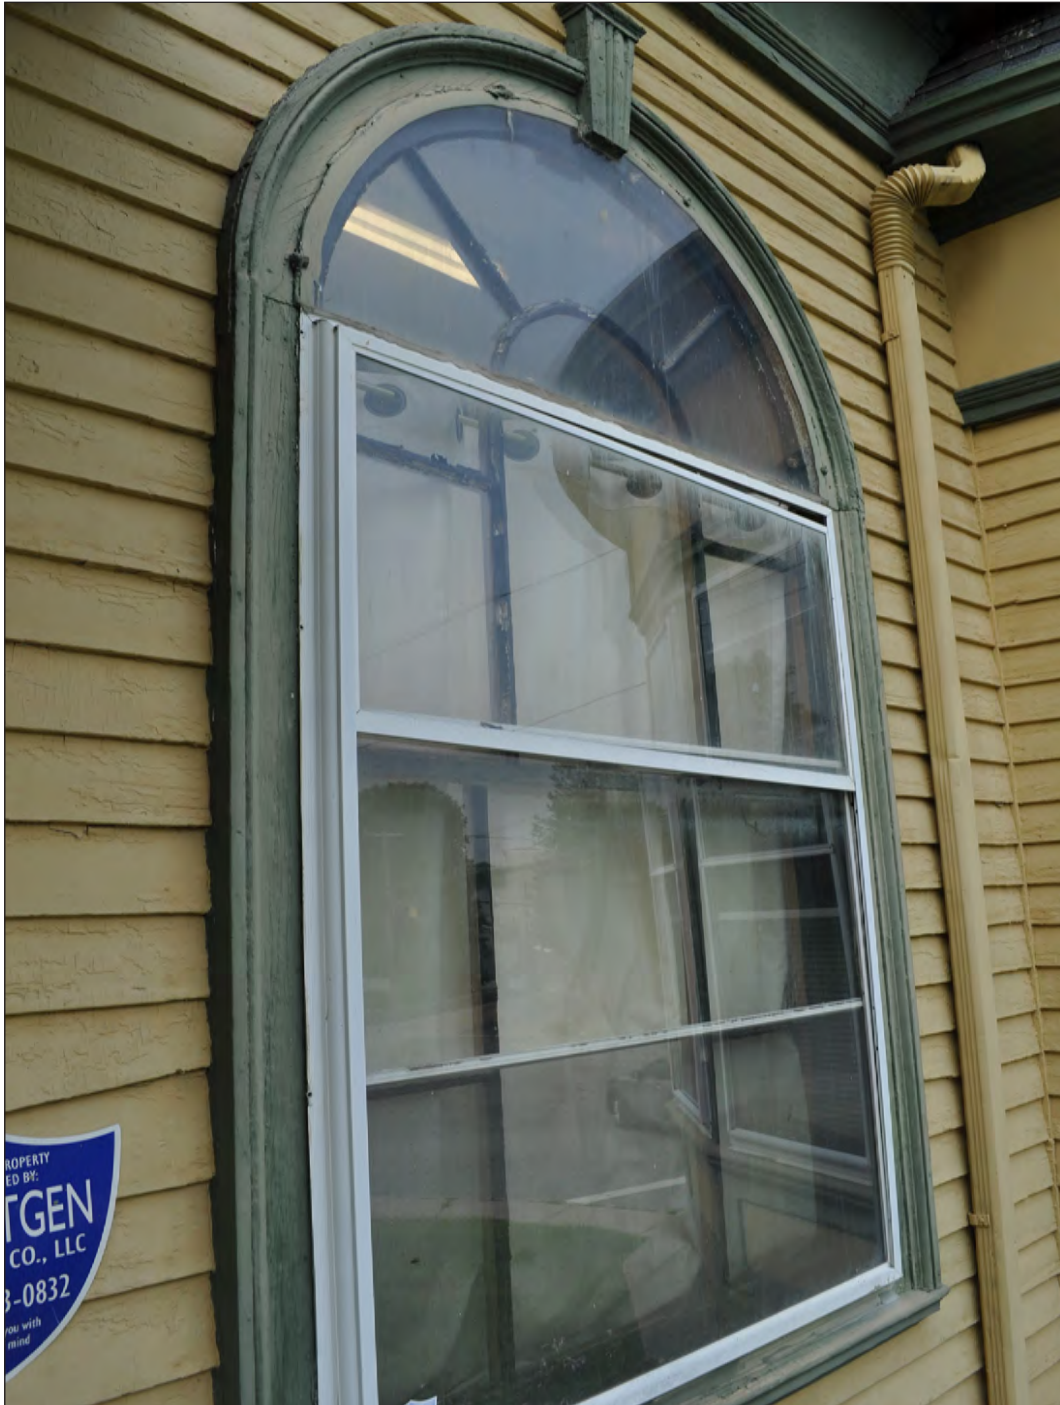
8. South elevation, close-up of window with exterior storm.

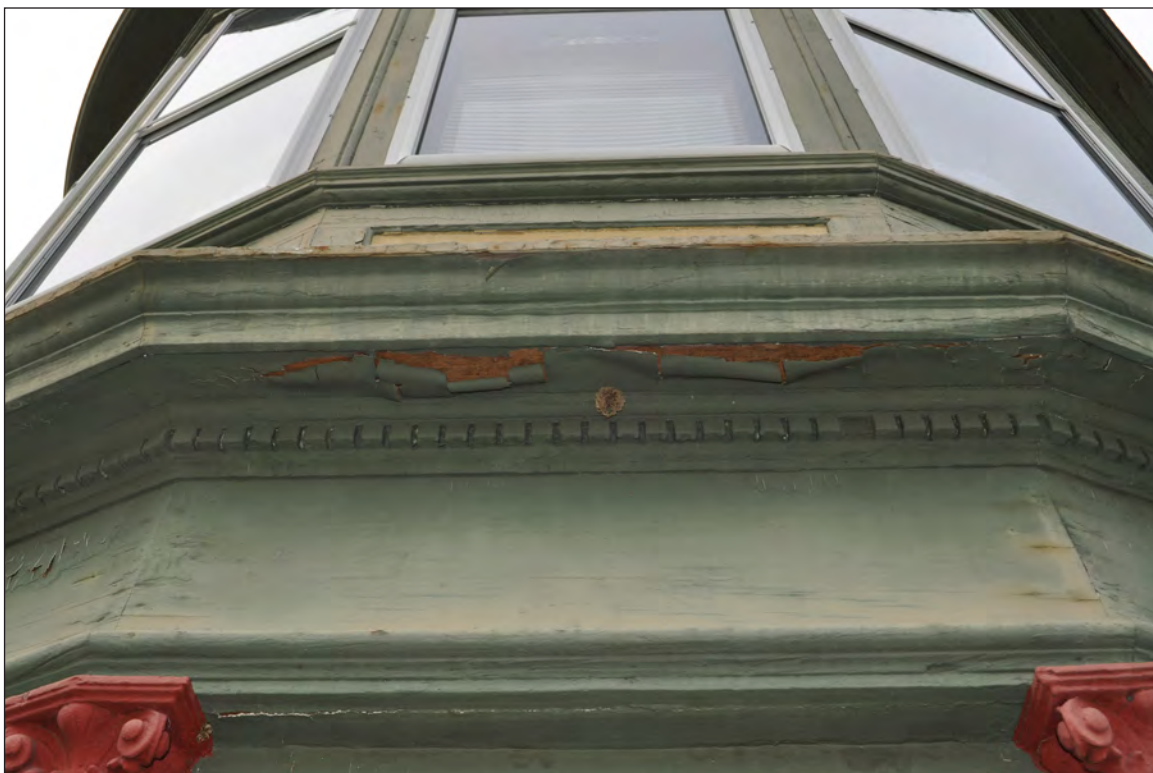
24. South elevation, tower, underside of cornice, camera facing up and north.

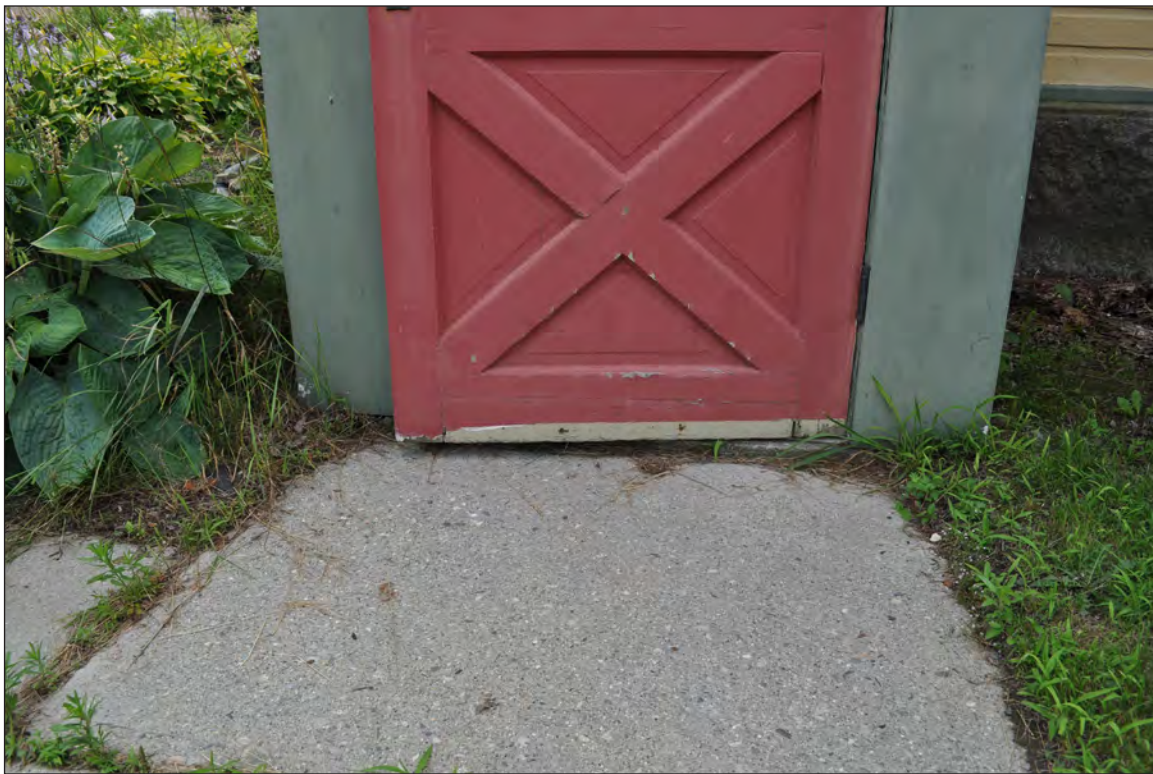
28. East elevation, exterior vestibule, bottom of door, camera facing west.

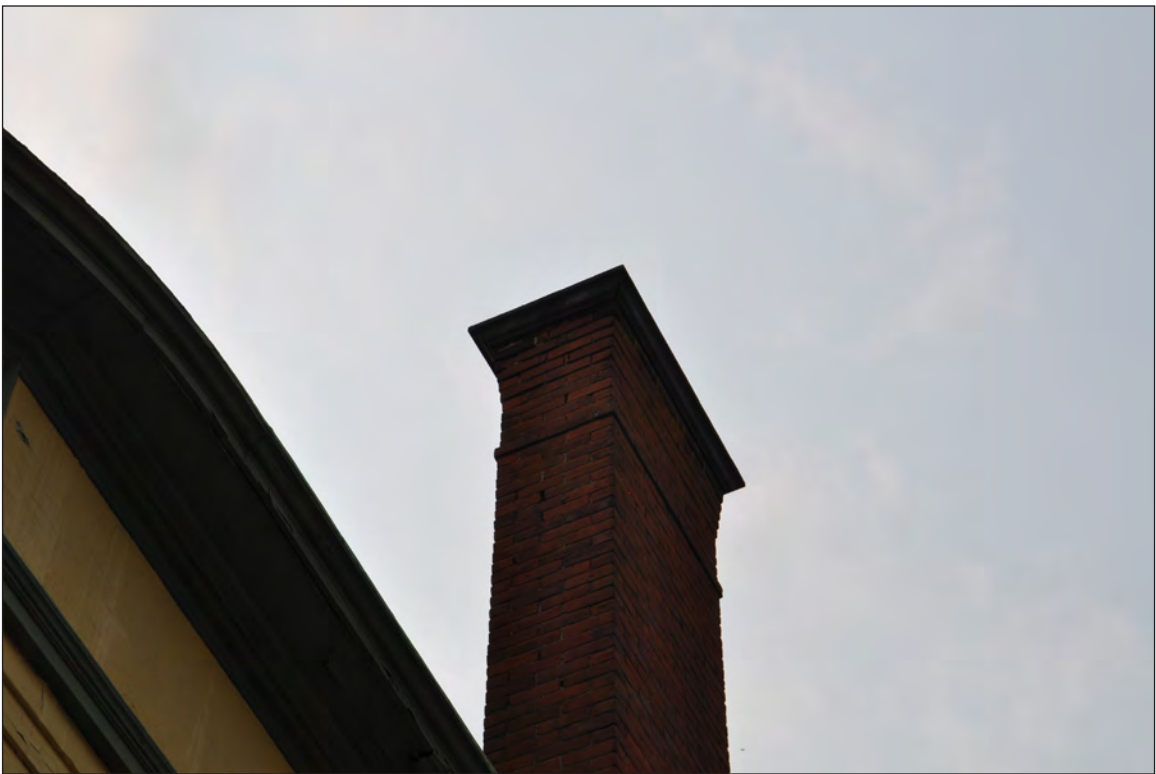
35. East elevation, southeast perspective of chimney, camera facing up and northwest.

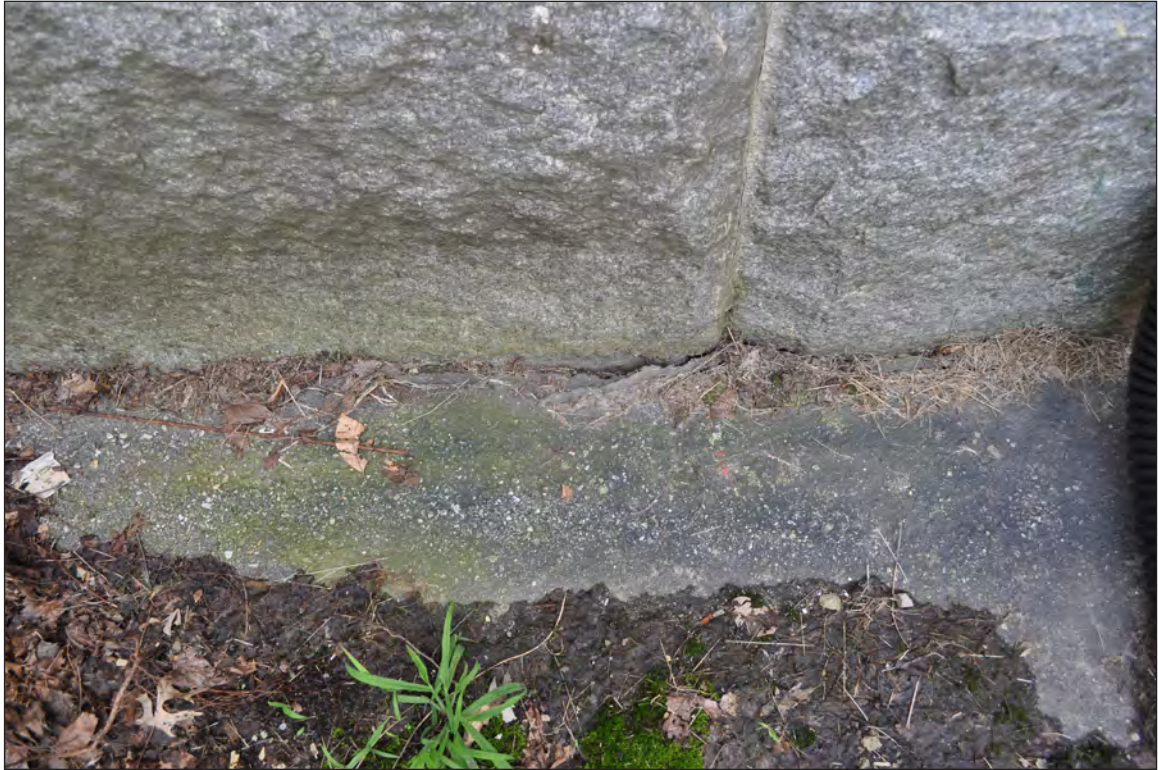
41. East elevation, grade at foundation, camera facing west.

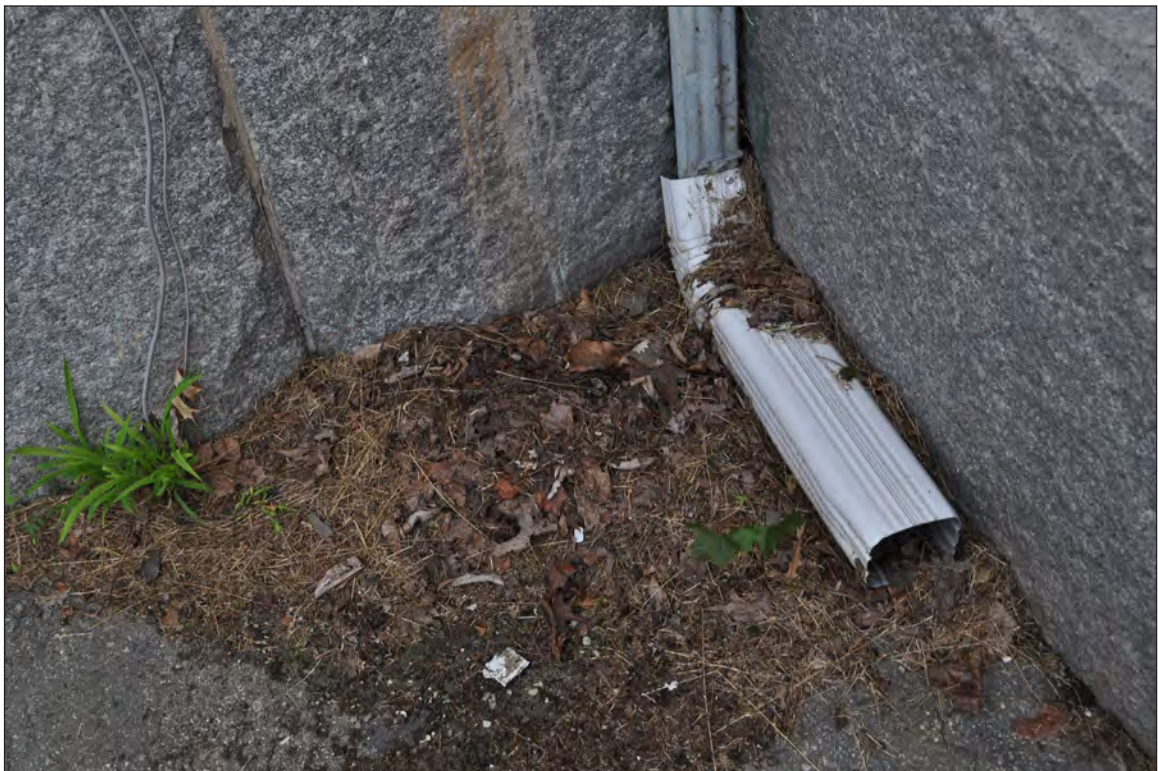
42. East elevation, grade at foundation, camera facing northwest.

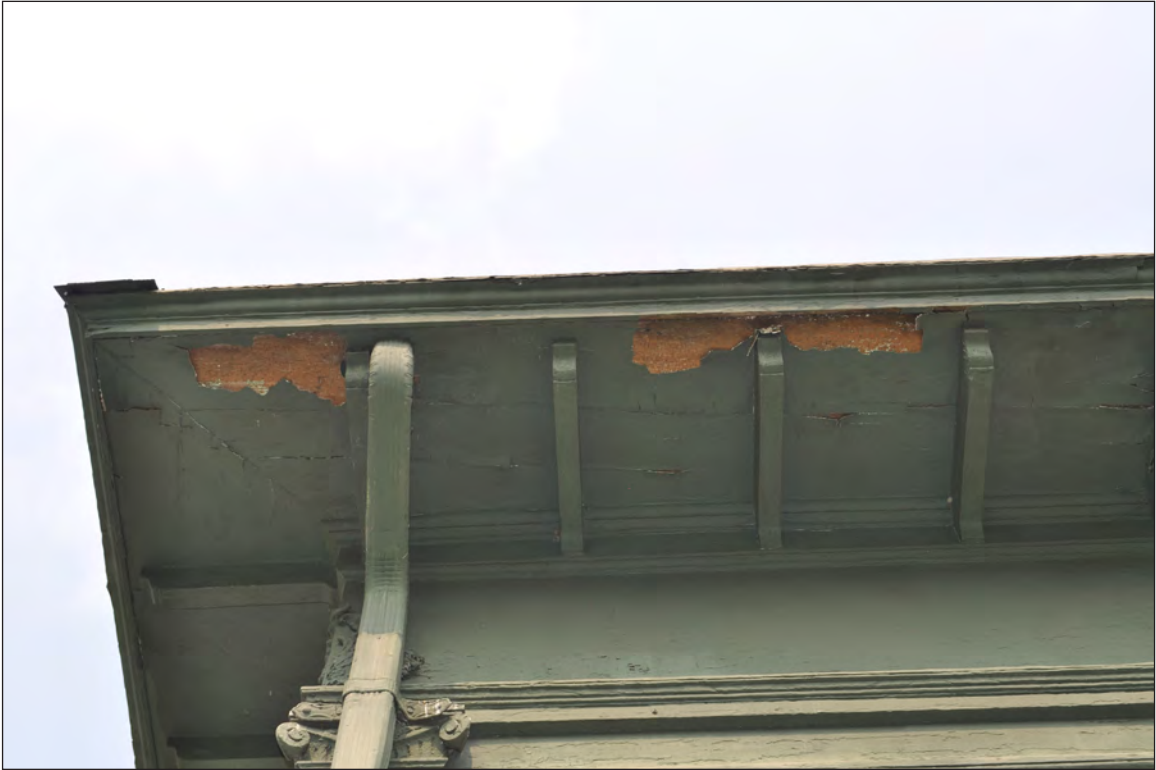
58. Northwest building corner, replacement trim, camera facing southeast.

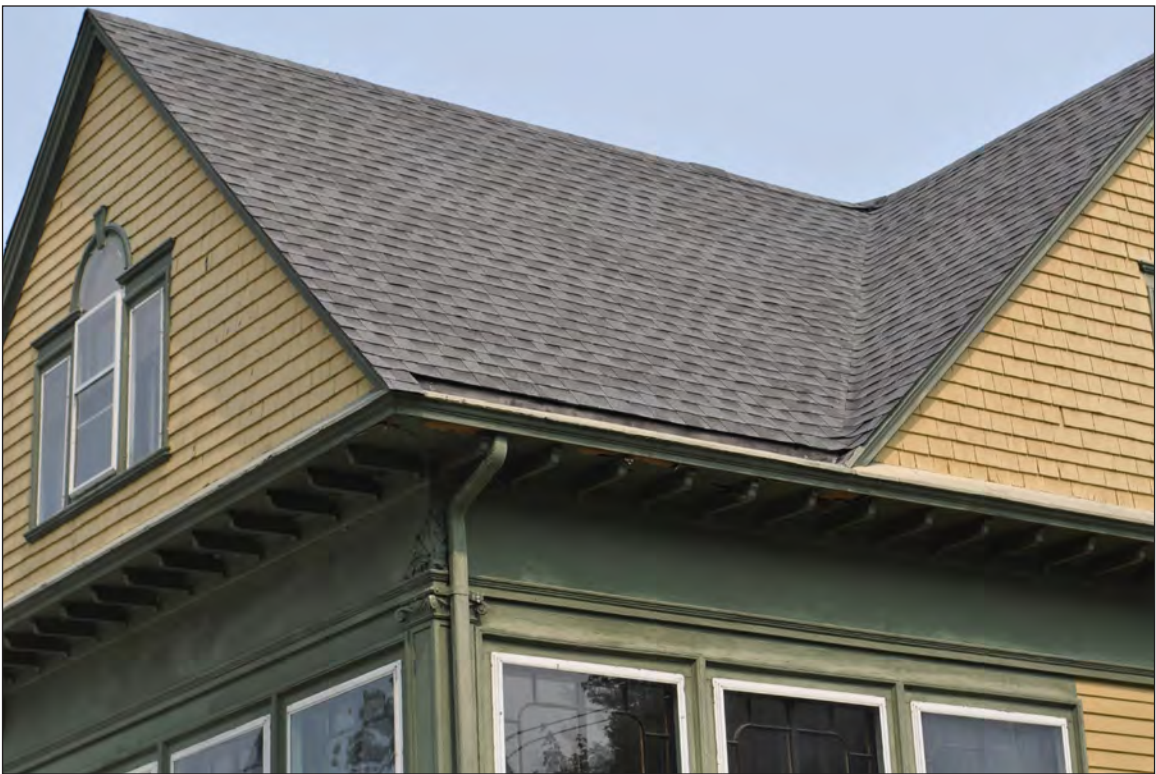
59. West elevation, underside of soffit below integrated gutter, camera facing up and southeast.

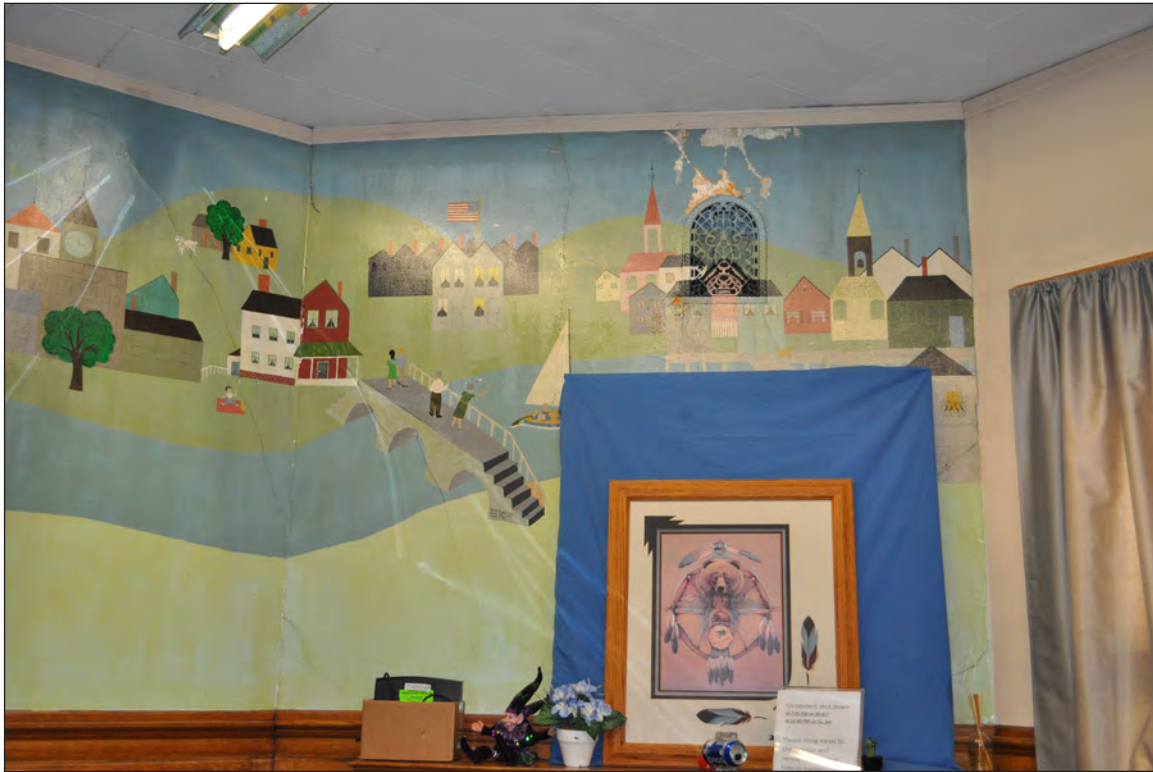
101. First-floor, computer room (201), camera facing northeast.

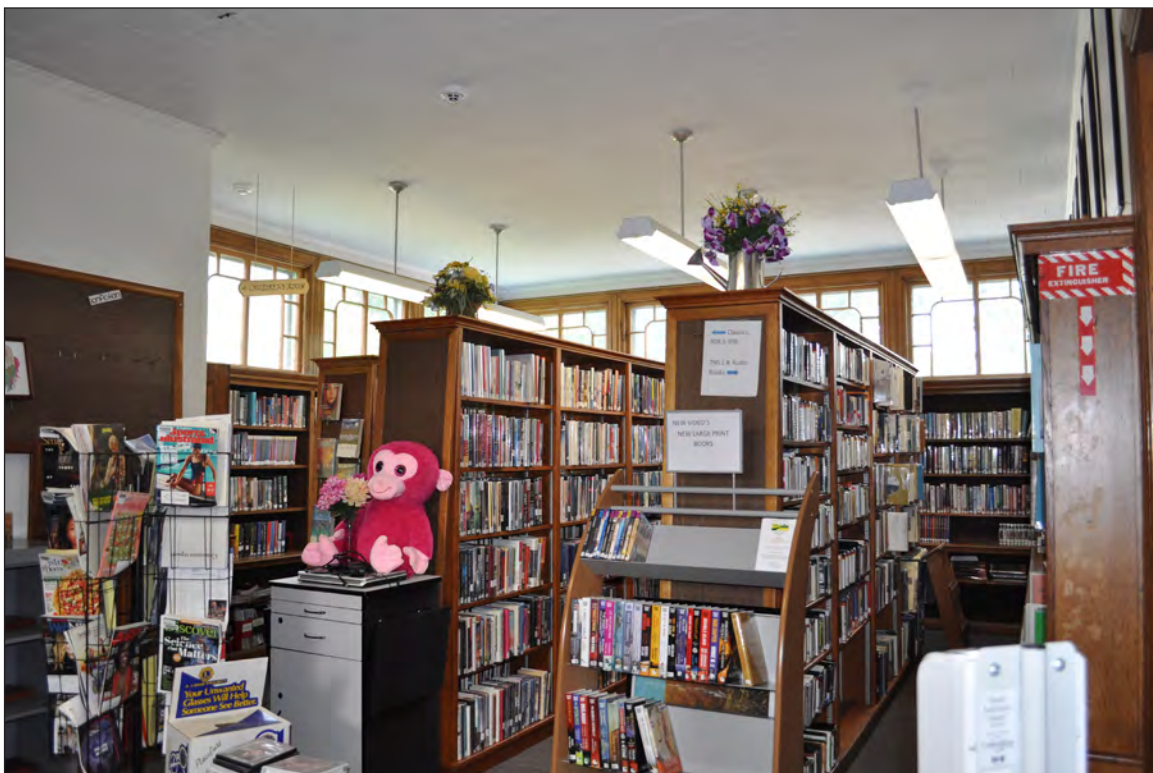
102. First-floor, library (204), camera facing northwest.

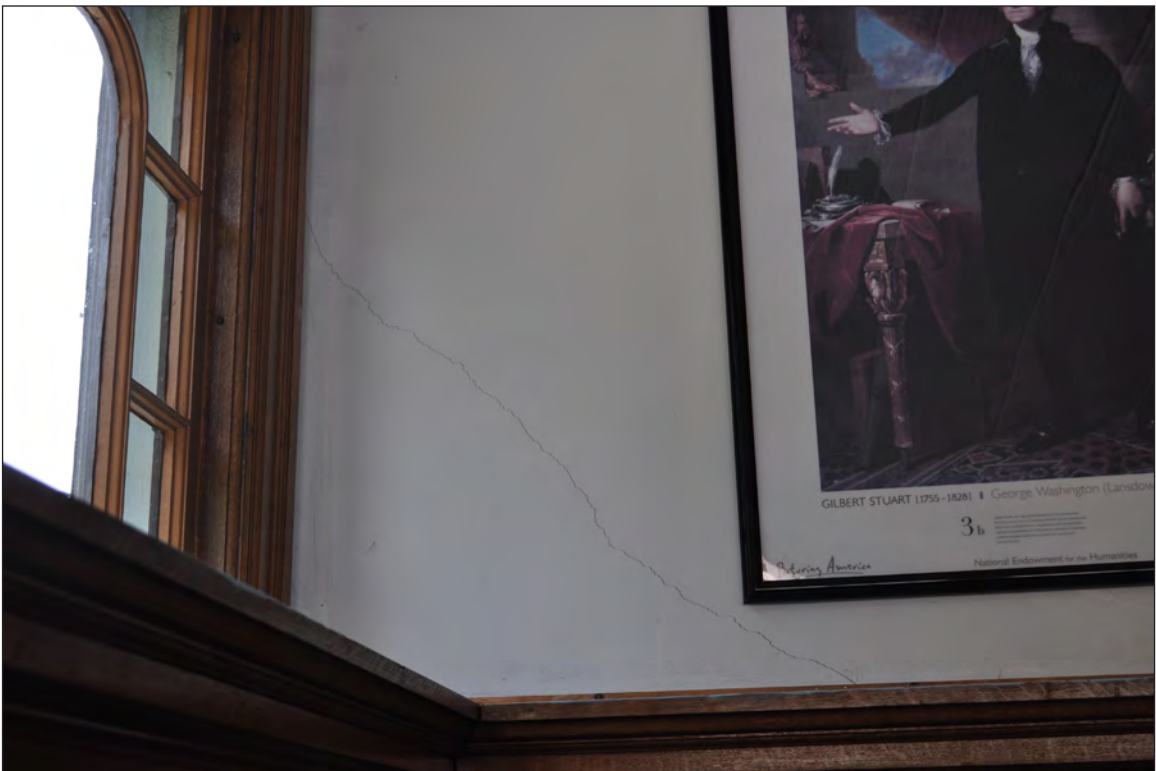
104. First-floor, library (204), camera facing up and northeast.

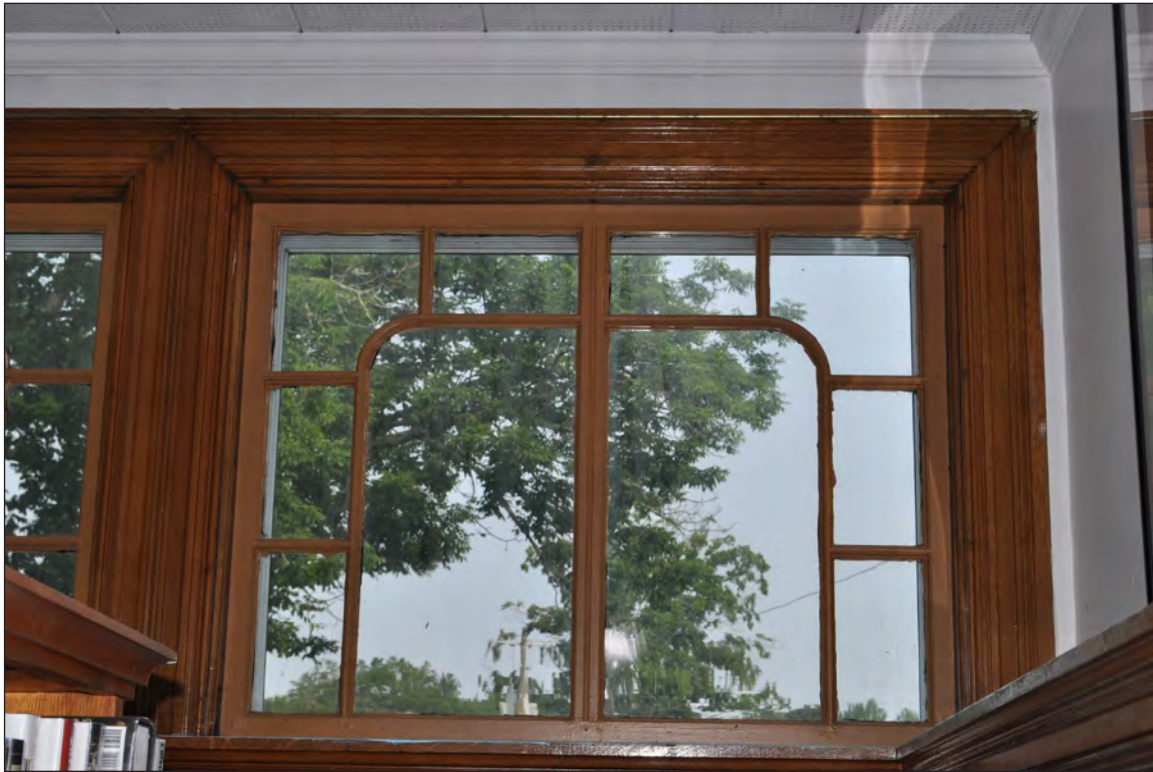
105. First-floor, library (204), camera facing up and north.

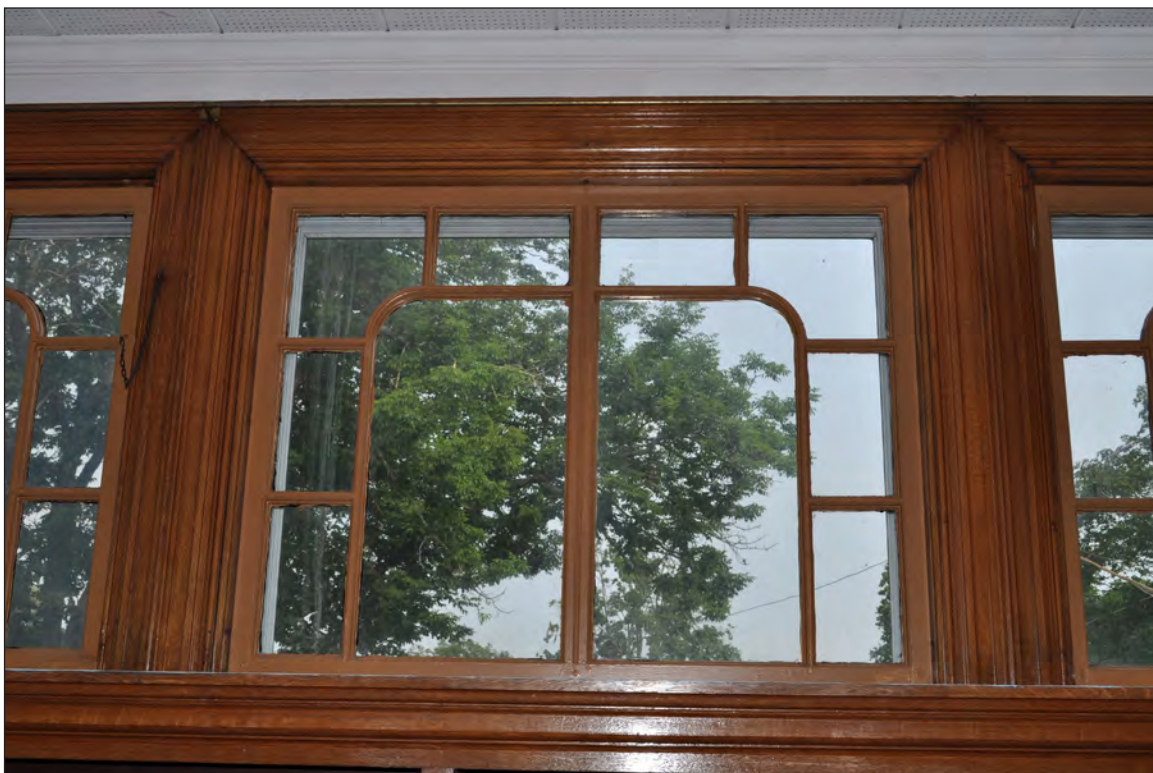
106. First-floor, library (204), camera facing up and north.

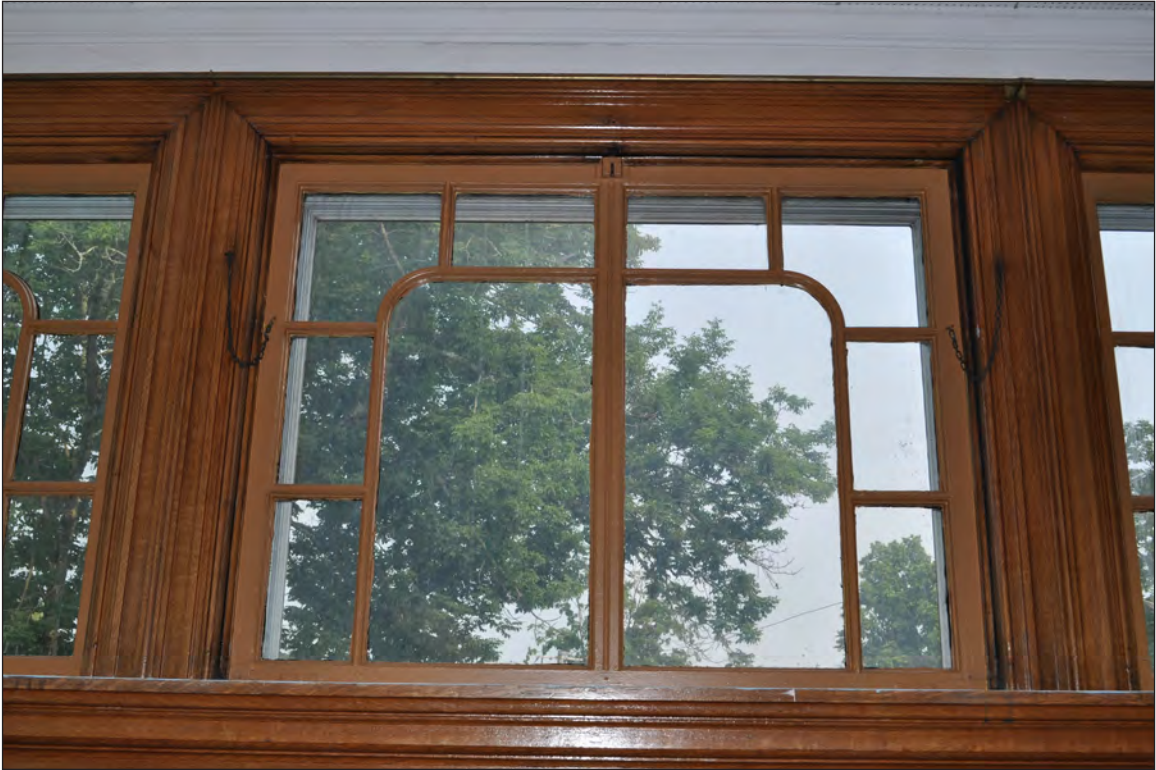
107. First-floor, library (204), camera facing up and north.

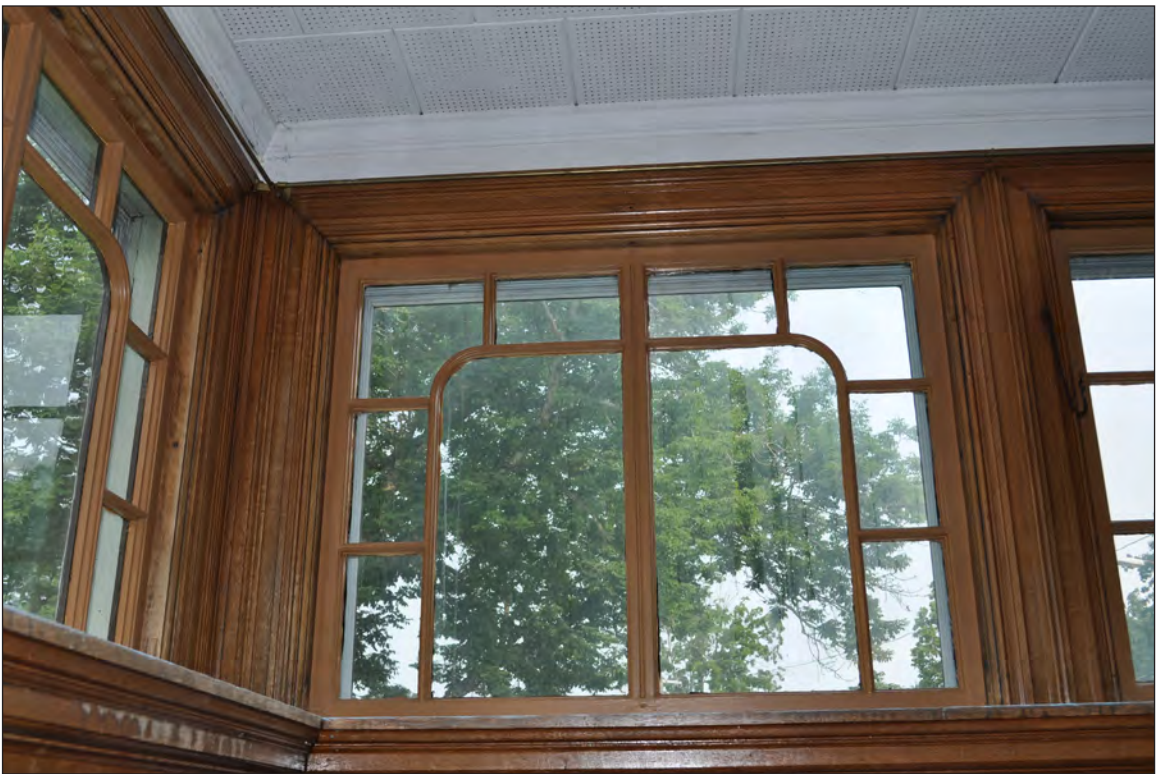
108. First-floor, library (204), camera facing up and north.

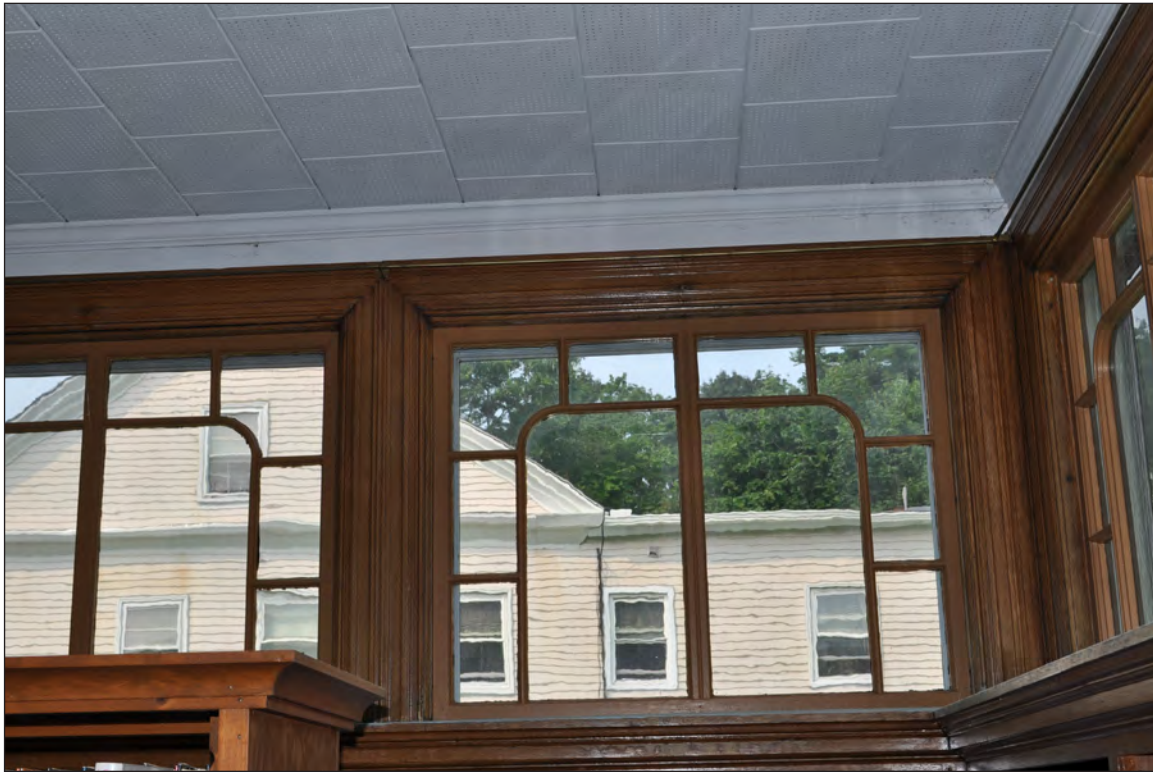
109. First-floor, library (204), camera facing up and west.

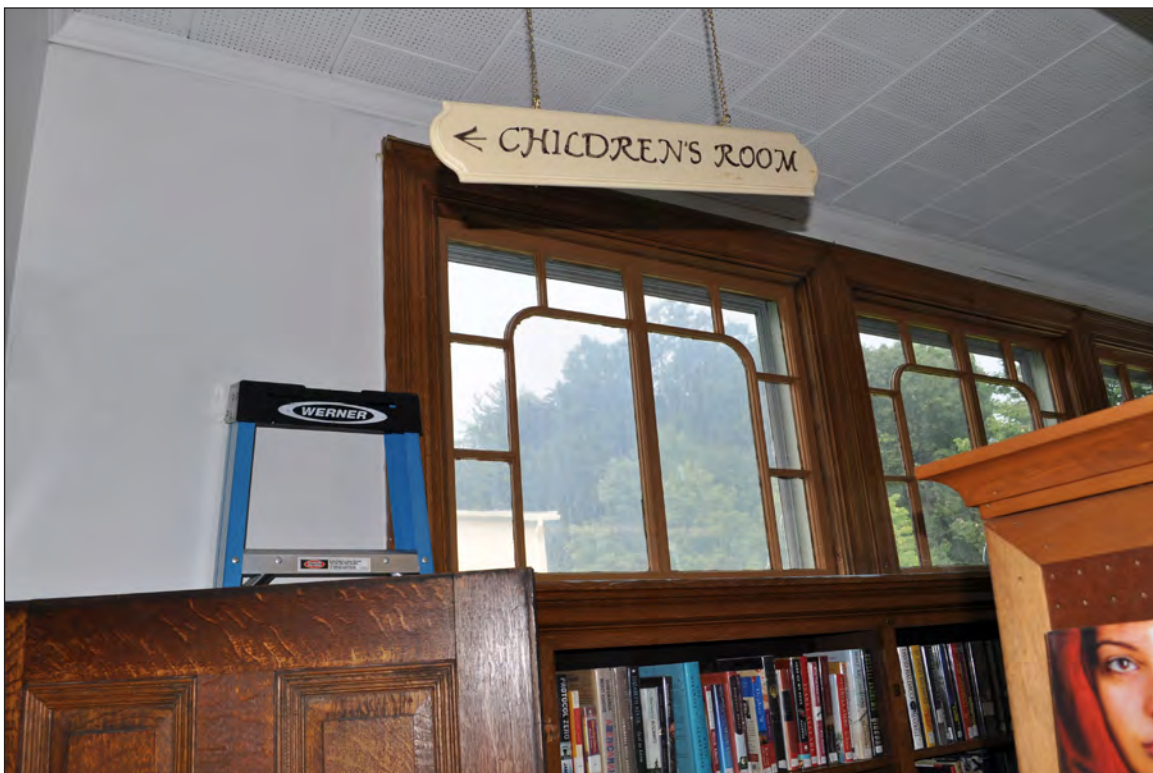
110. First-floor, library (204), camera facing up and west.

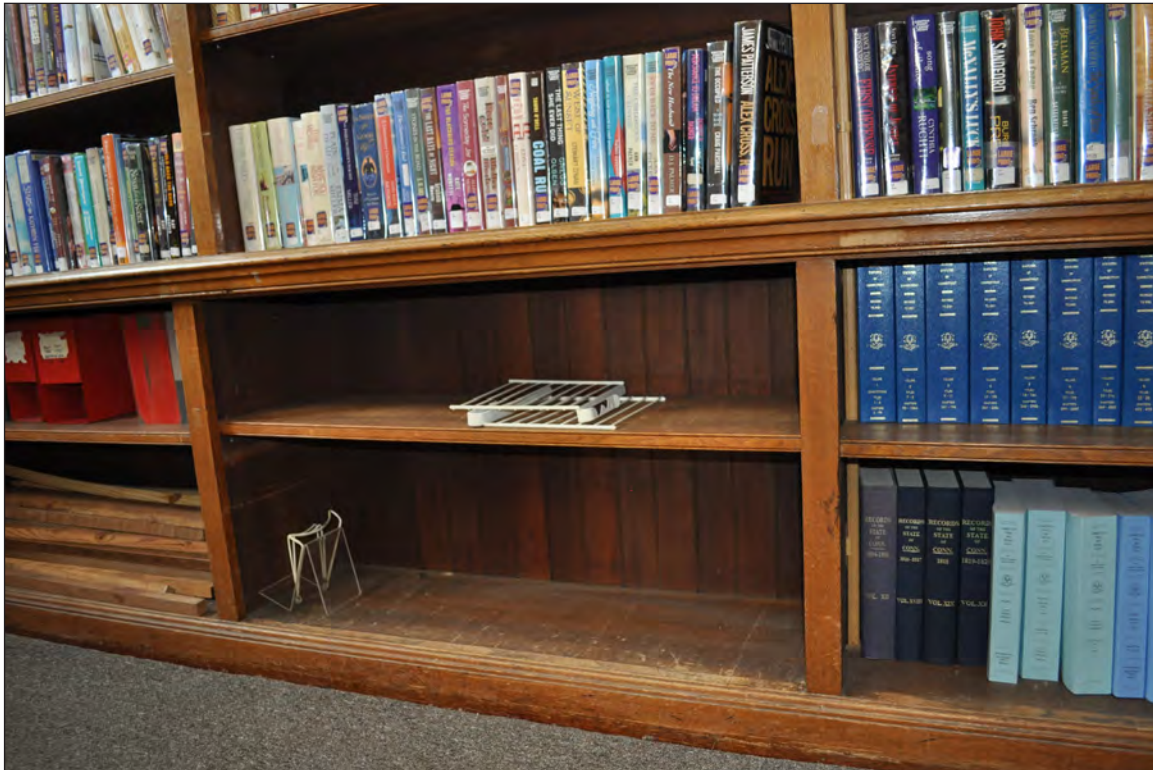
111. First-floor, library (204), camera facing down and northwest.

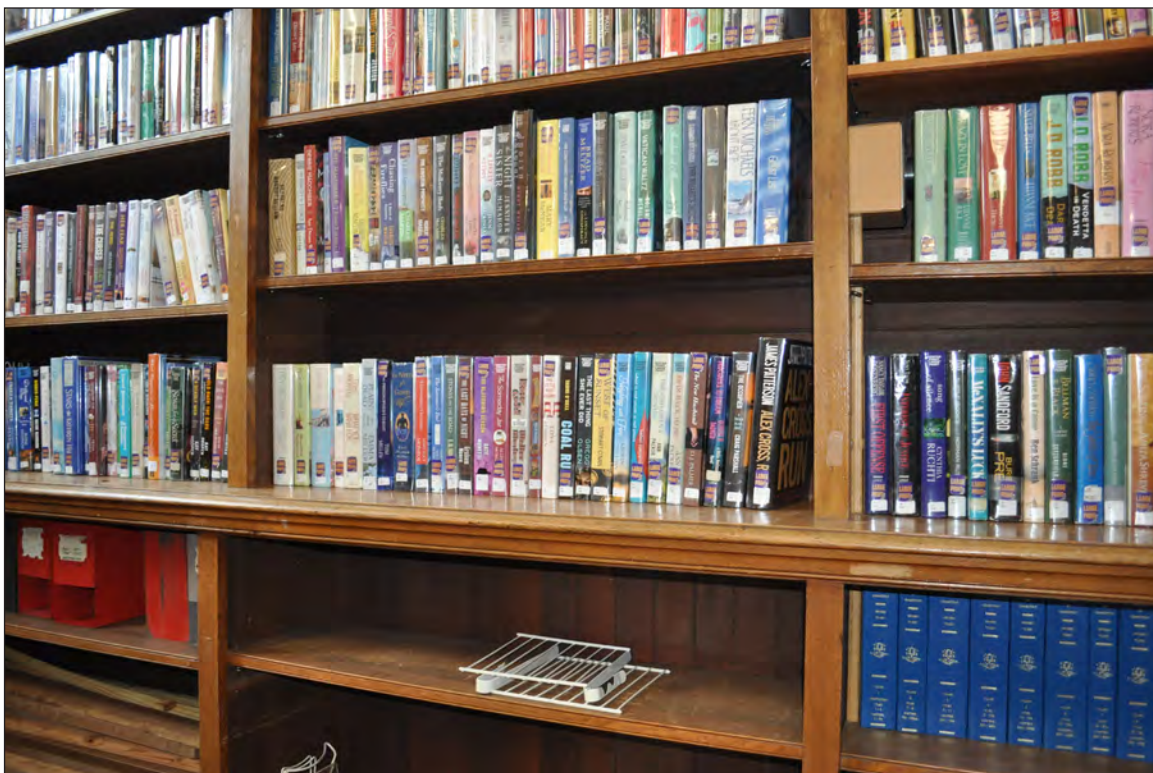
112. First-floor, library (204), camera facing down and northwest.

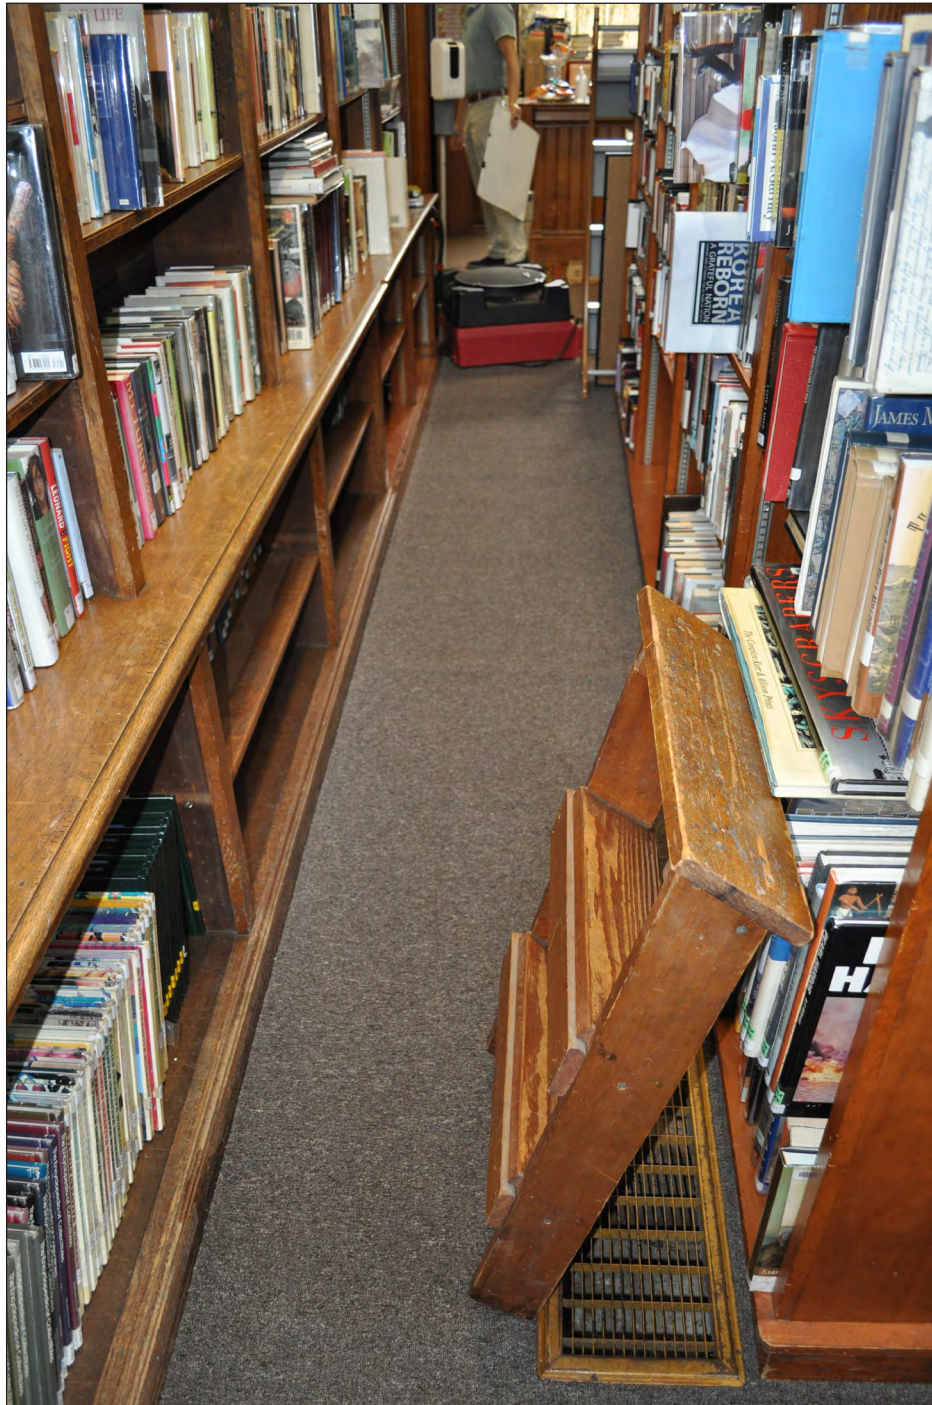
113. First-floor, library (204), camera facing down and south.

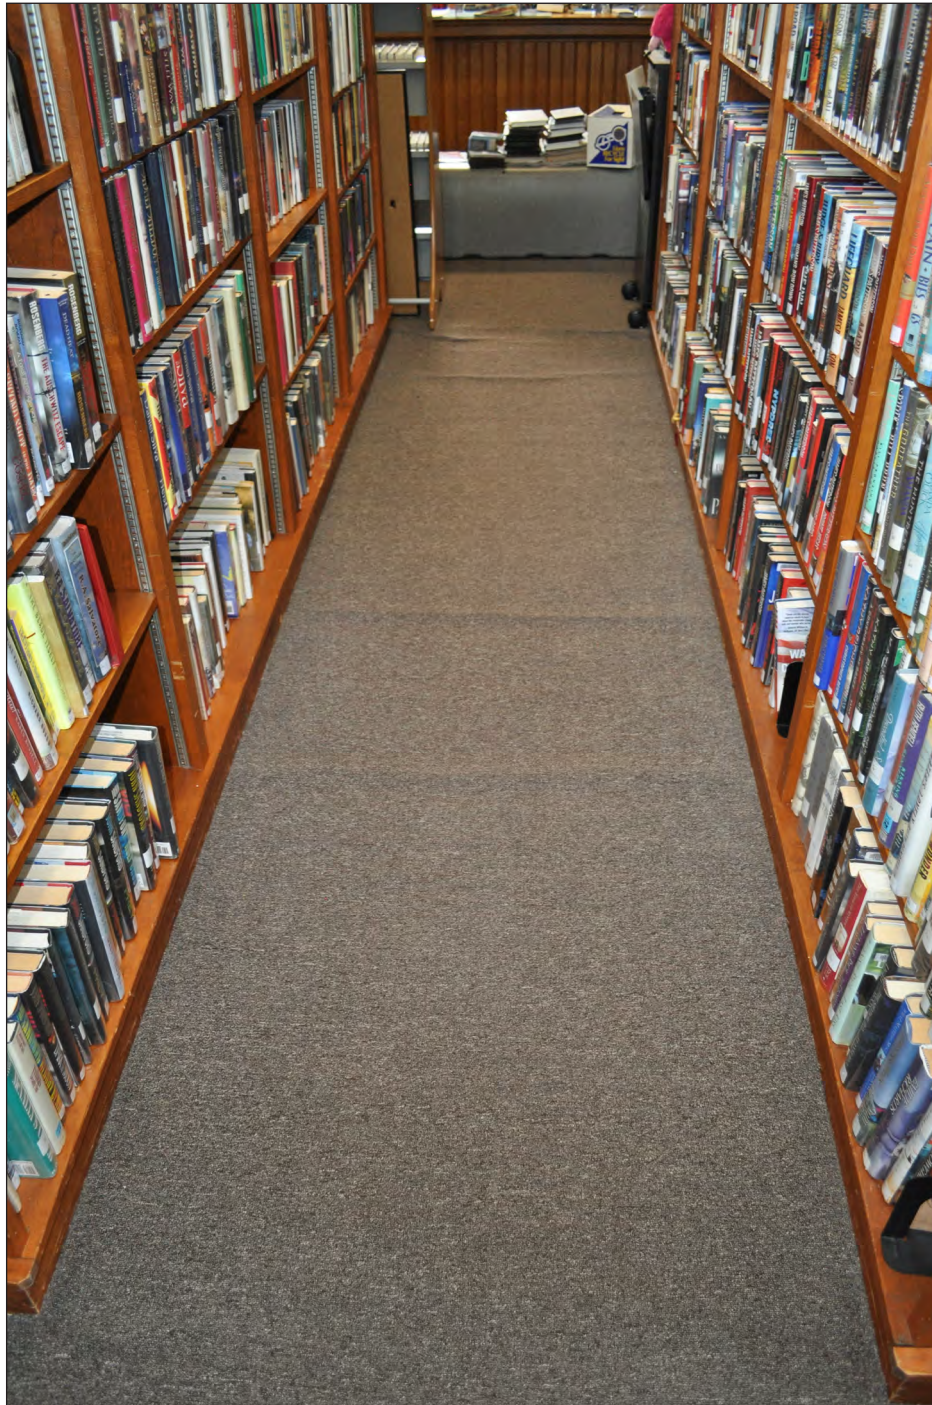
114. First-floor, library (204), camera facing down and south.
