ALDRICH PUBLIC LIBRARY

FEASIBILITY STUDY

Issued: October 21, 2021

CROSSKEY ARCHITECTS, LLC
750 Main Street, Suite 150
Hartford, CT 06103

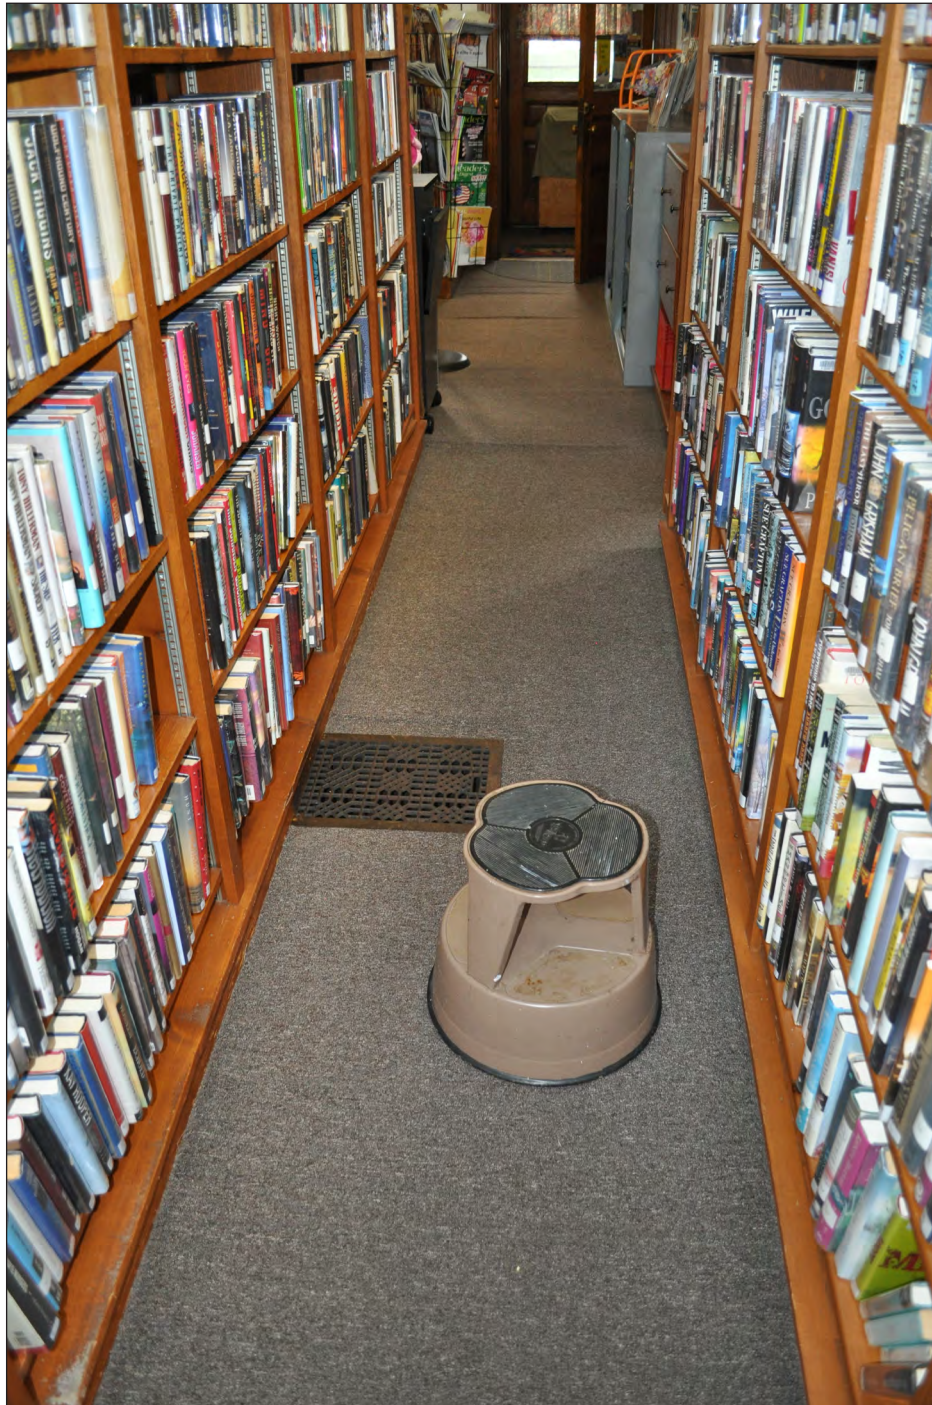
115. First-floor, library (204), camera facing down and south.

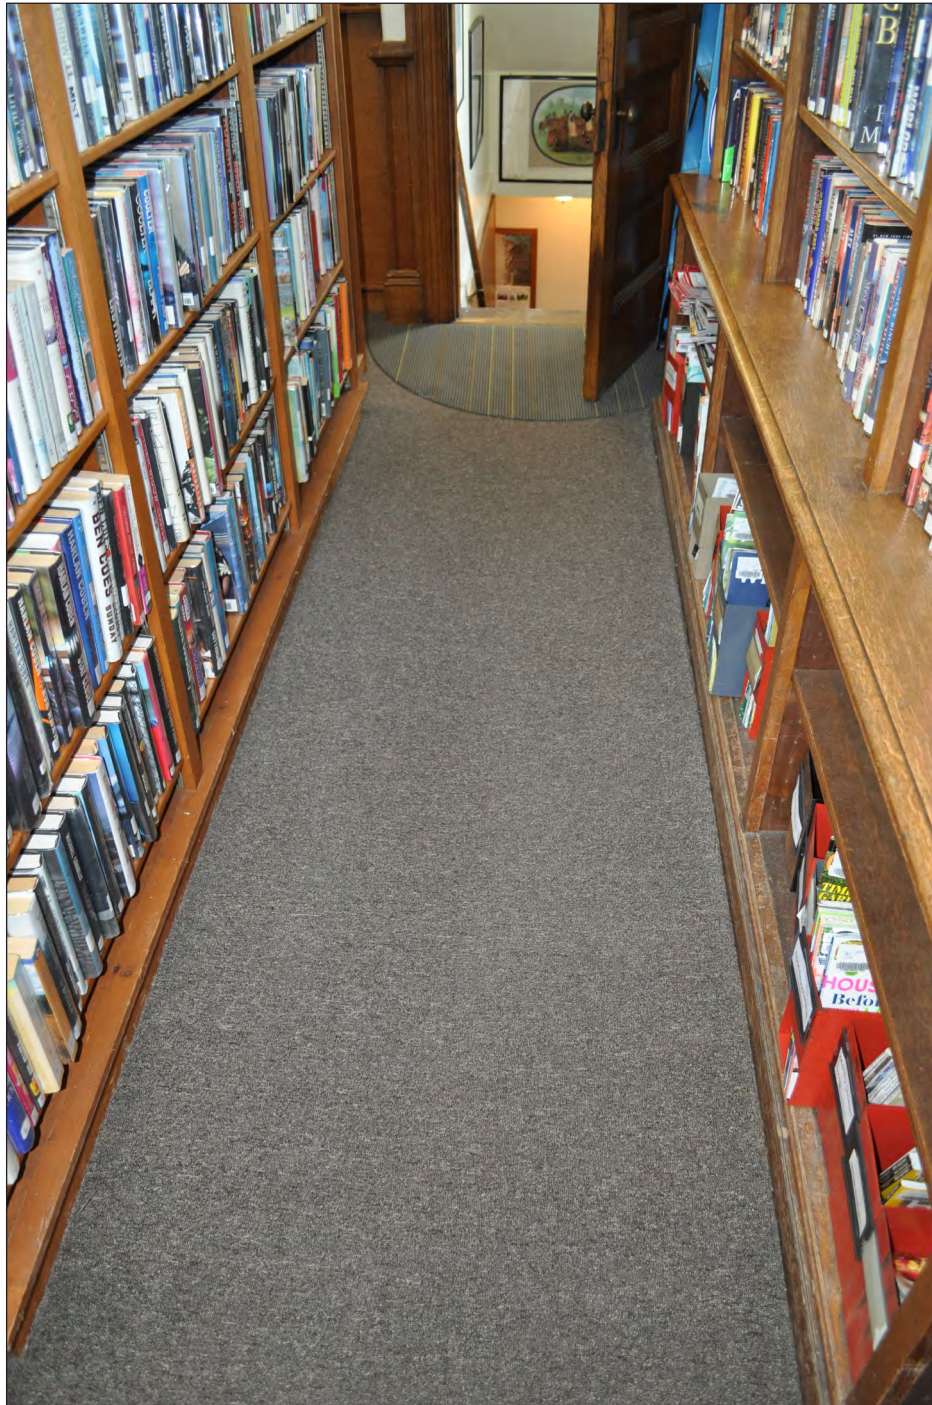
116. First-floor, library (204), camera facing down and south.

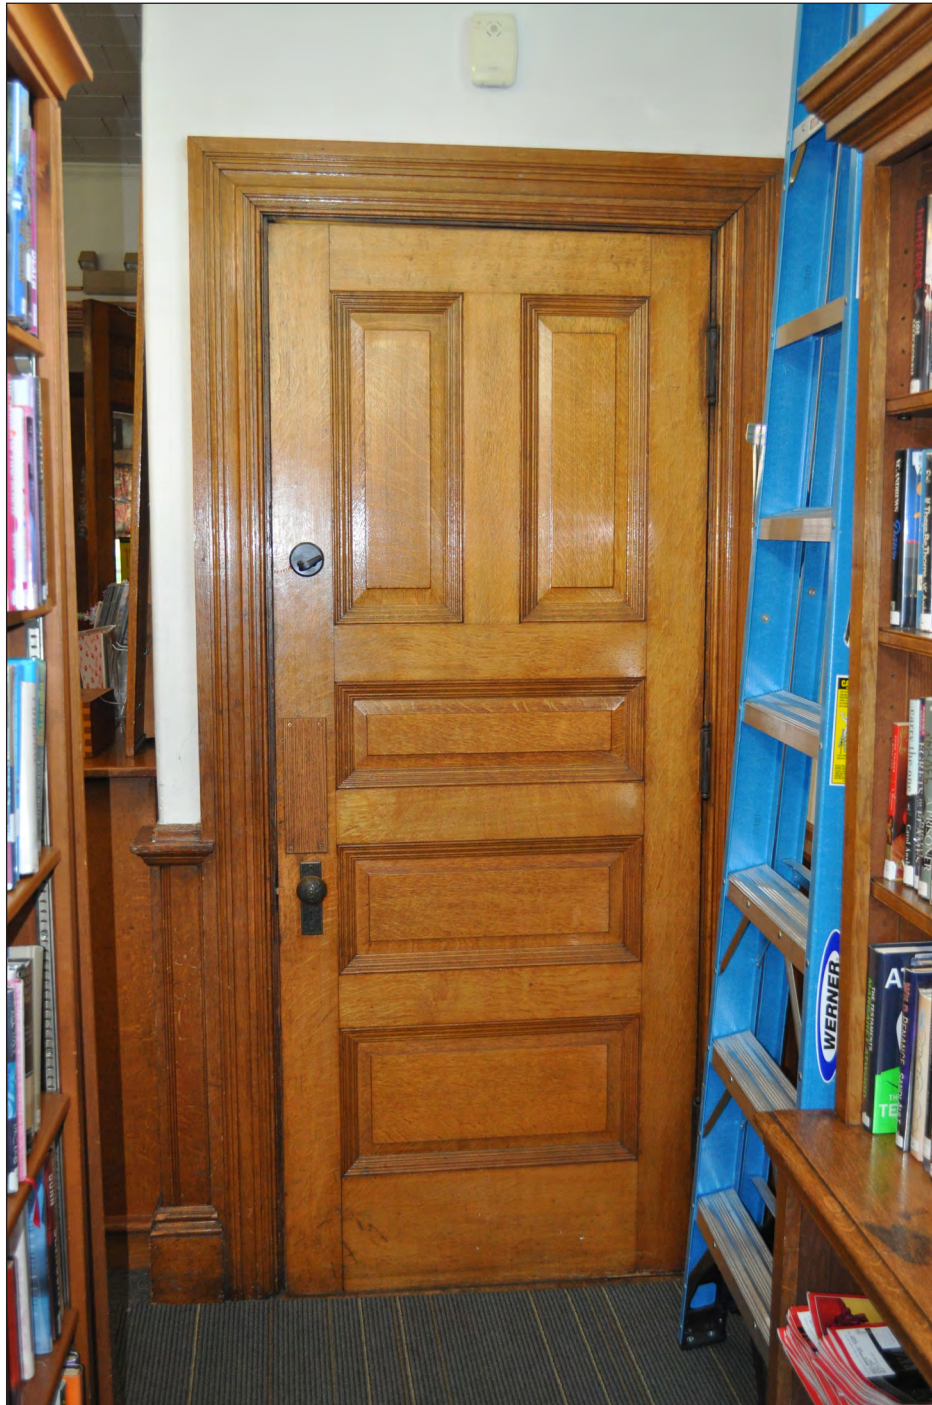
117. First-floor, library (204), camera facing south.

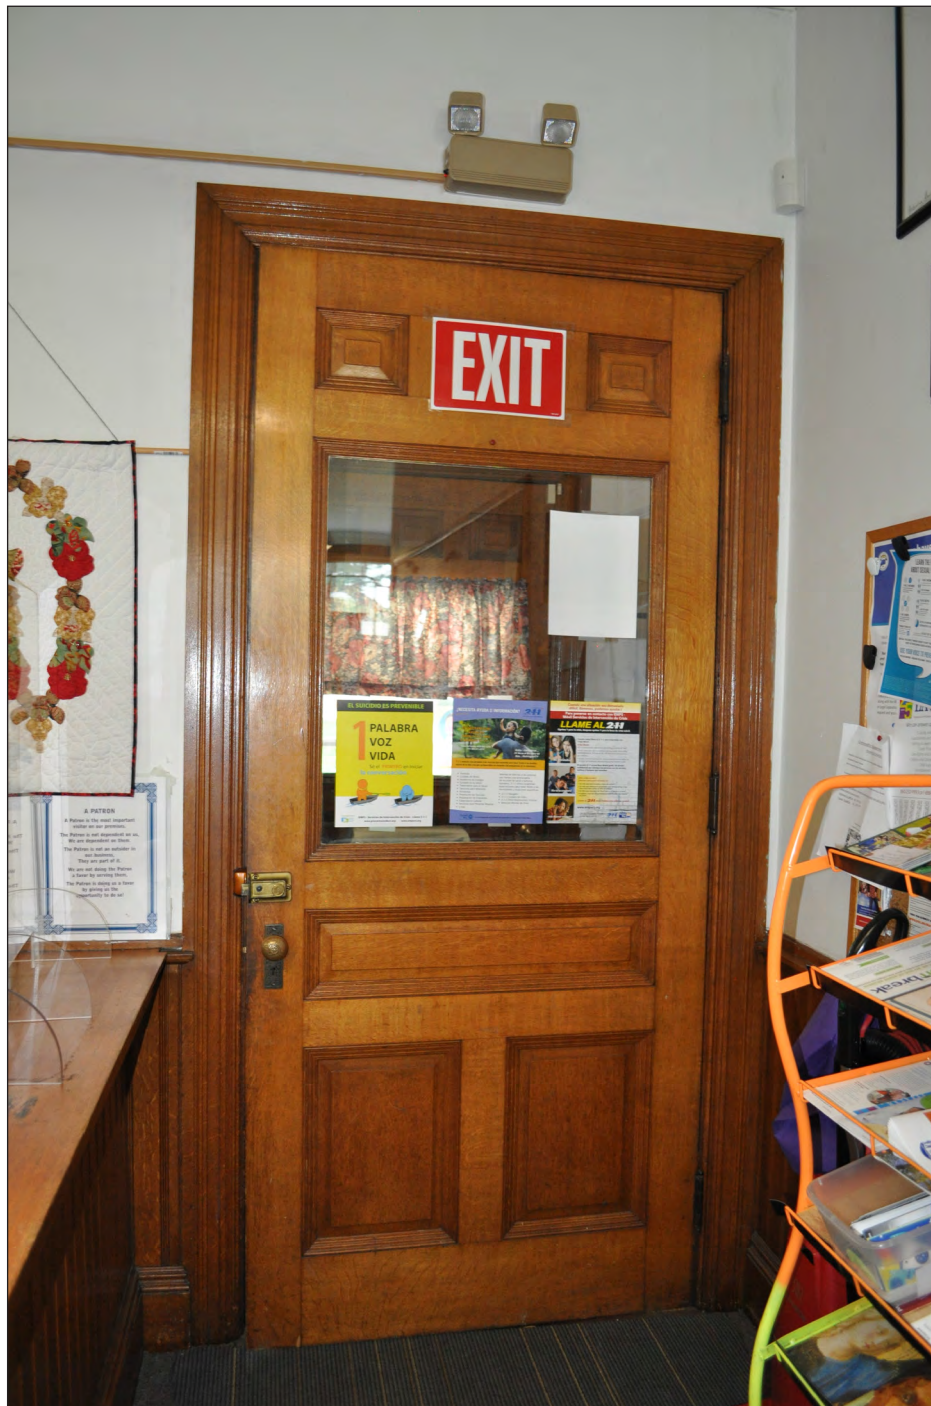
118. First-floor, library (204), camera facing southwest.

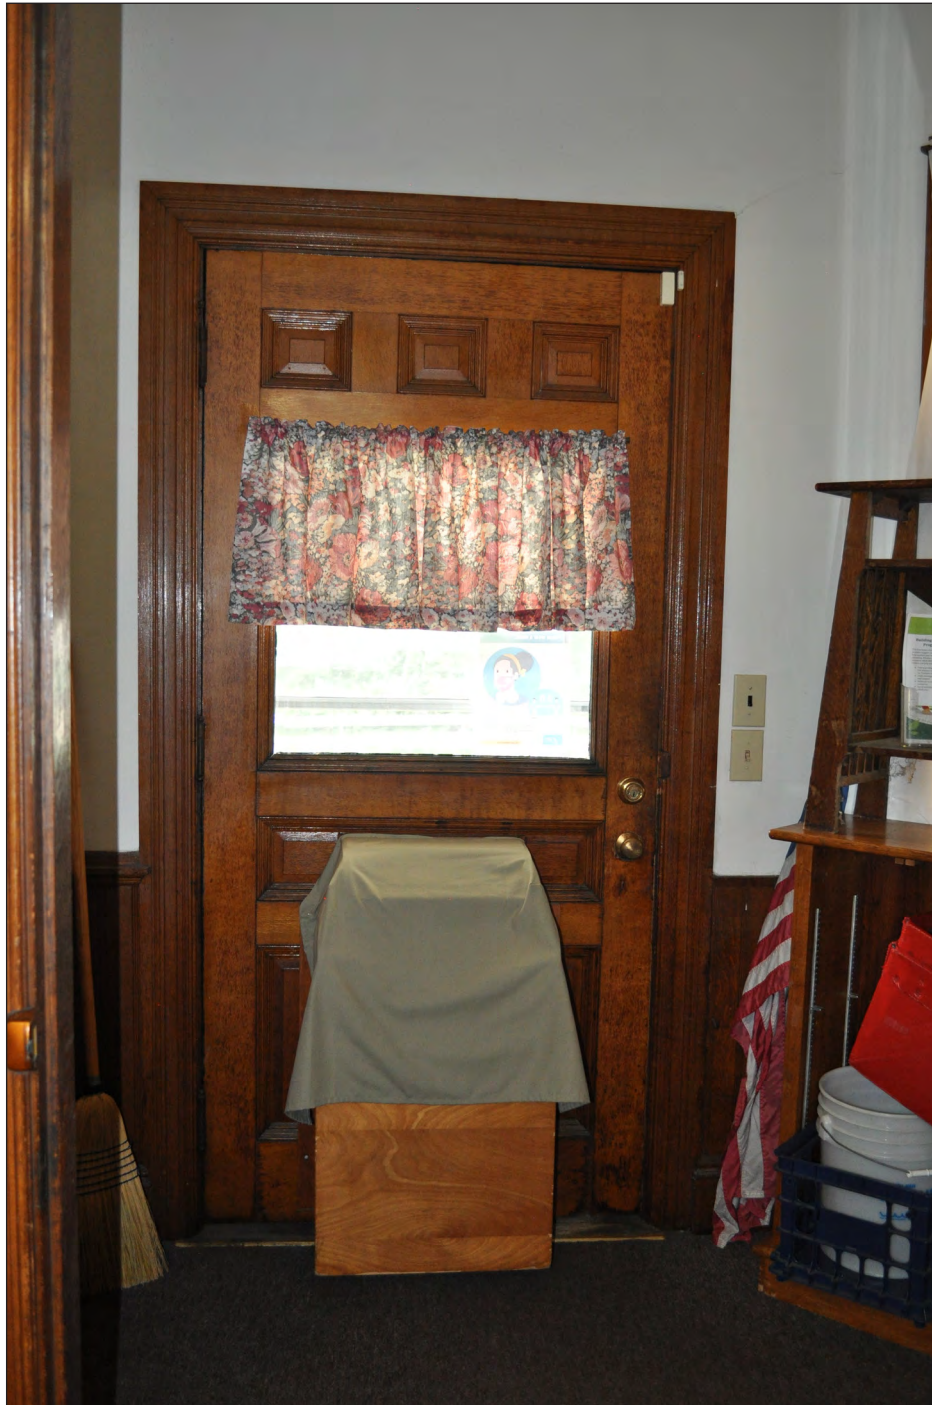
119. First-floor, vestibule 203, camera facing south.

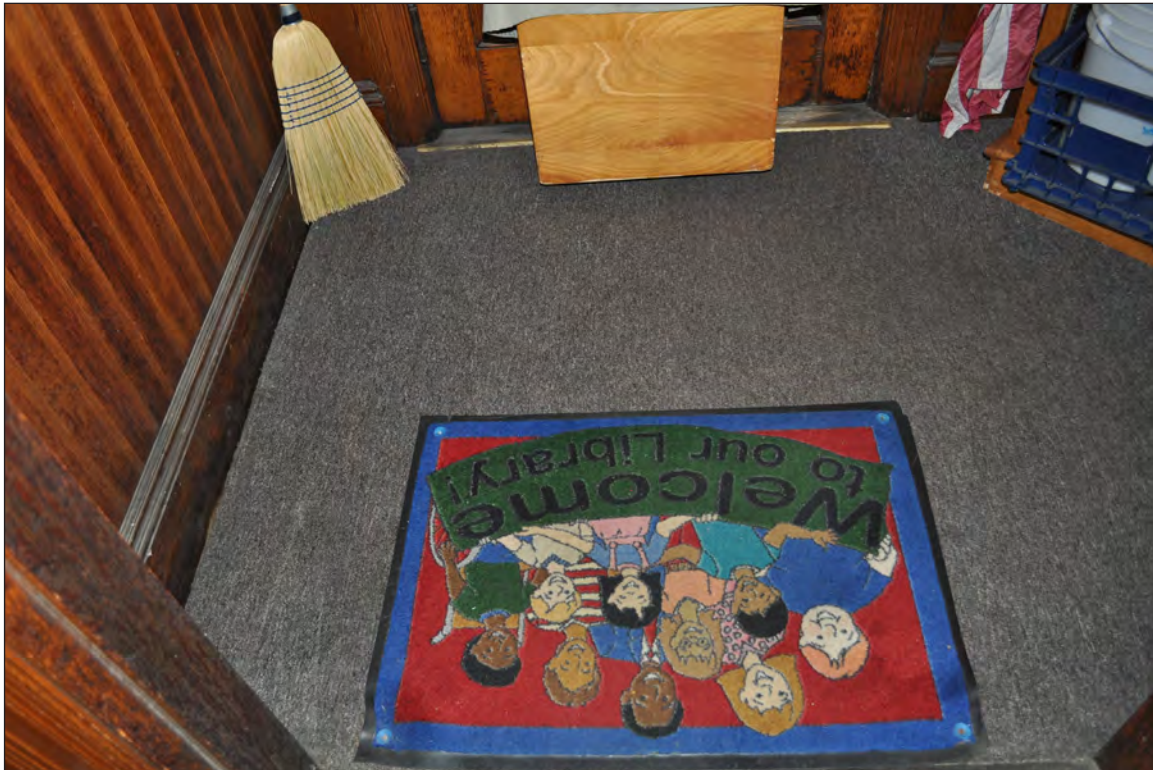
120. First-floor, vestibule 203, camera facing down and south.

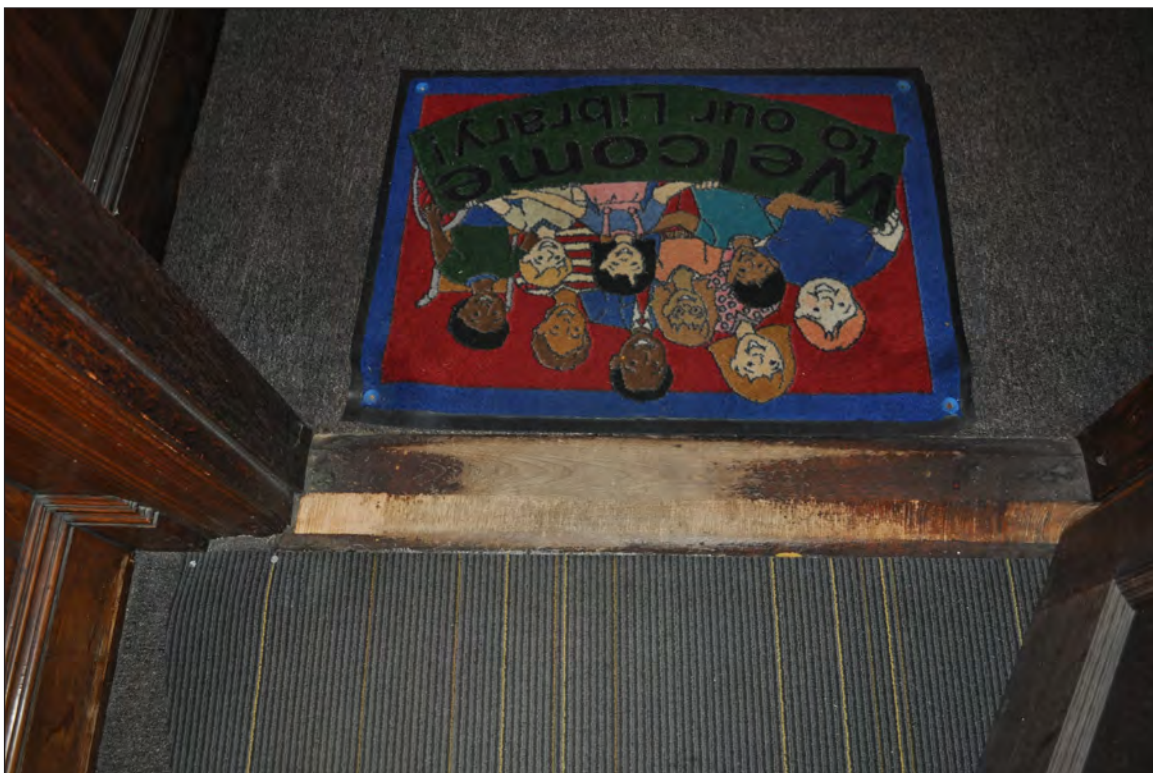
121. First-floor, vestibule 203, camera facing down and south.

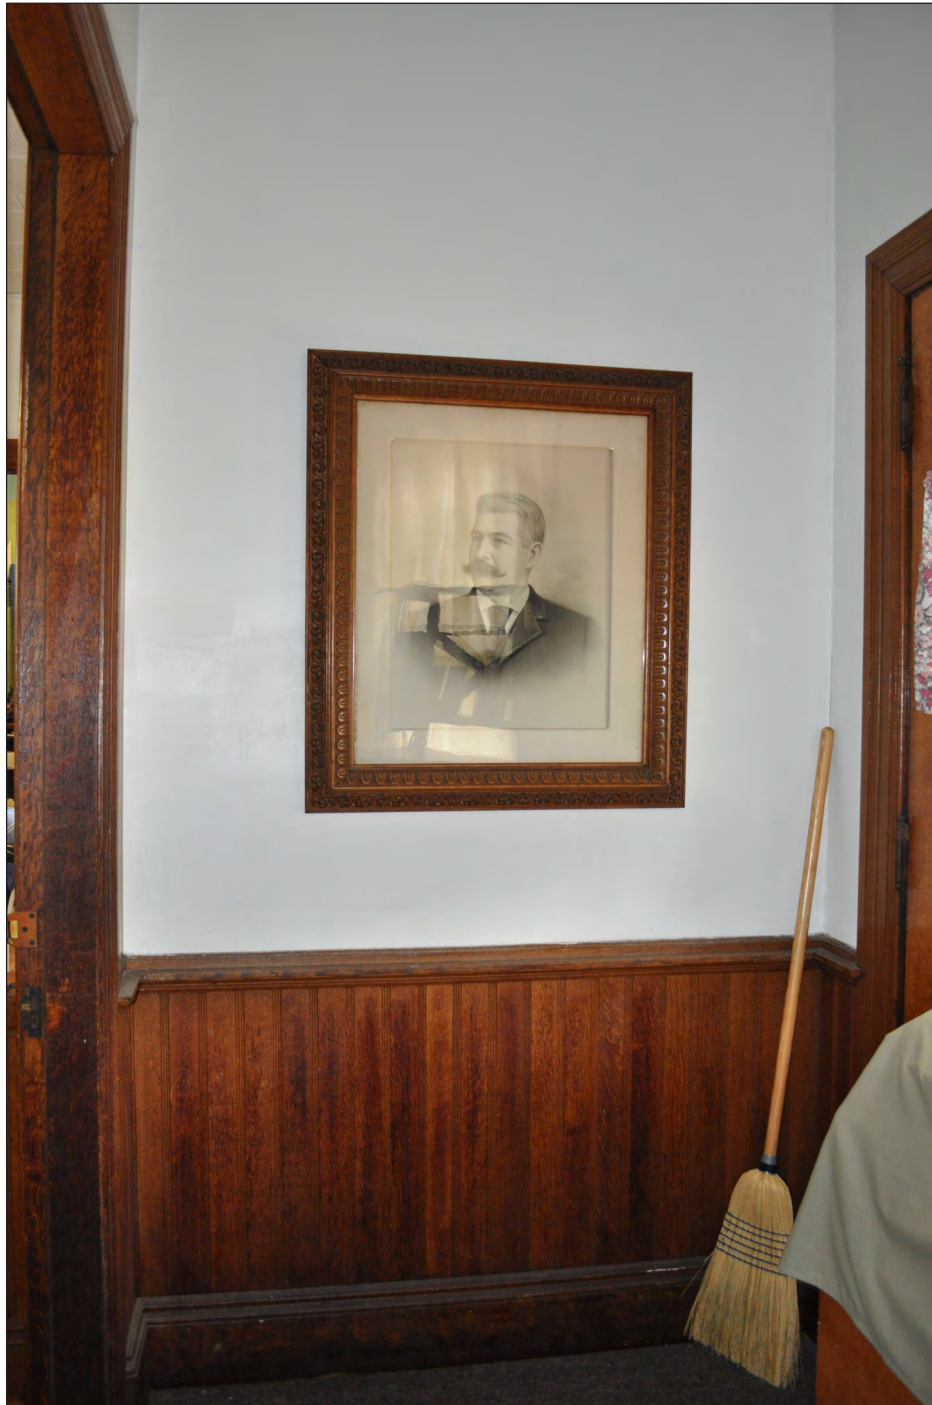
122. First-floor, vestibule 203, camera facing east.

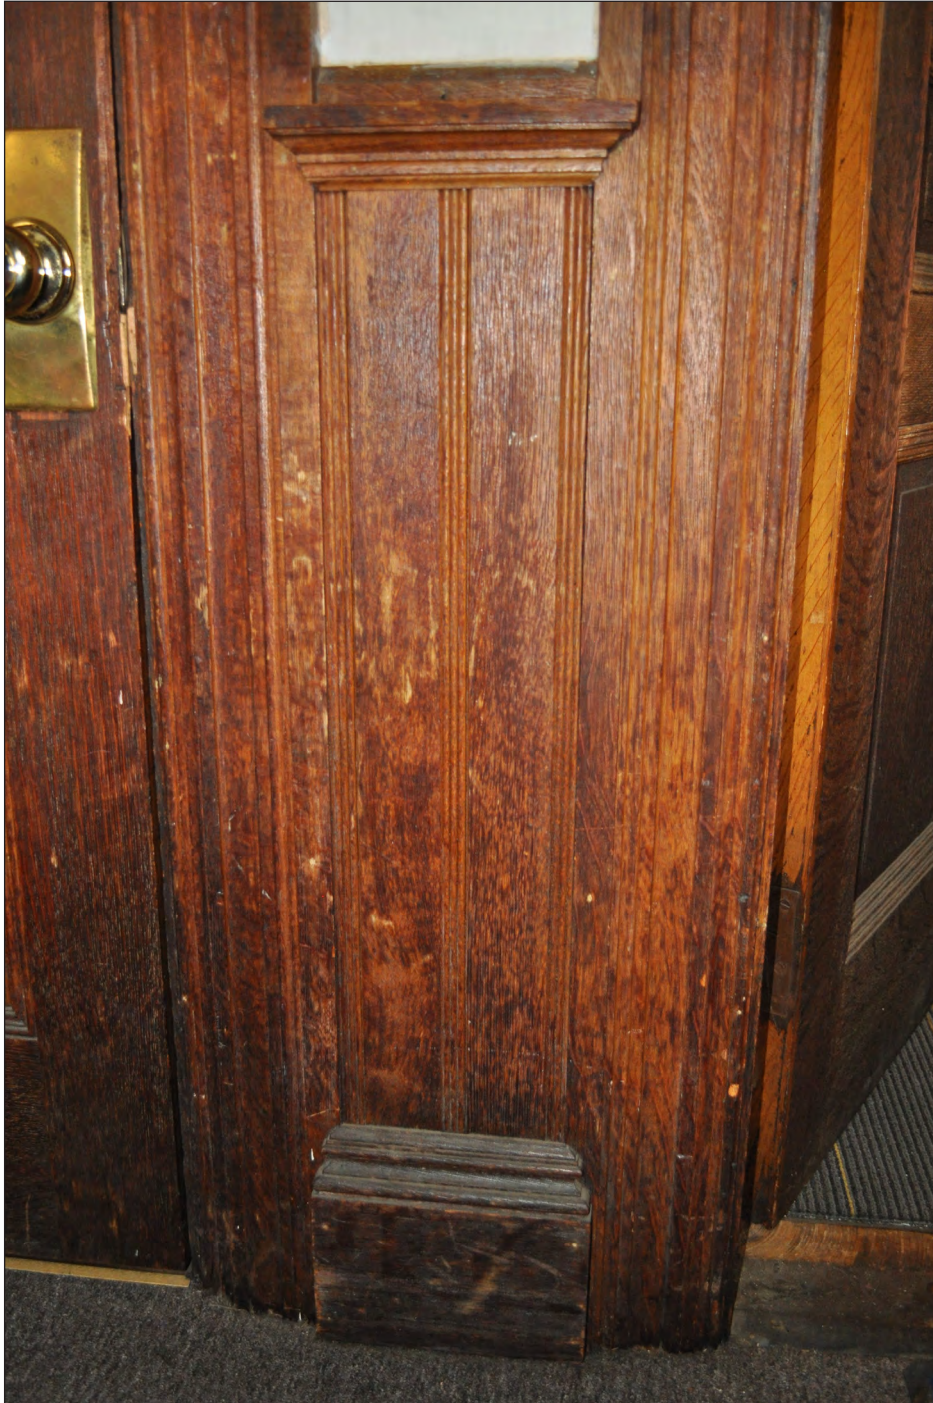
123. First-floor, vestibule 203, camera facing north.

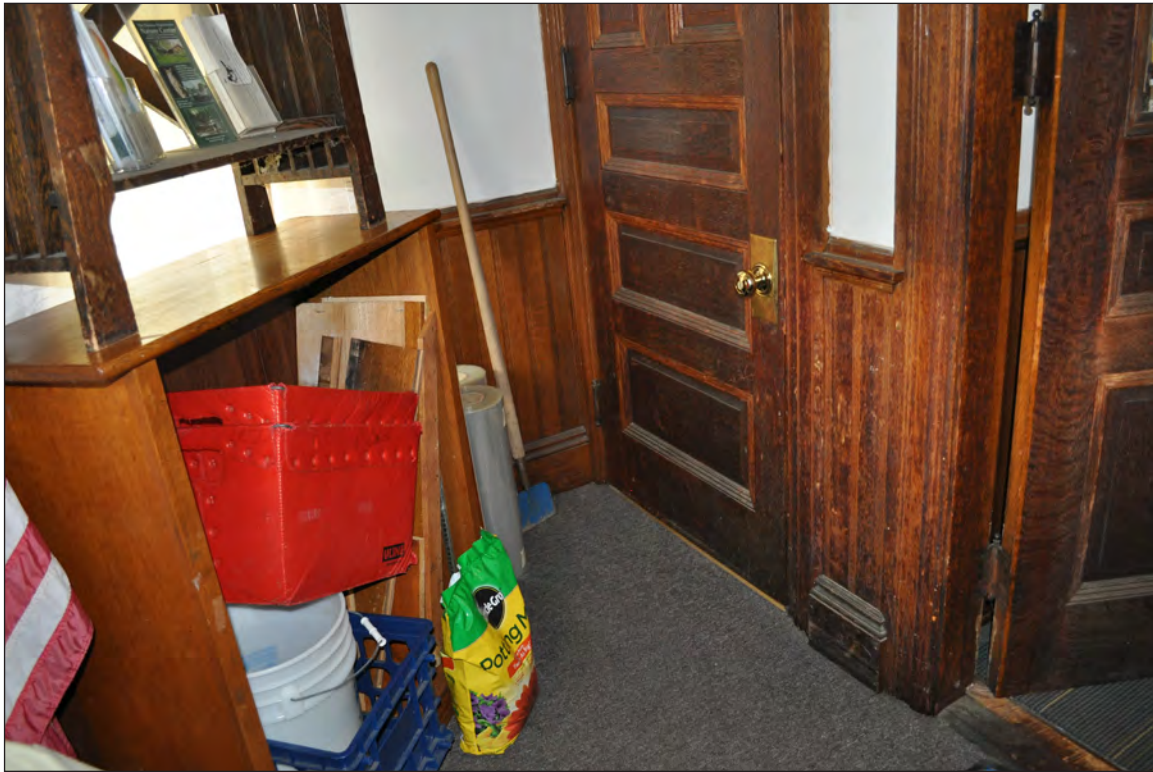
124. First-floor, vestibule 203, camera facing northwest.

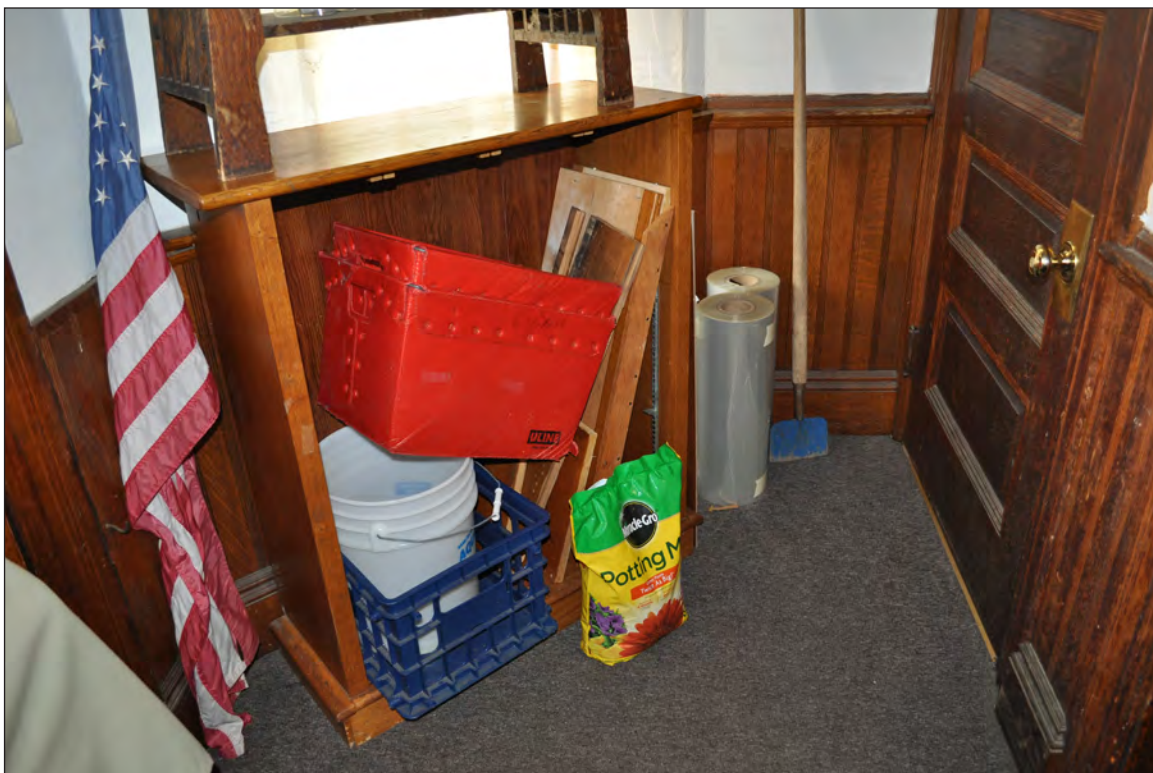
125. First-floor, vestibule 203, camera facing northwest.

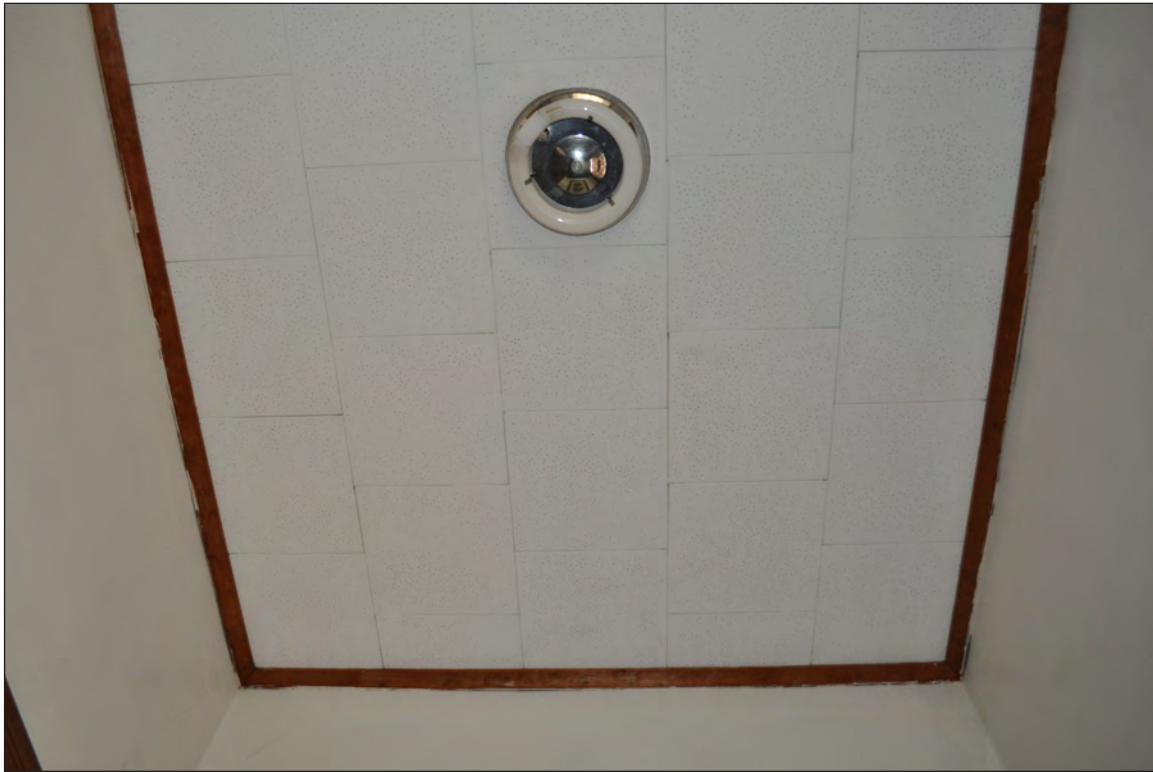
126. First-floor, vestibule 203, camera facing up and east.

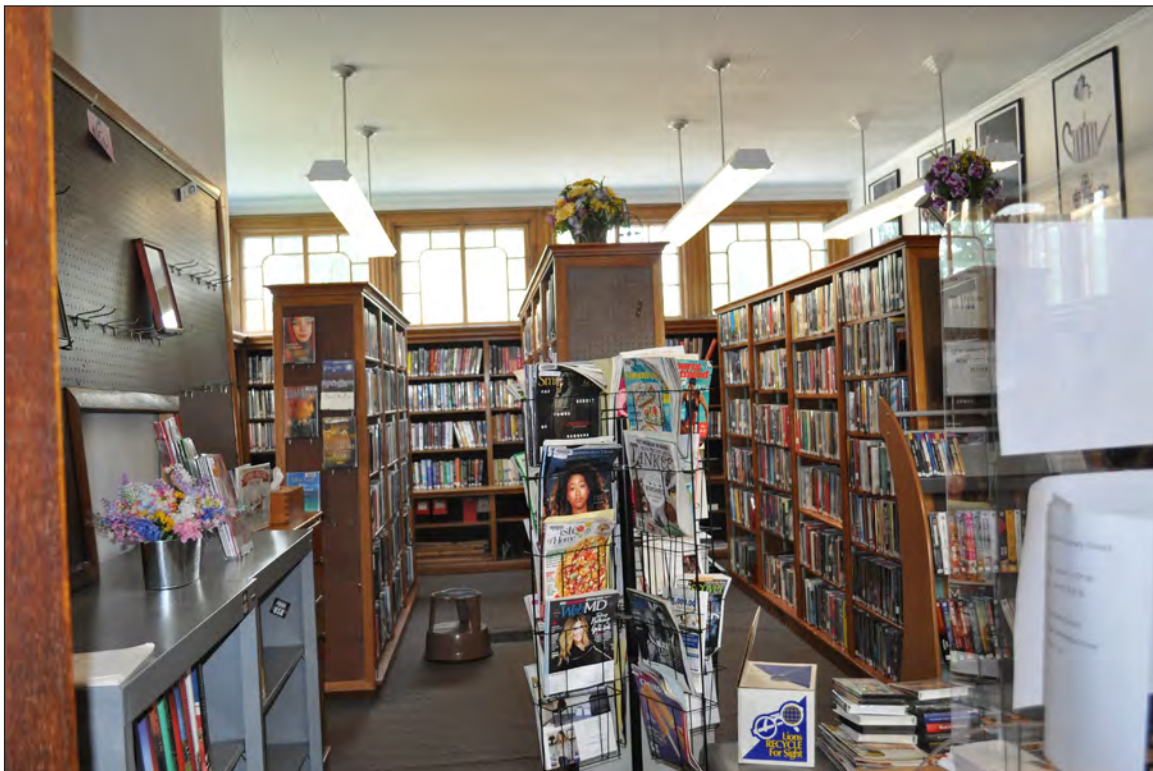
127. First-floor, library (204), camera facing northeast.

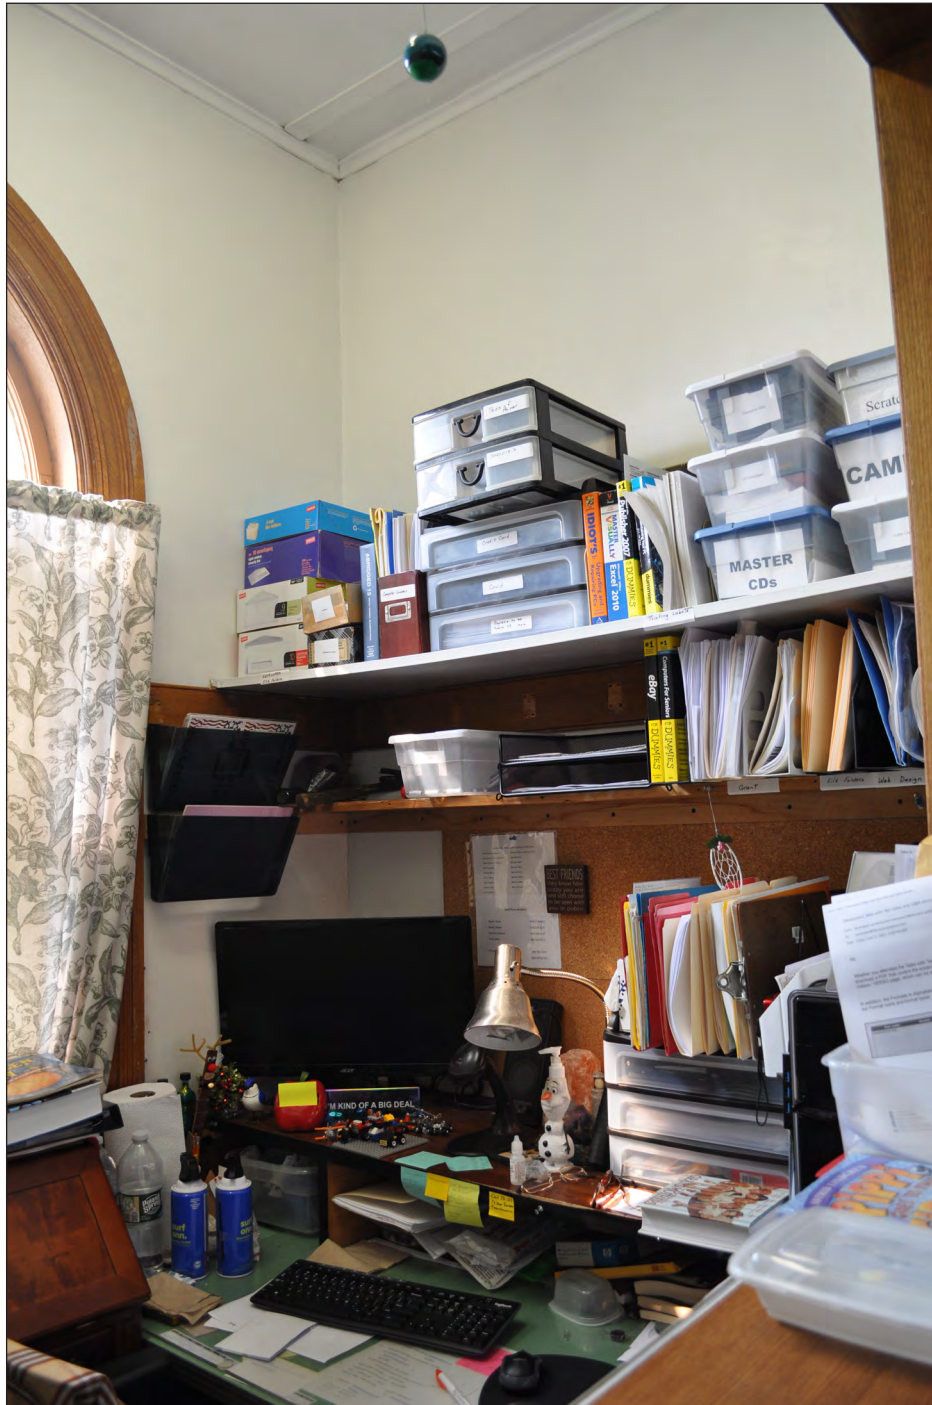
128. First-floor, Librarian's office (202), camera facing southwest.

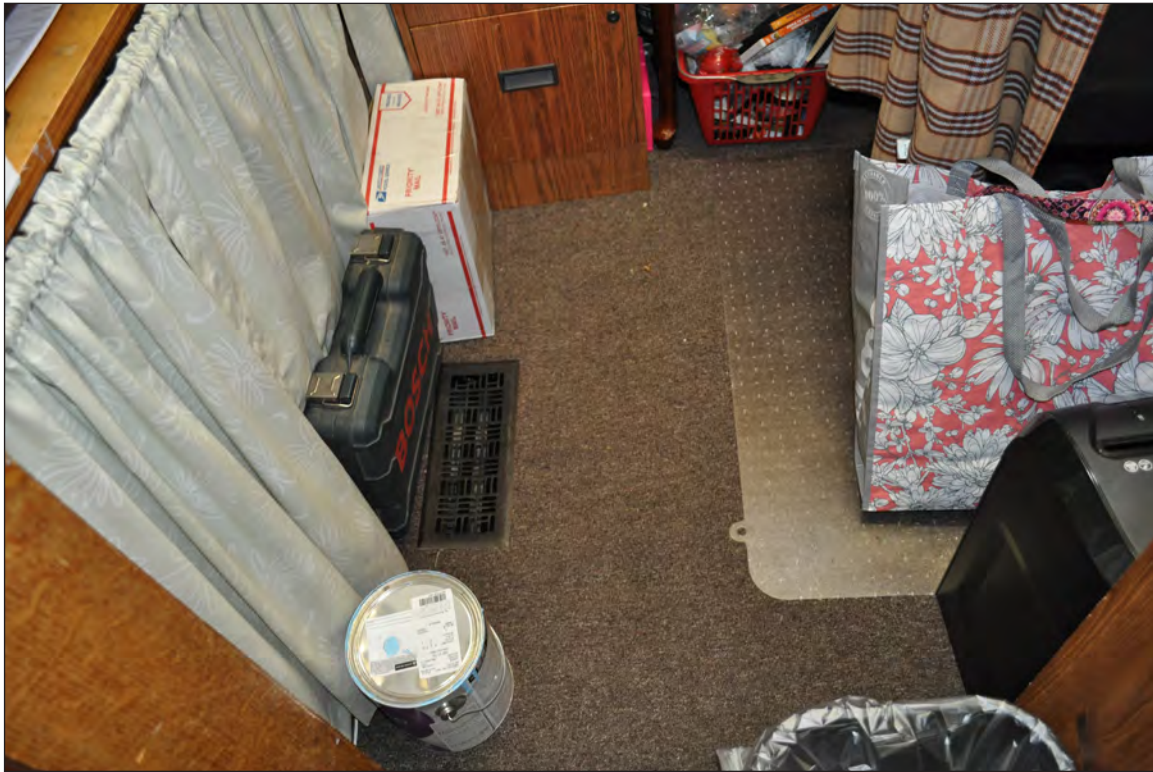
129. First-floor, Librarian's office (202), camera facing south.

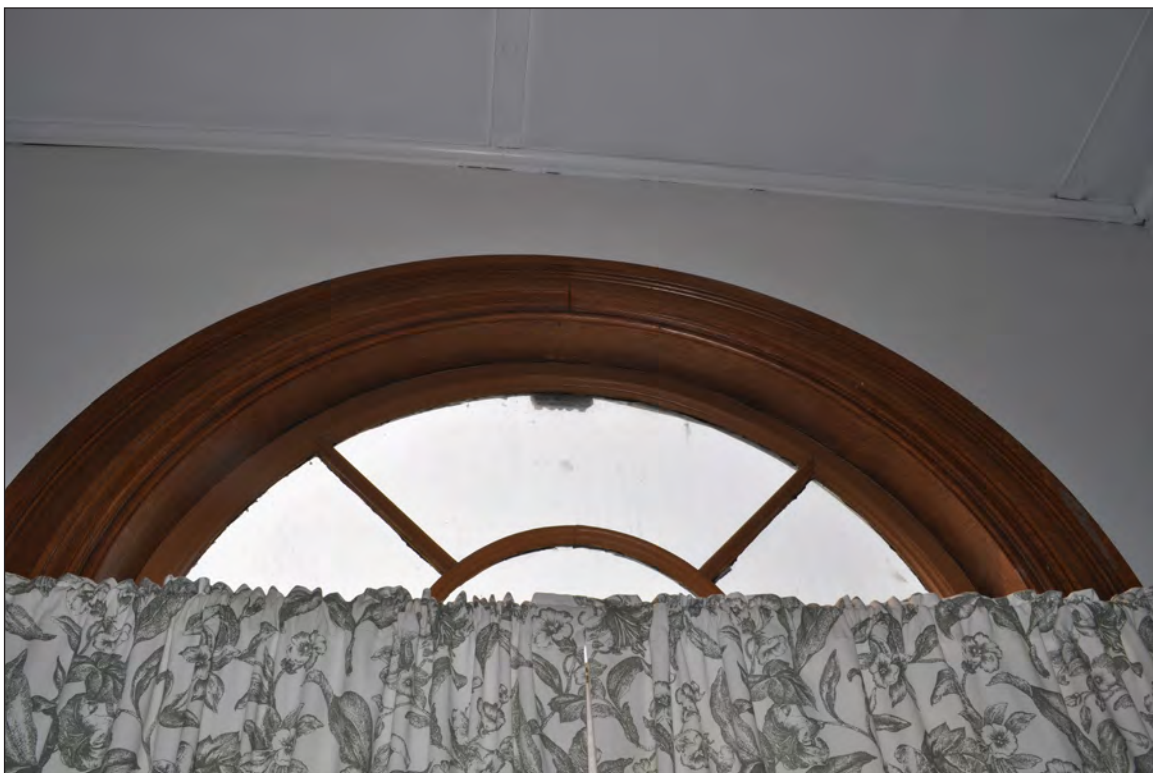
130. First-floor, Librarian's office (202), camera facing up and south.

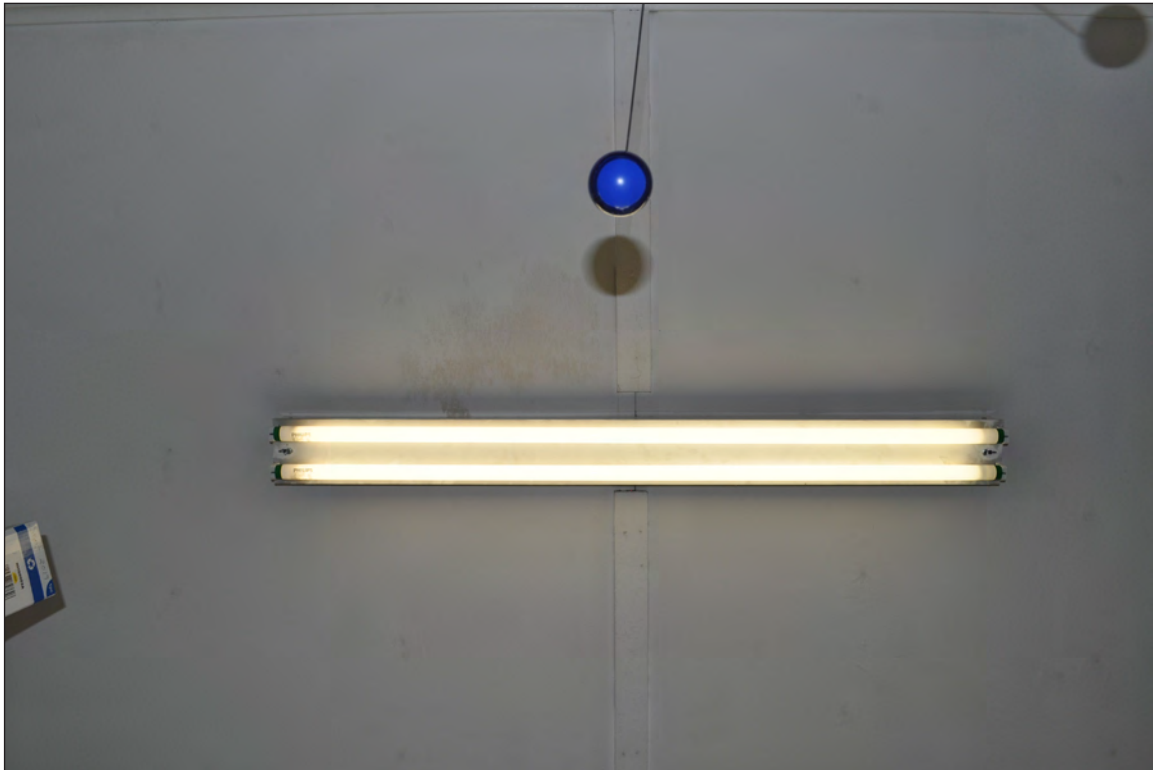
131. First-floor, Librarian's office (202), camera facing south.

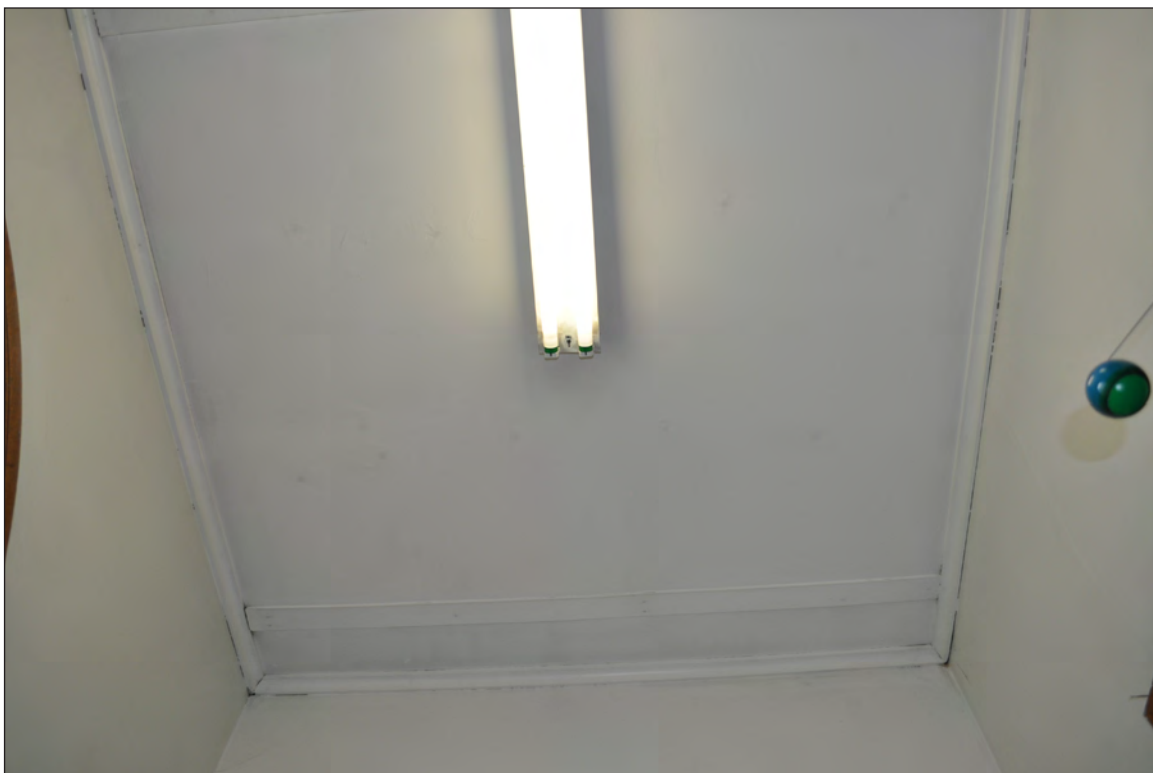
132. First-floor, Librarian's office (202), camera facing west.

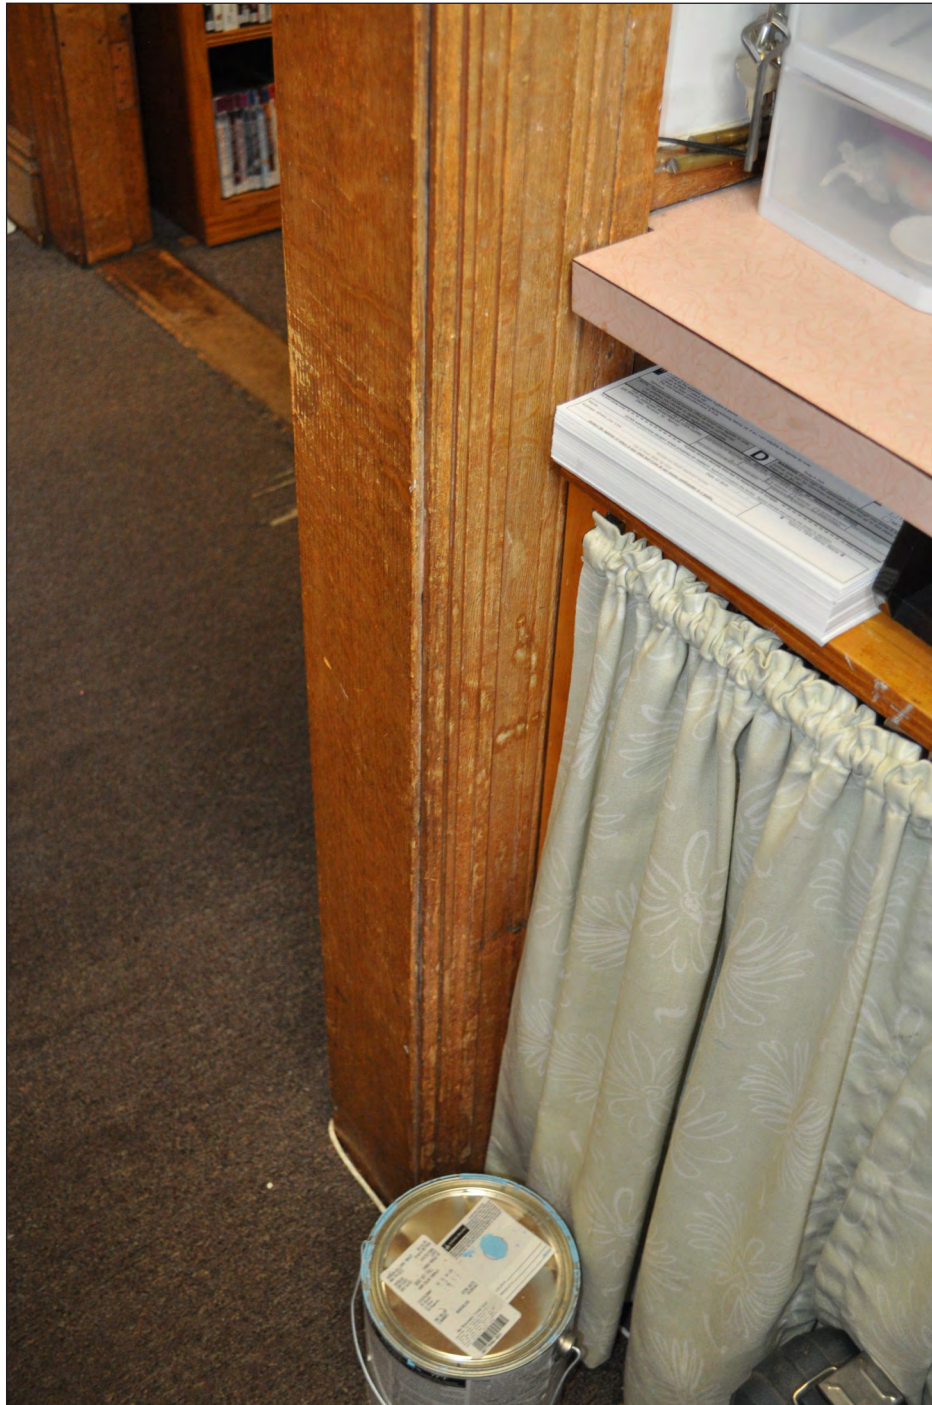
133. First-floor, Librarian's office (202), camera facing northeast.

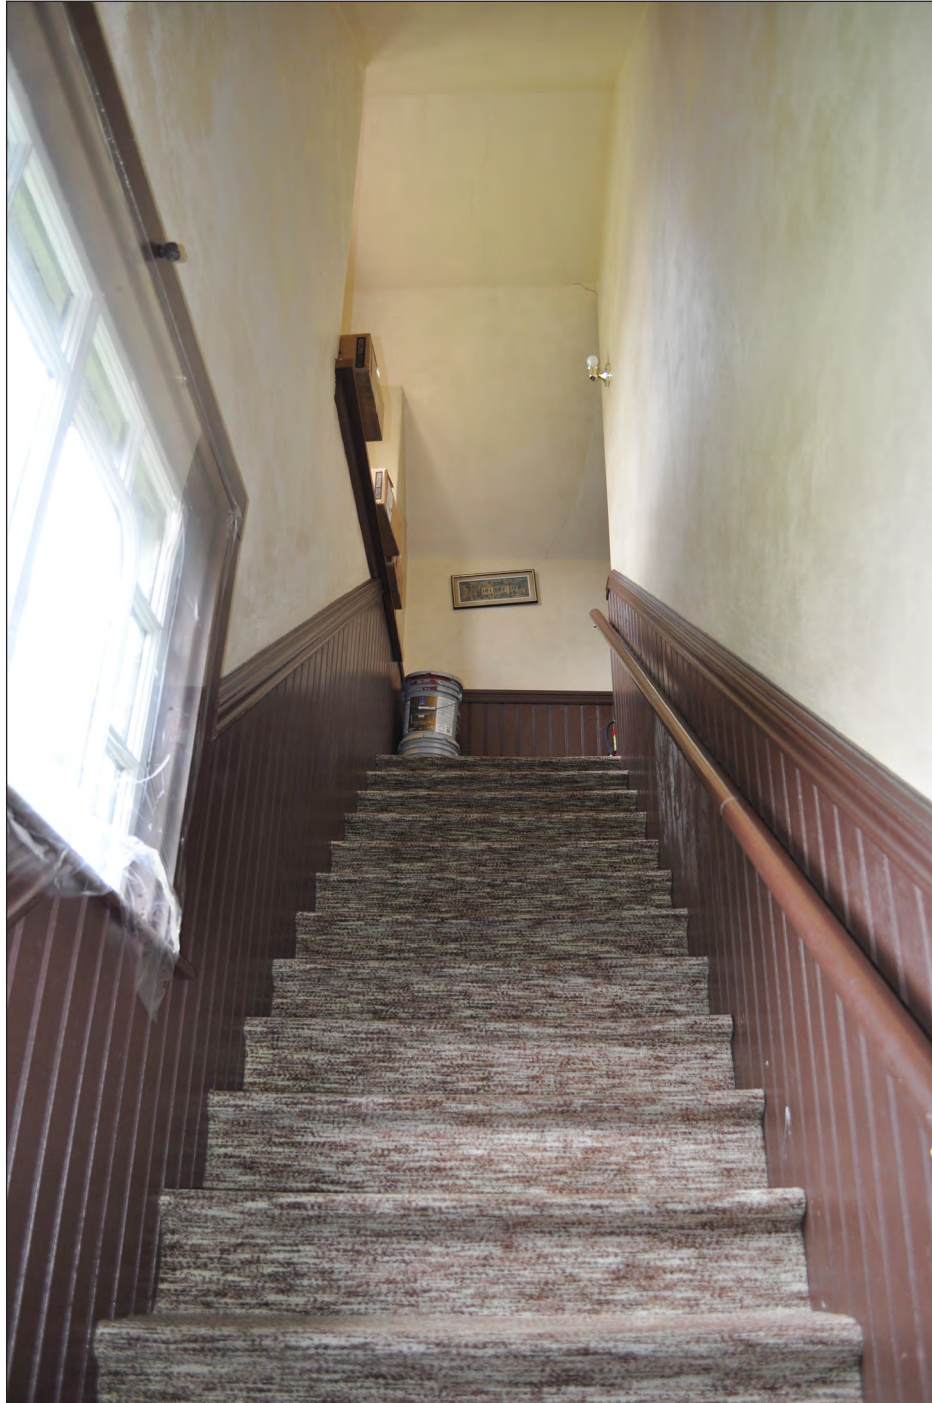
134. First-floor, vestibule (203), stair, camera facing up and north.
