ALDRICH PUBLIC LIBRARY

FEASIBILITY STUDY

Issued: October 21, 2021

CROSSKEY ARCHITECTS, LLC
750 Main Street, Suite 150
Hartford, CT 06103

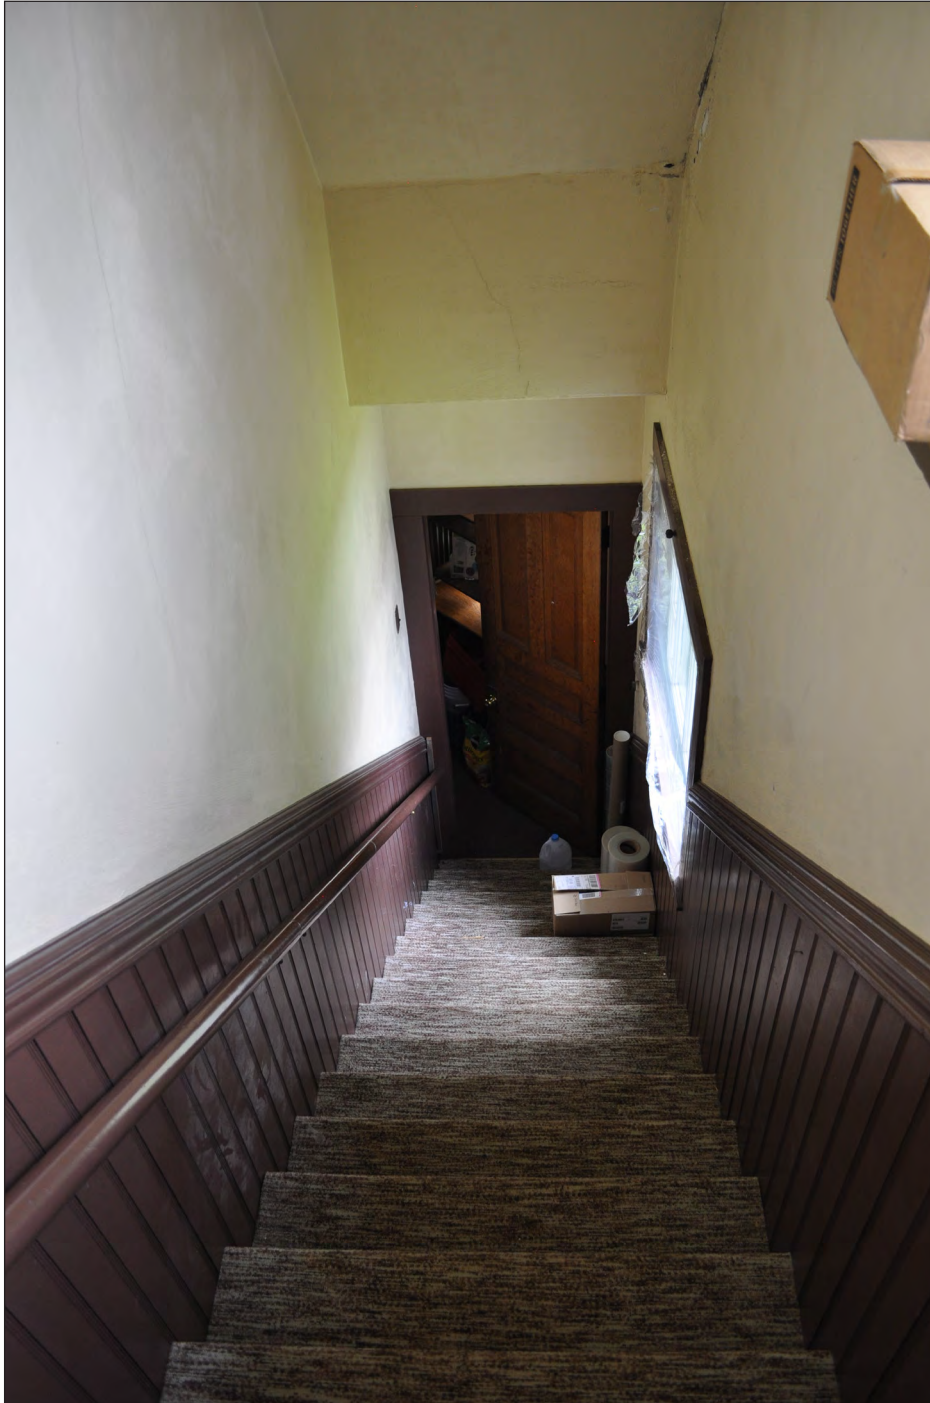
135. Second-floor, stair, camera facing down and south.

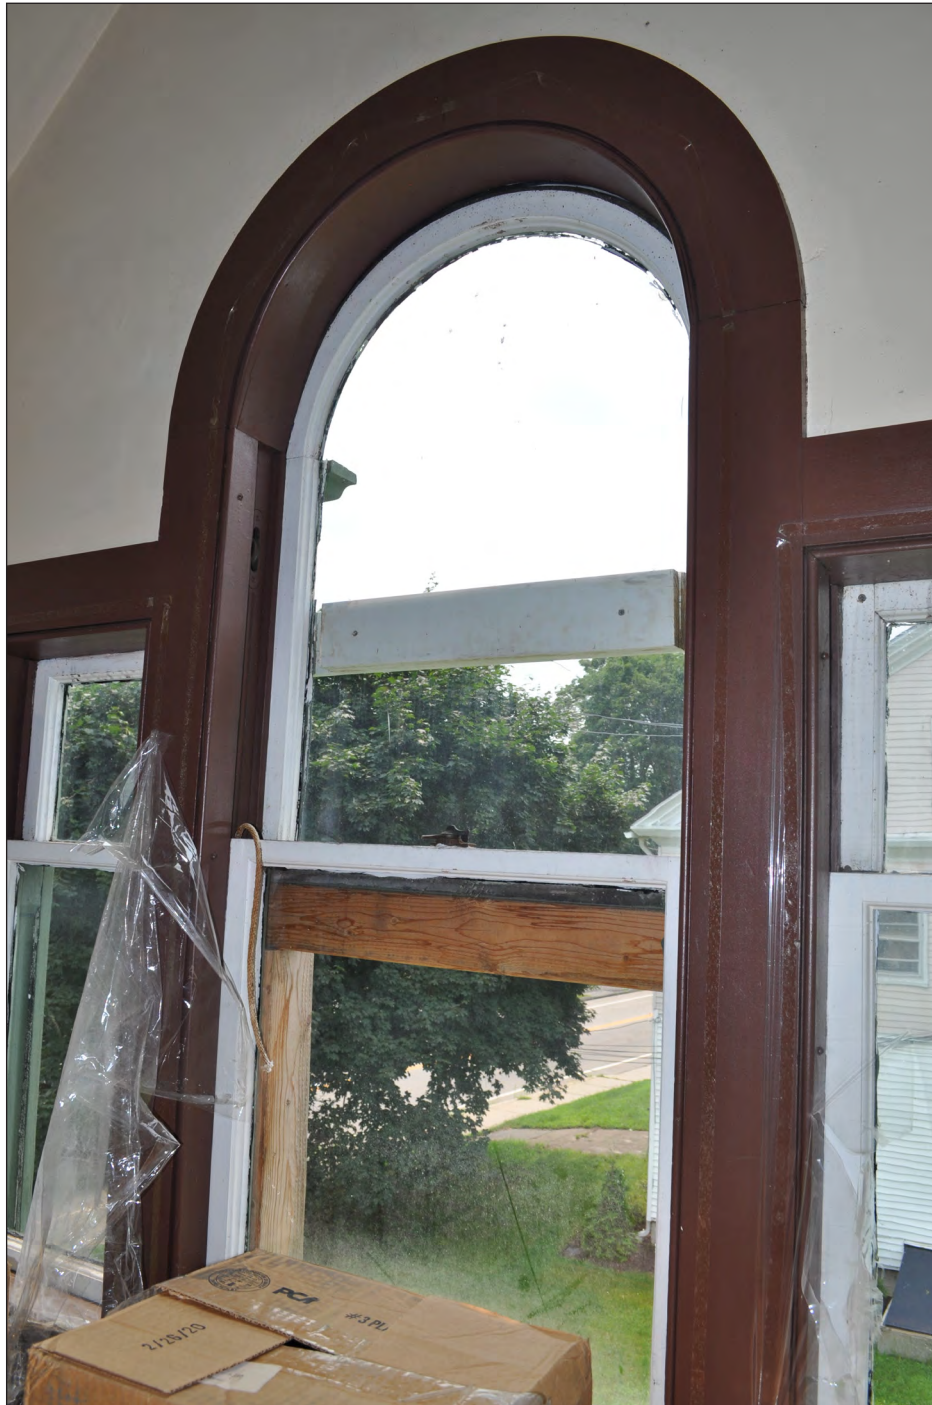
136. Second-floor, window in stair, camera facing southwest.

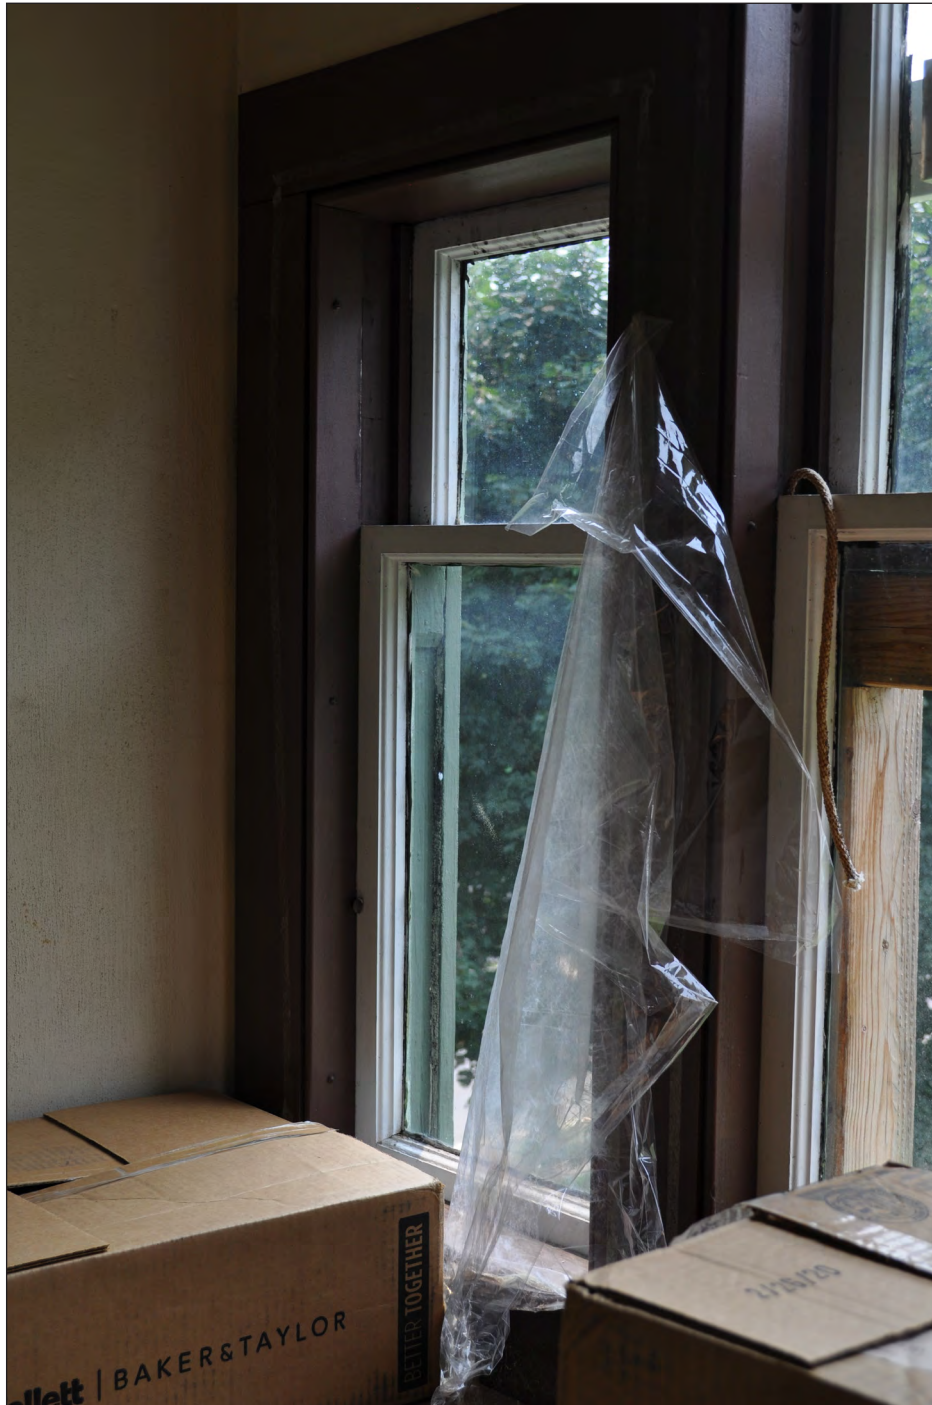
137. Second-floor, window in stair, camera facing southwest.

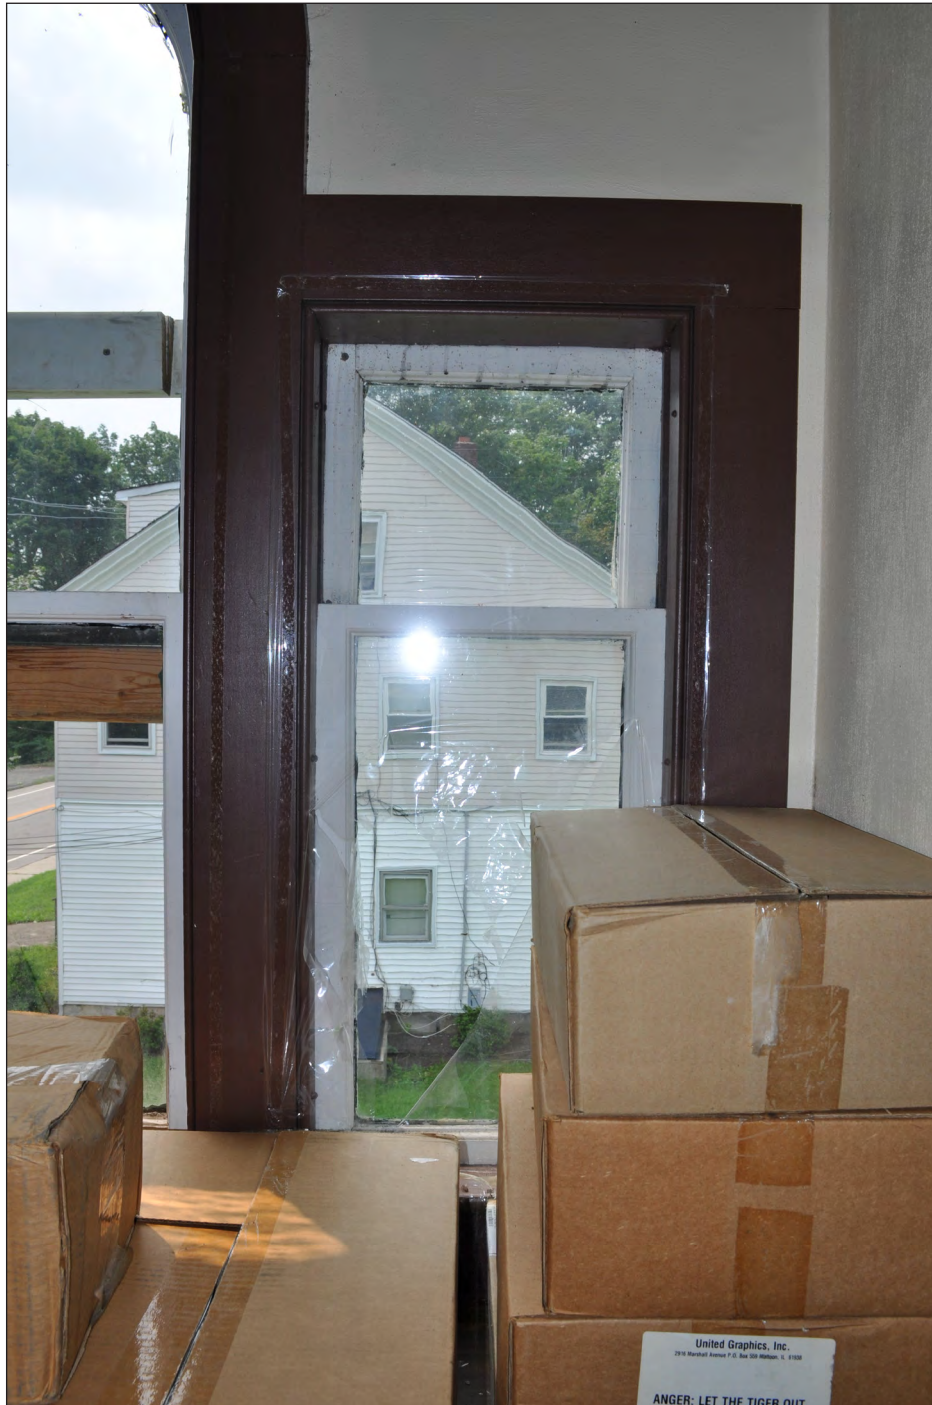
138. Second-floor, window in stair, camera facing west.

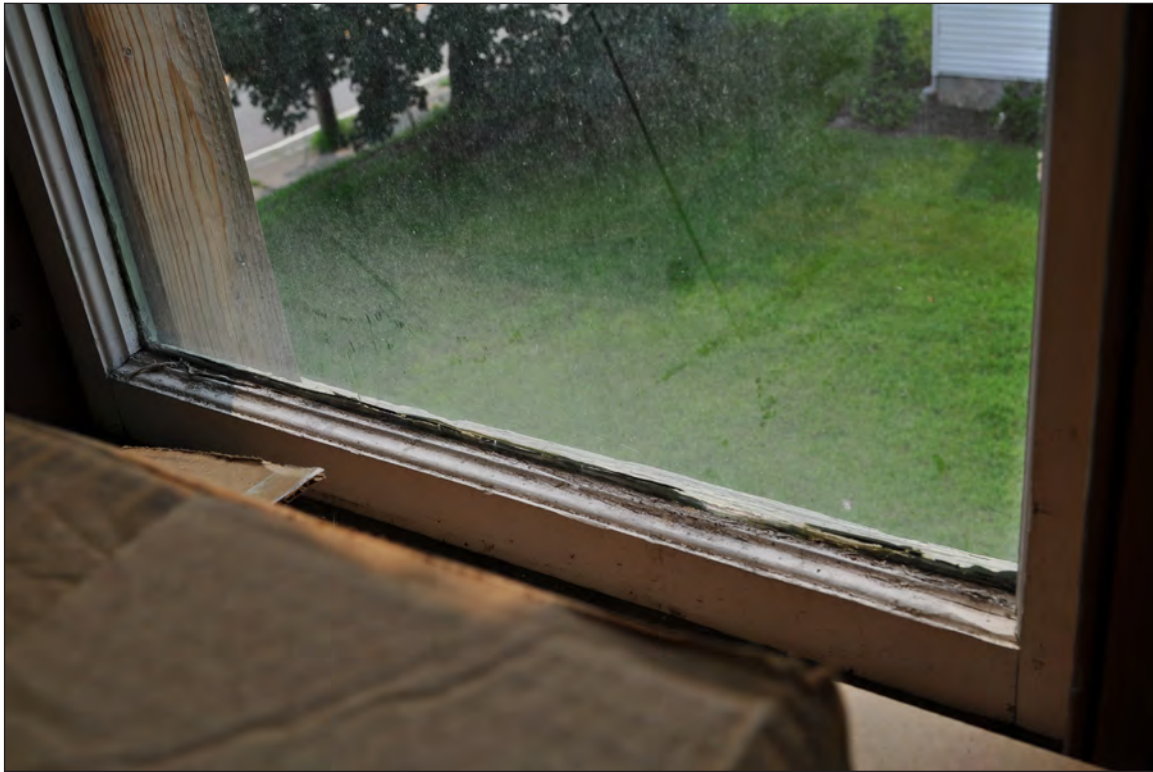
139. Second-floor, window in stair, camera facing southwest.

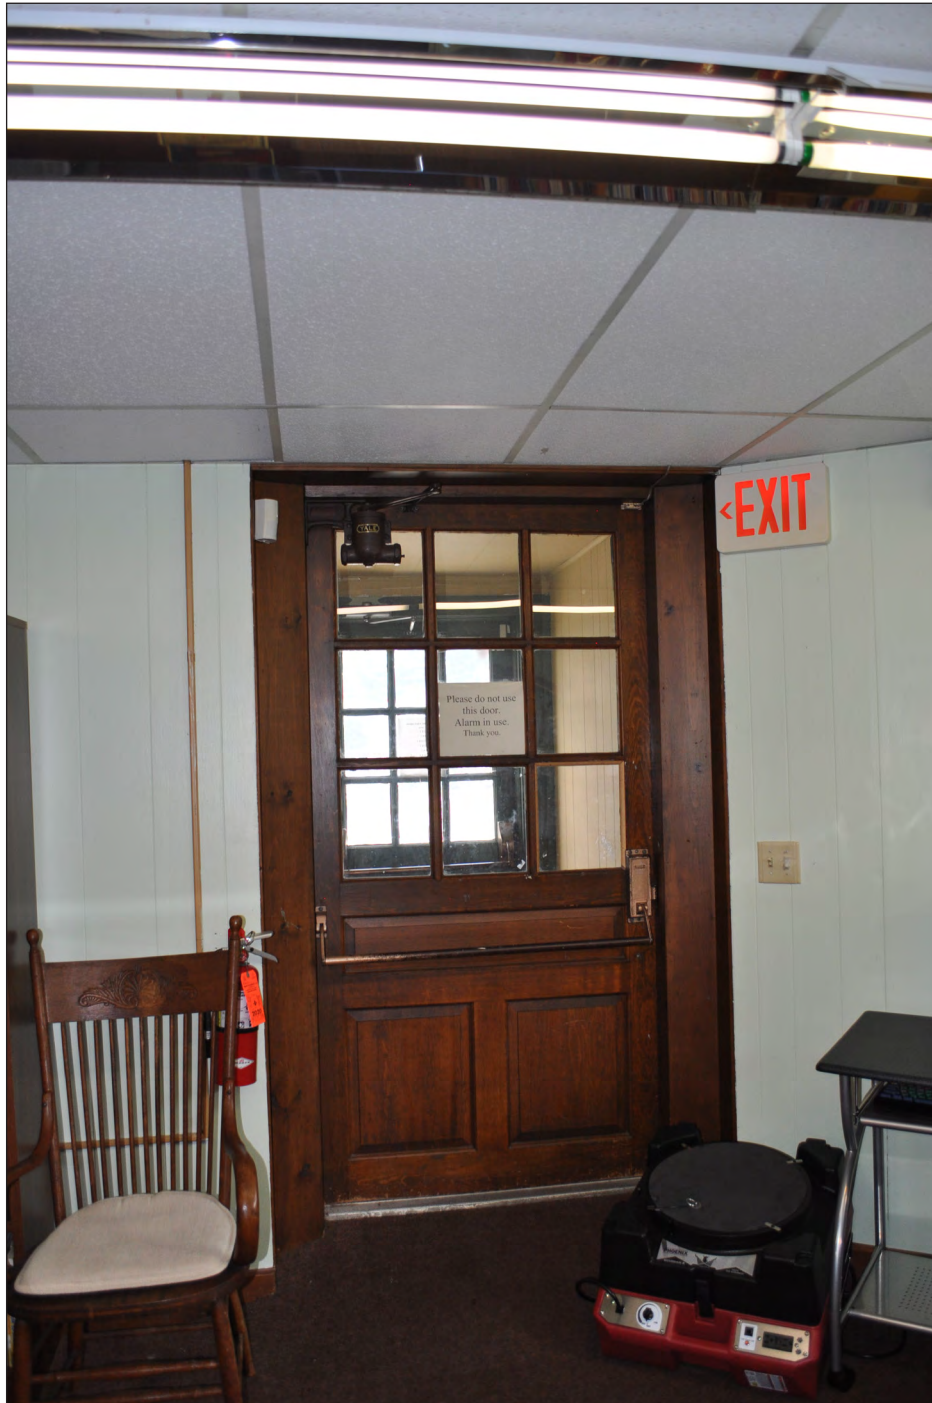
181. Basement, children's library (101), camera facing east.

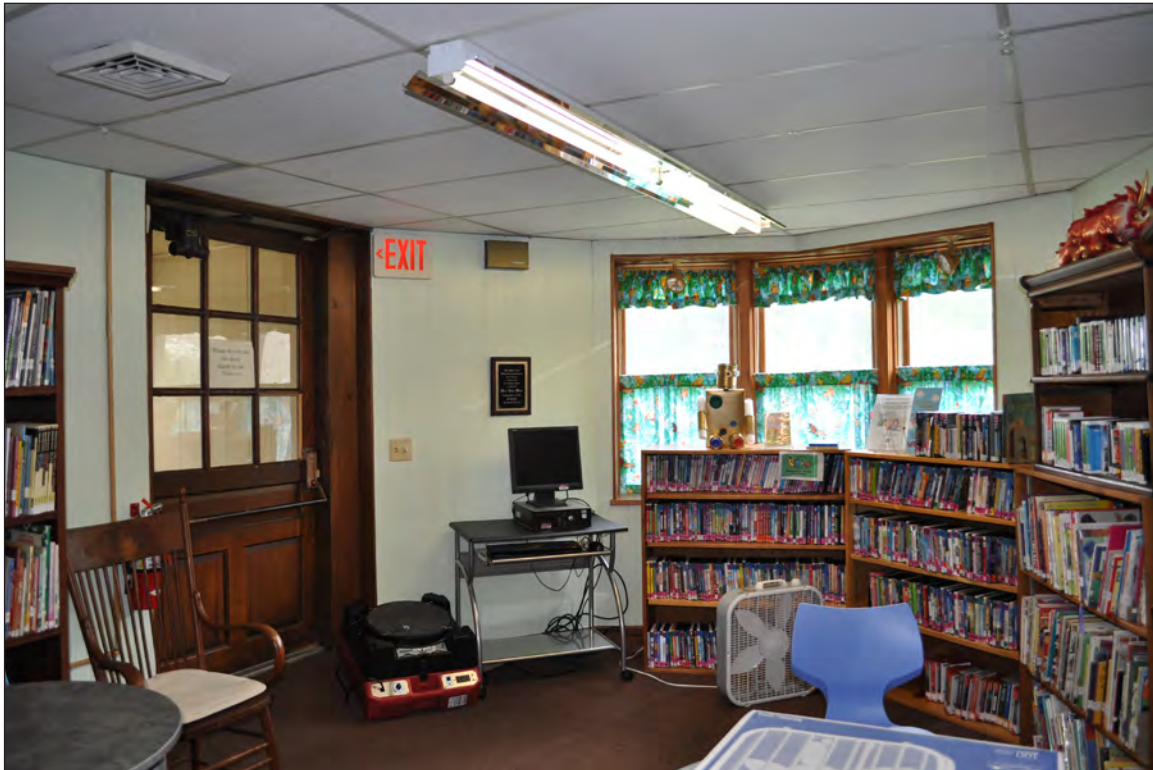
182. Basement, children's library (101), camera facing southeast.

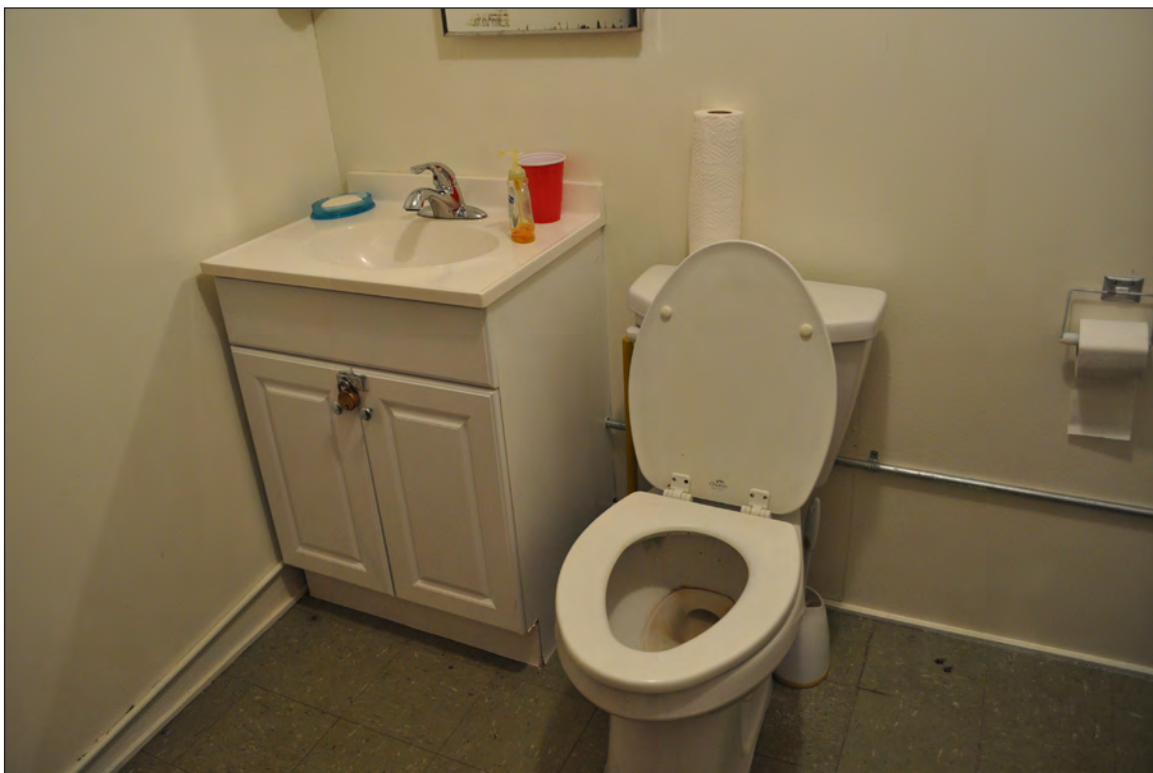
183. Basement, bathroom (106), camera facing northwest.

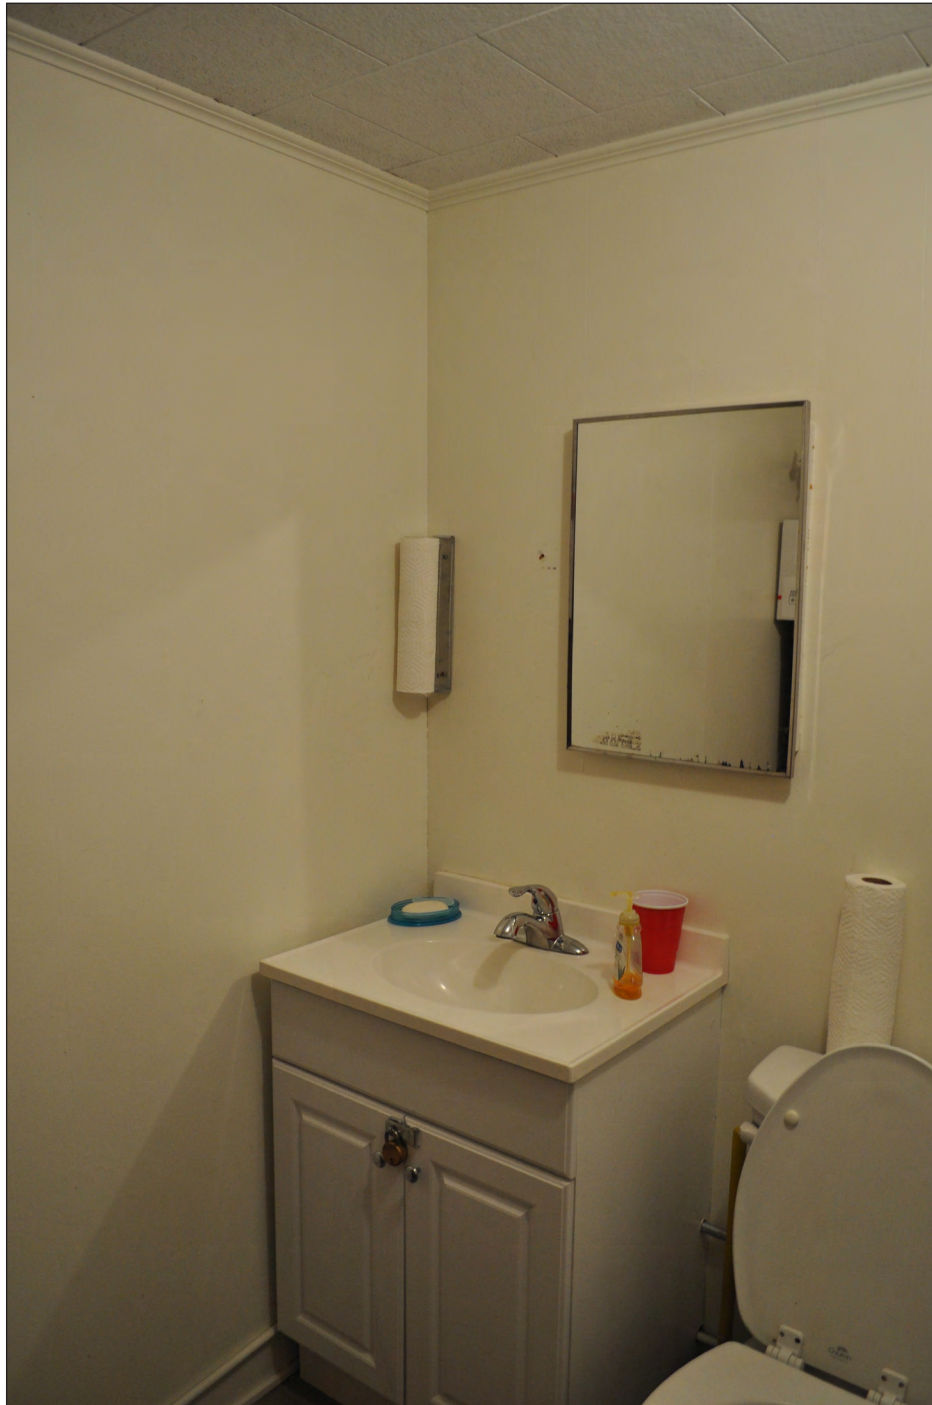
184. Basement, bathroom (106), camera facing northwest.

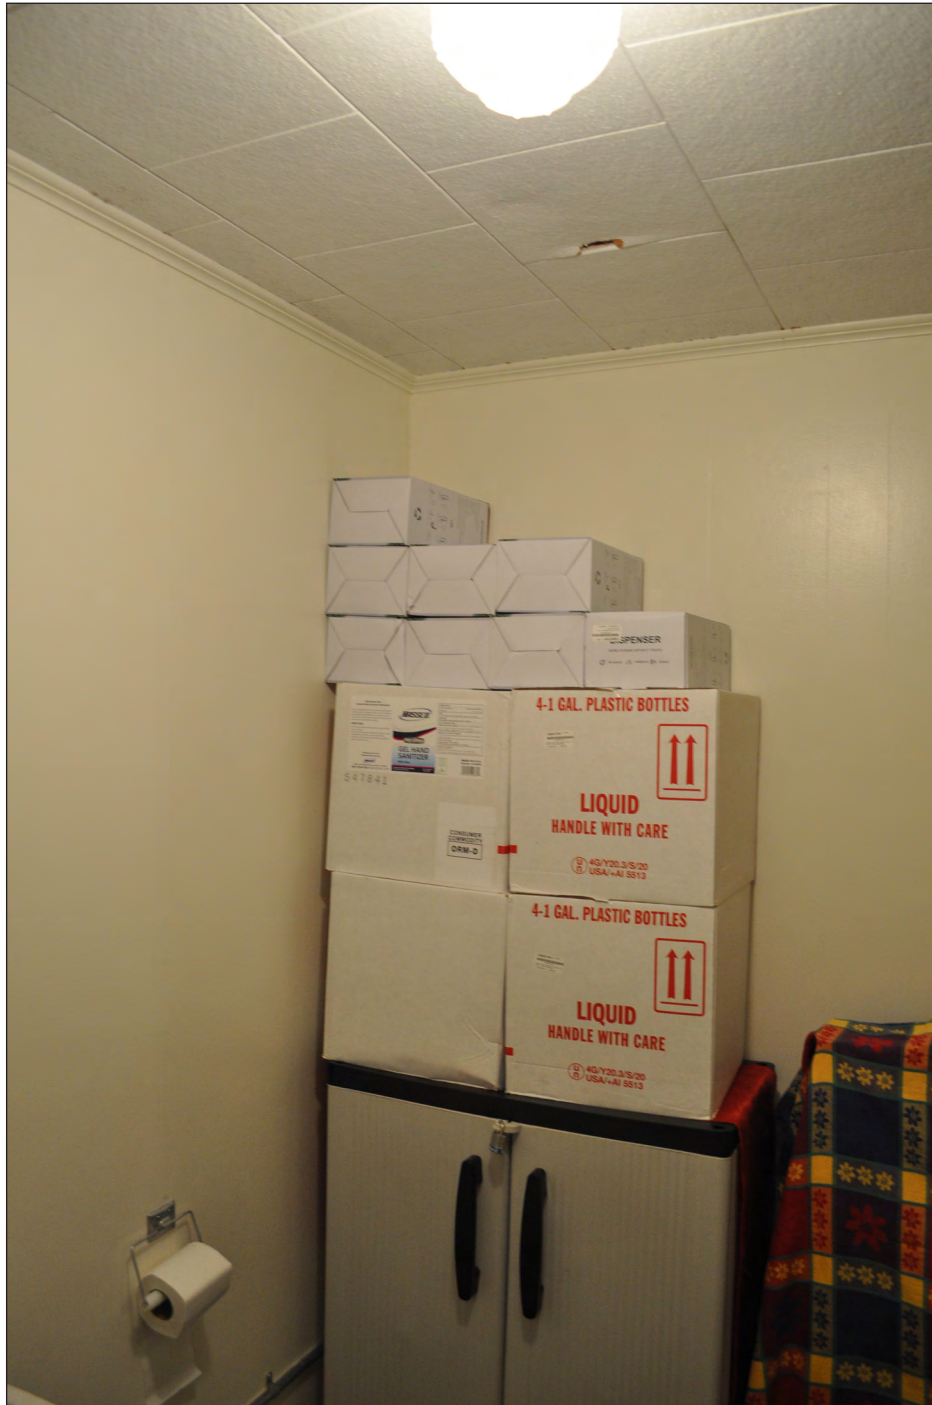
185. Basement, bathroom (106), camera facing southwest.

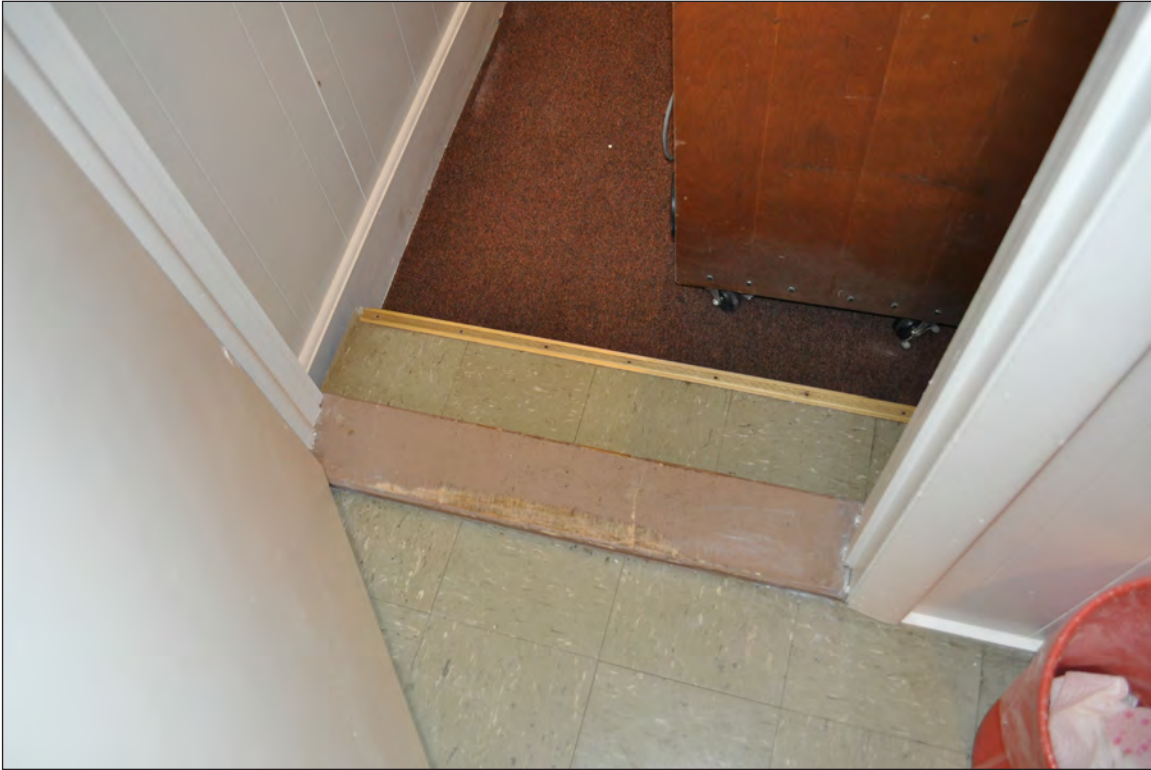
186. Basement, bathroom (106), camera facing down and southeast.

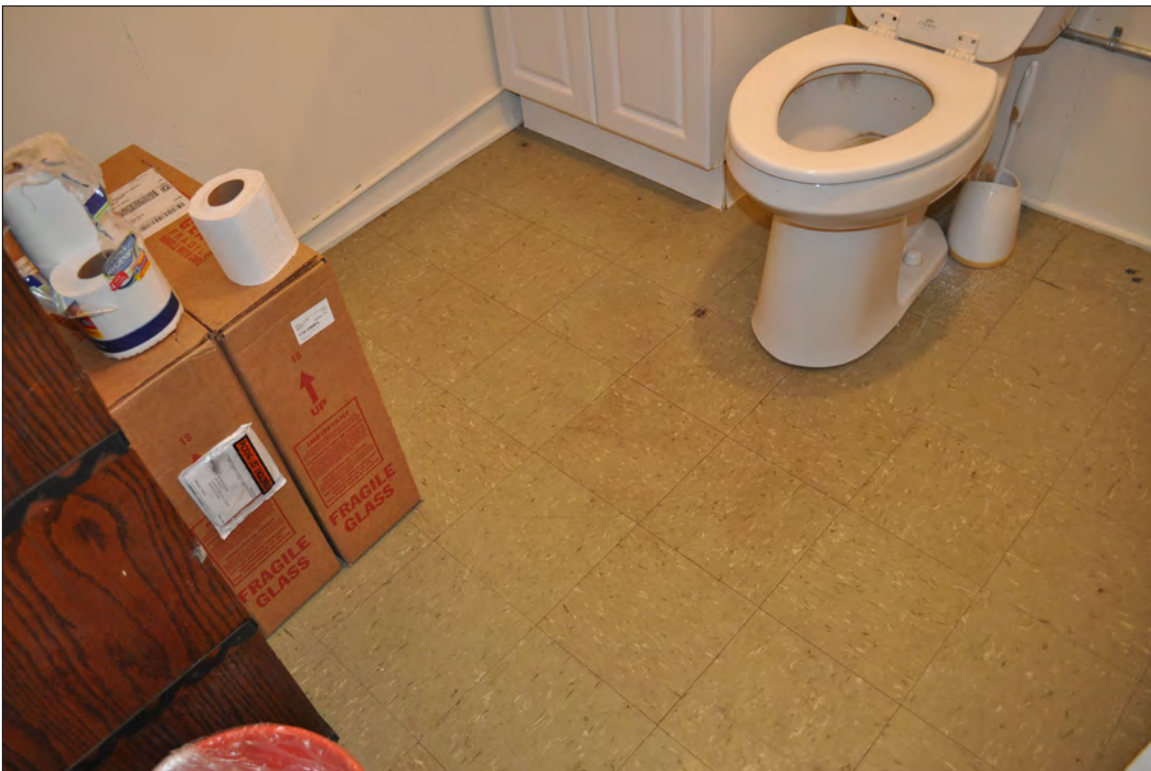
187. Basement, bathroom (106), camera facing down and northwest.

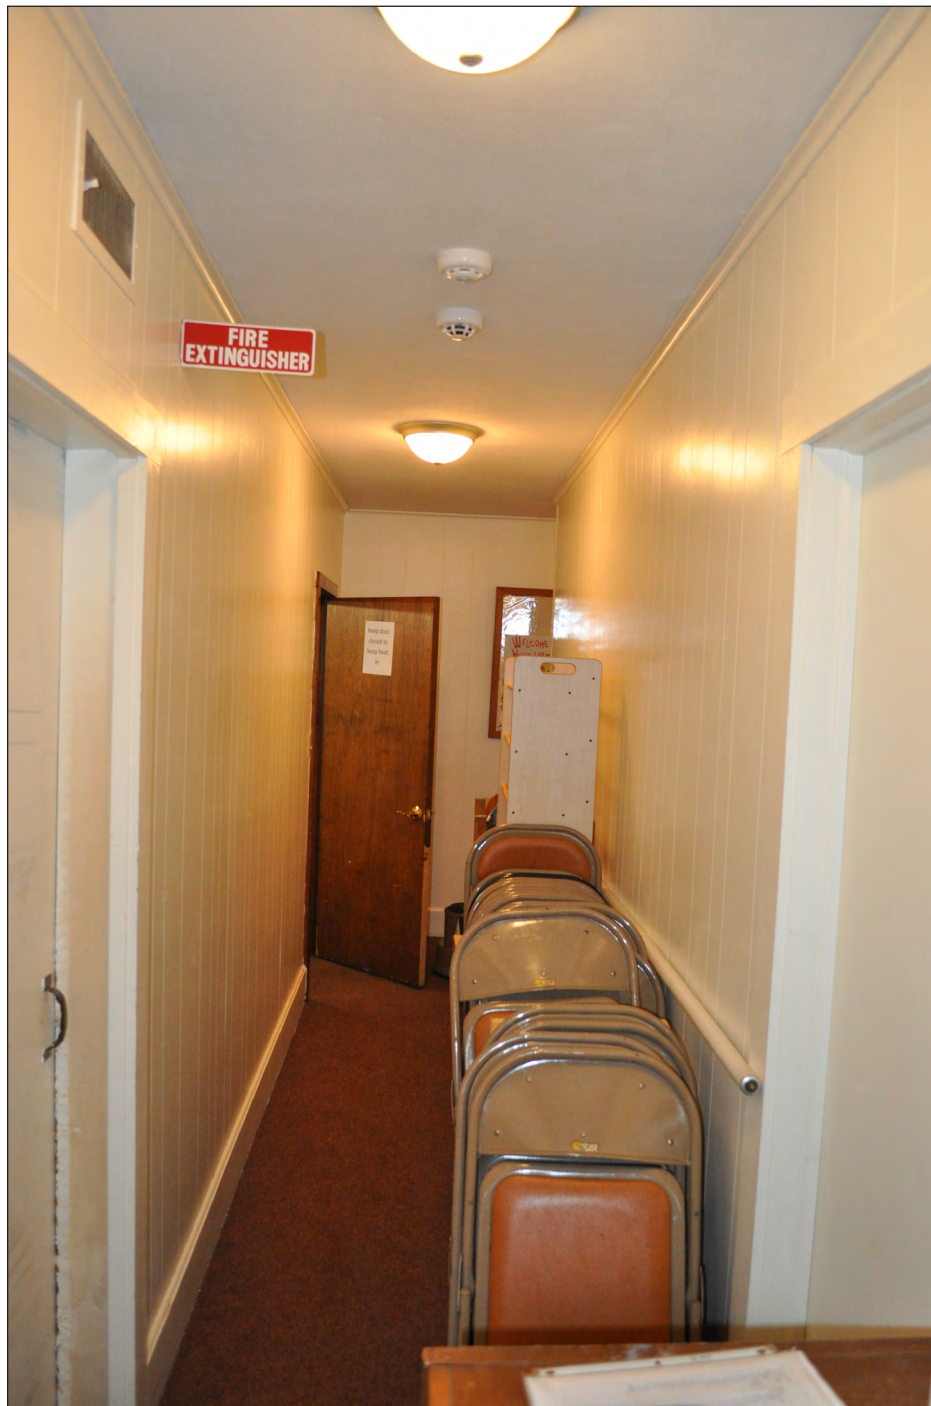
188. Basement, corridor (103), camera facing south.

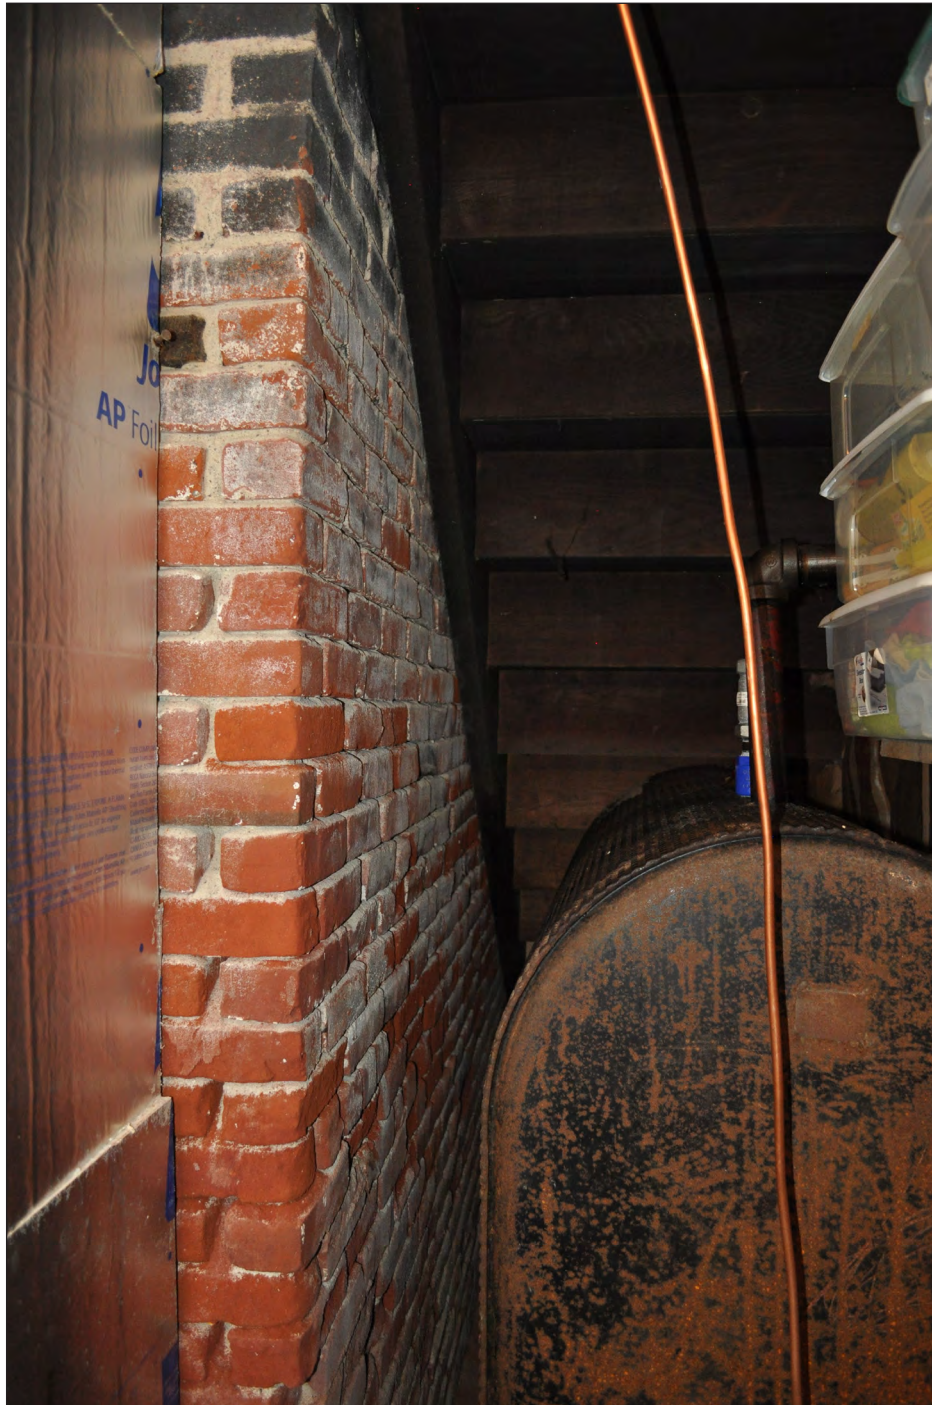
189. Basement, storage (104), camera facing south.

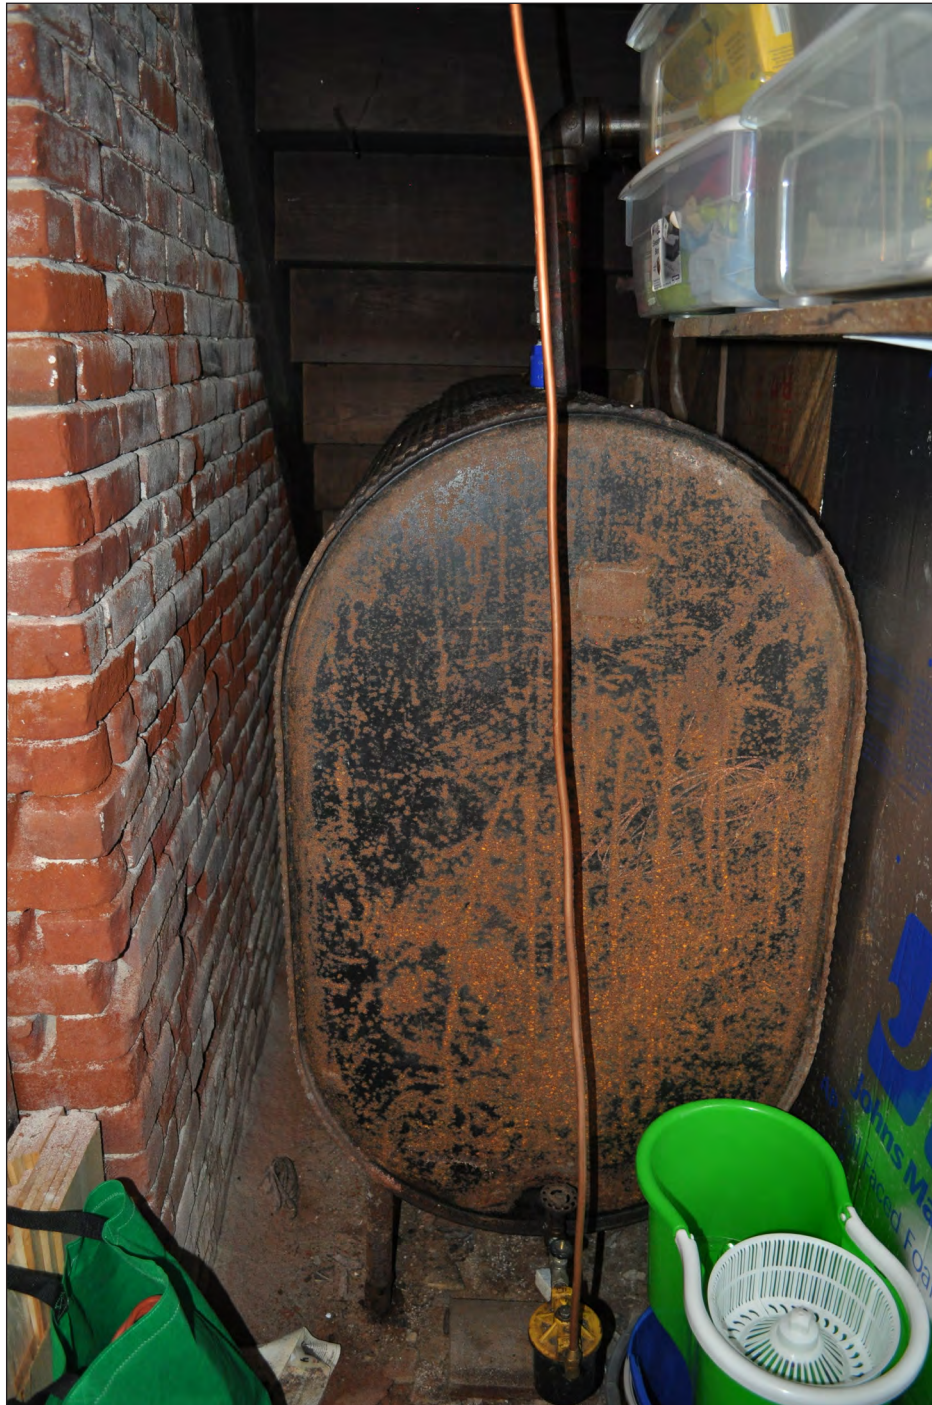
190. Basement, storage (104), camera facing south.

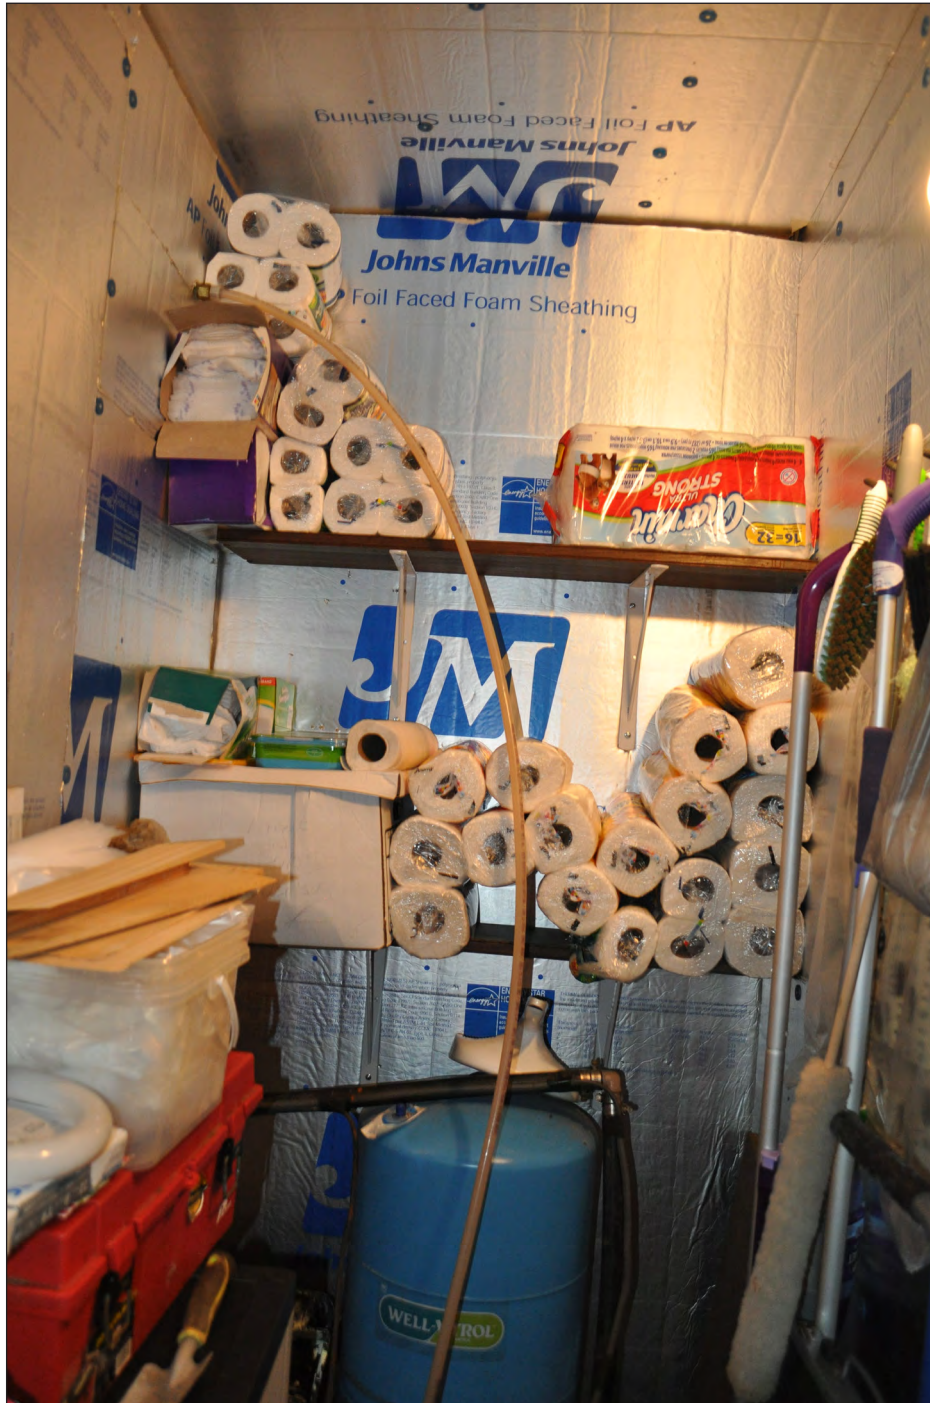
191. Basement, storage (104), camera facing north.

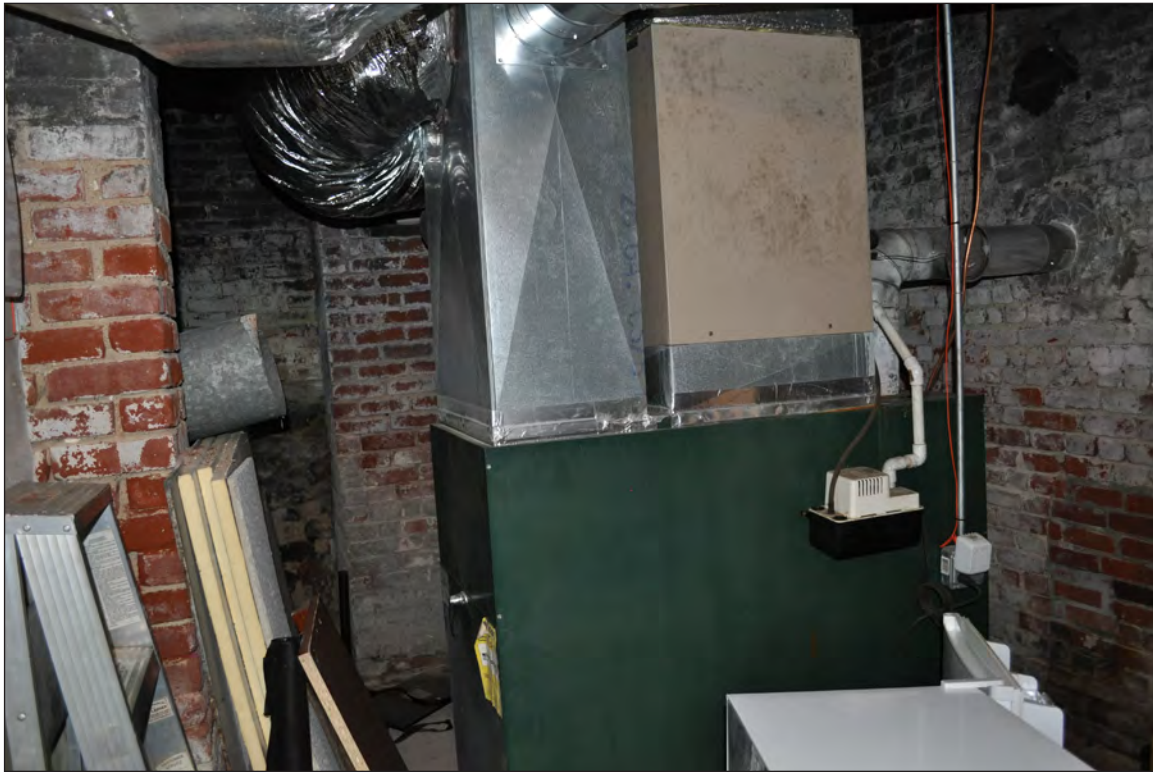
192. Basement, mechanical room (105), camera facing northeast.

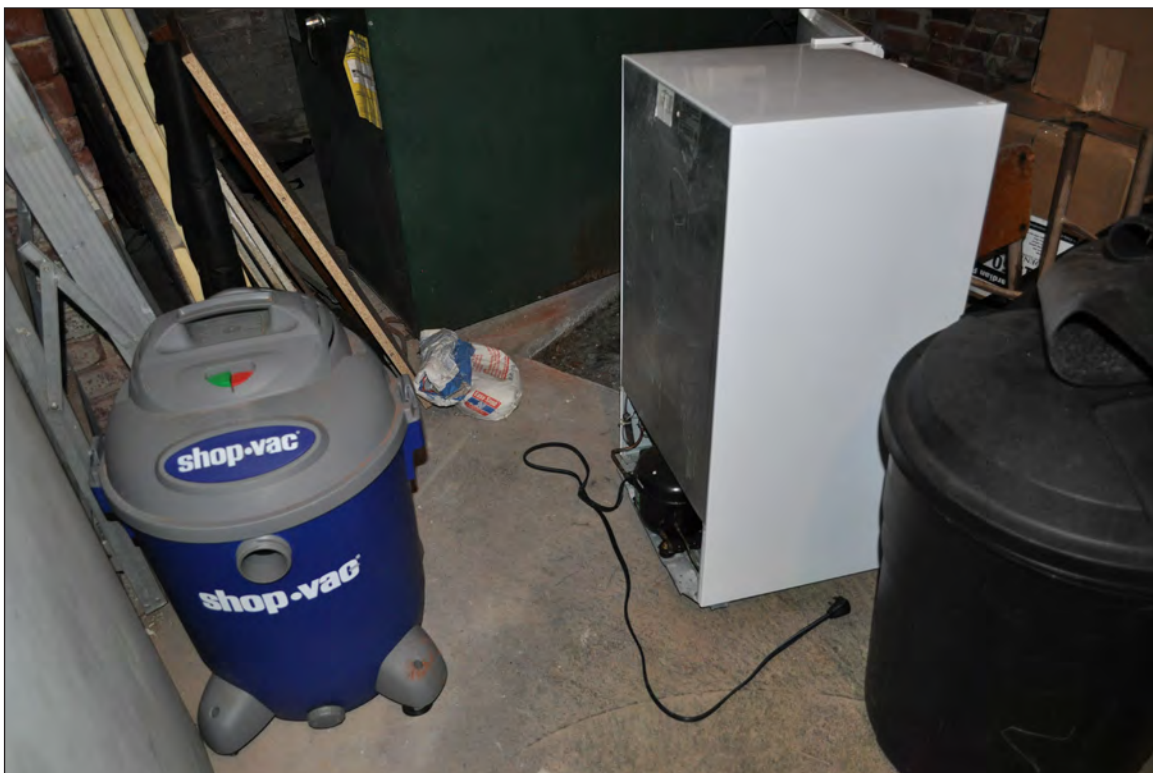
193. Basement, mechanical room (105), camera facing northeast.

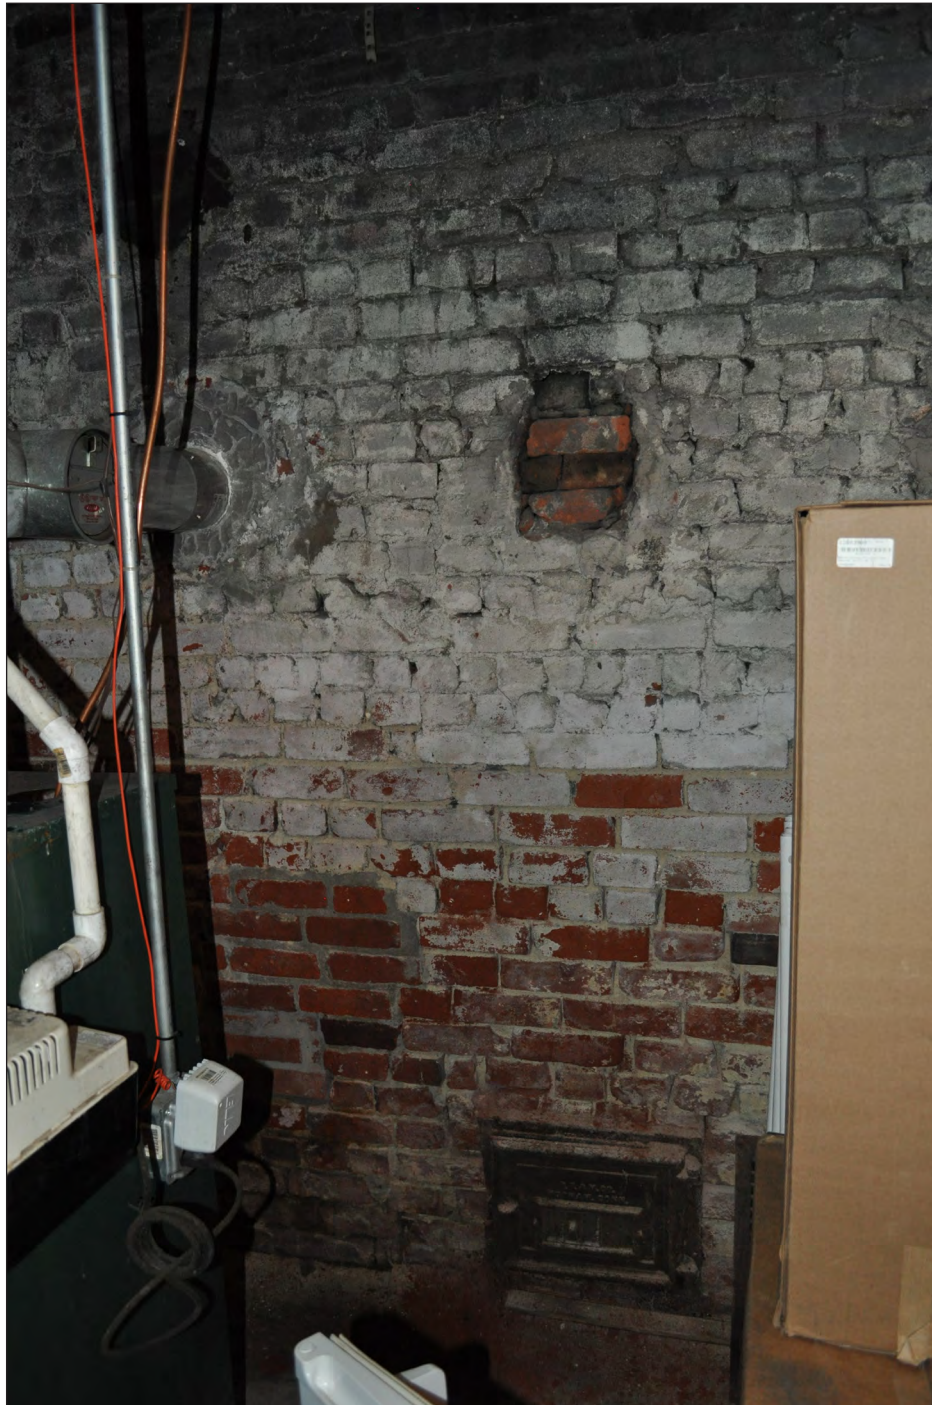
194. Basement, mechanical room (105), camera facing northeast.
