ALDRICH PUBLIC LIBRARY

FEASIBILITY STUDY

Issued: October 21, 2021

CROSSKEY ARCHITECTS, LLC
750 Main Street, Suite 150
Hartford, CT 06103

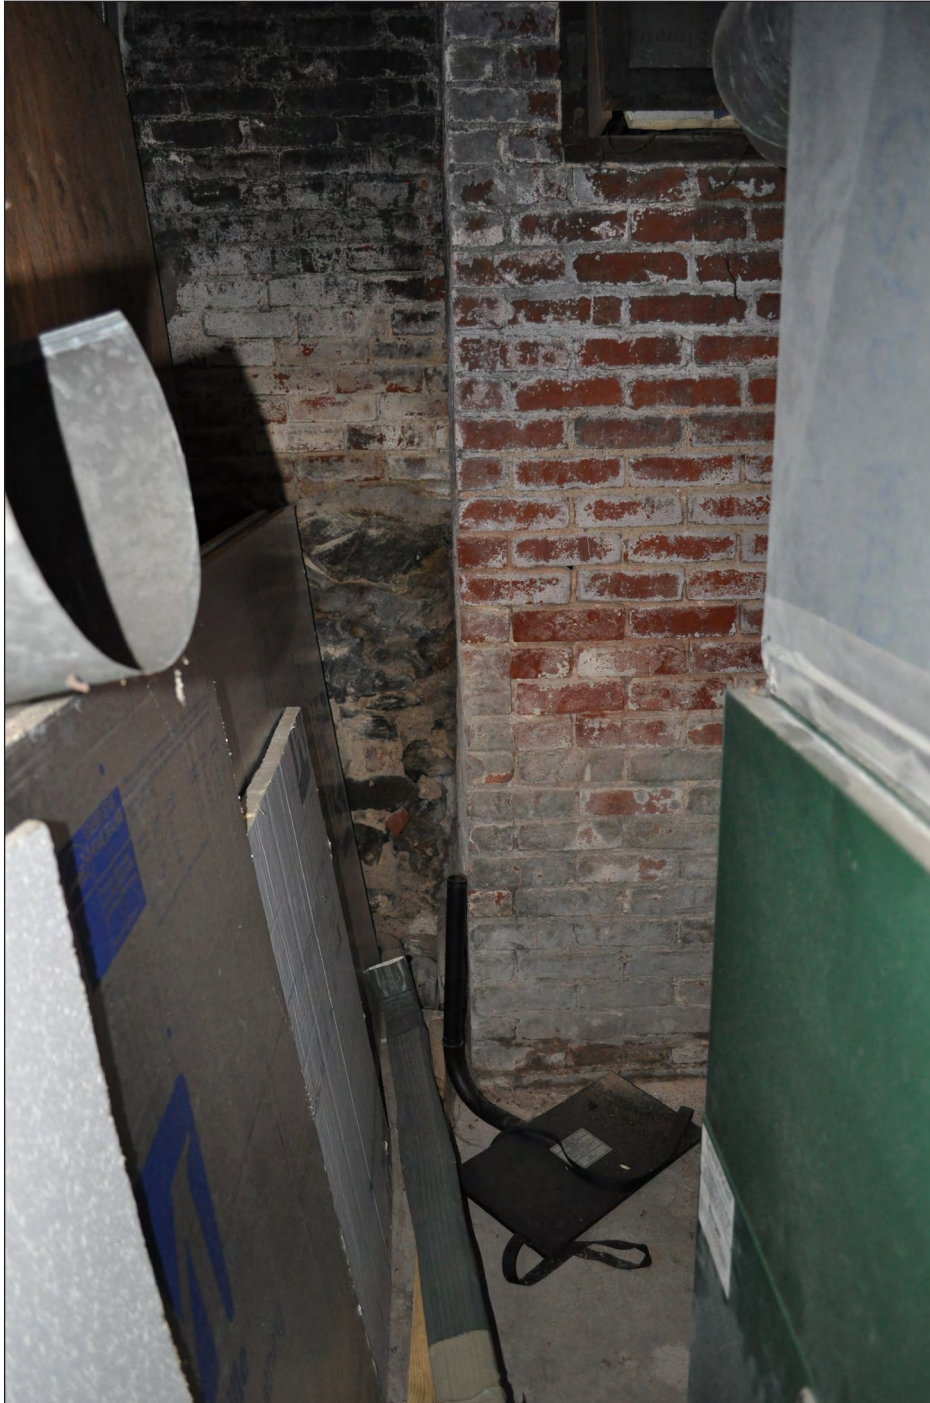
195. Basement, mechanical room (105), camera facing north.

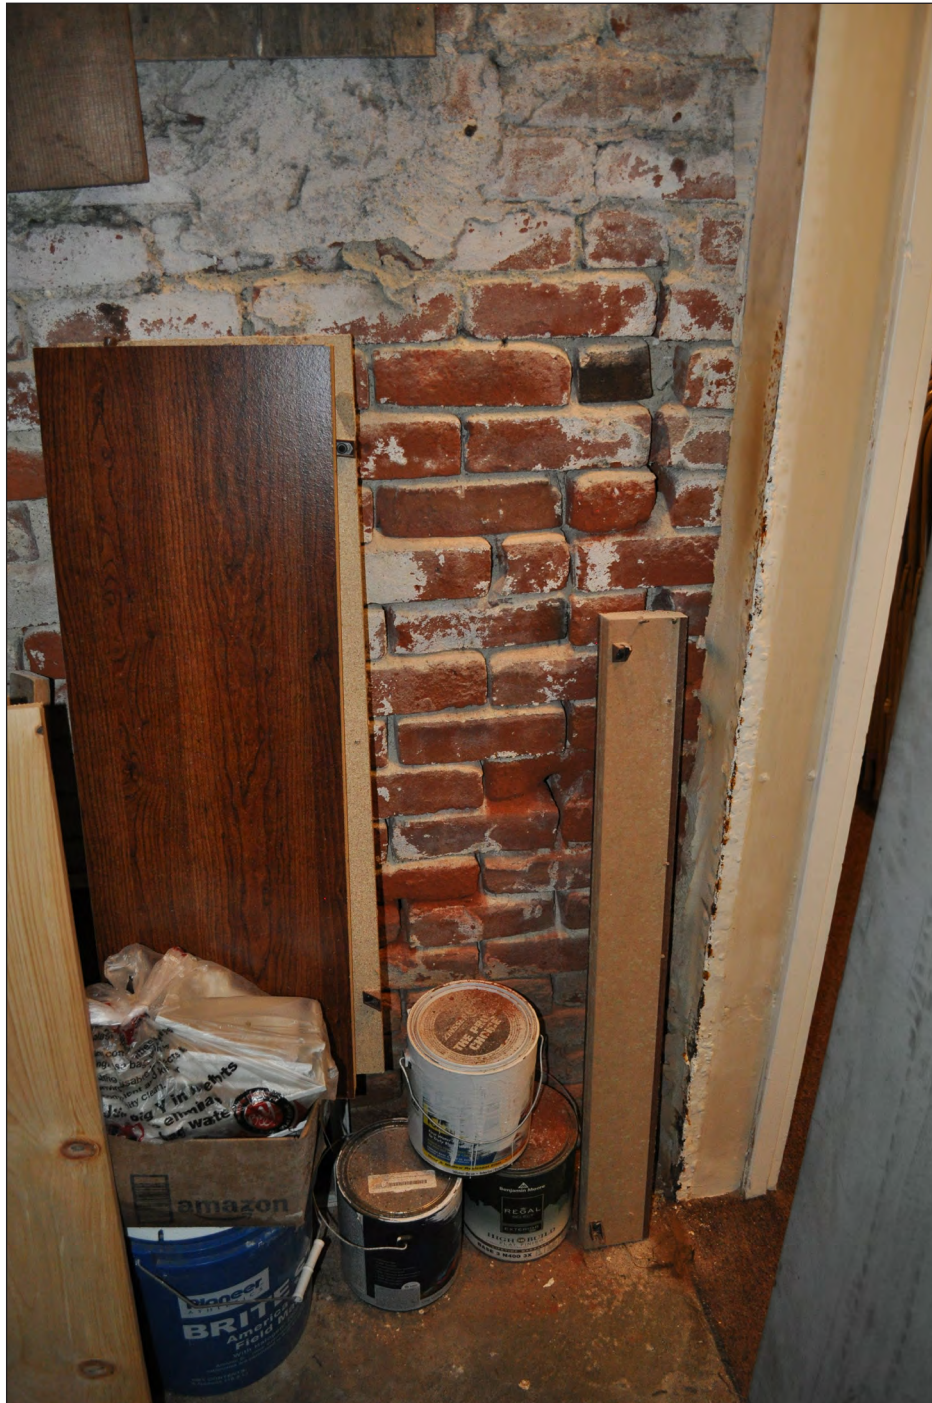
196. Basement, mechanical room (105), camera facing south.

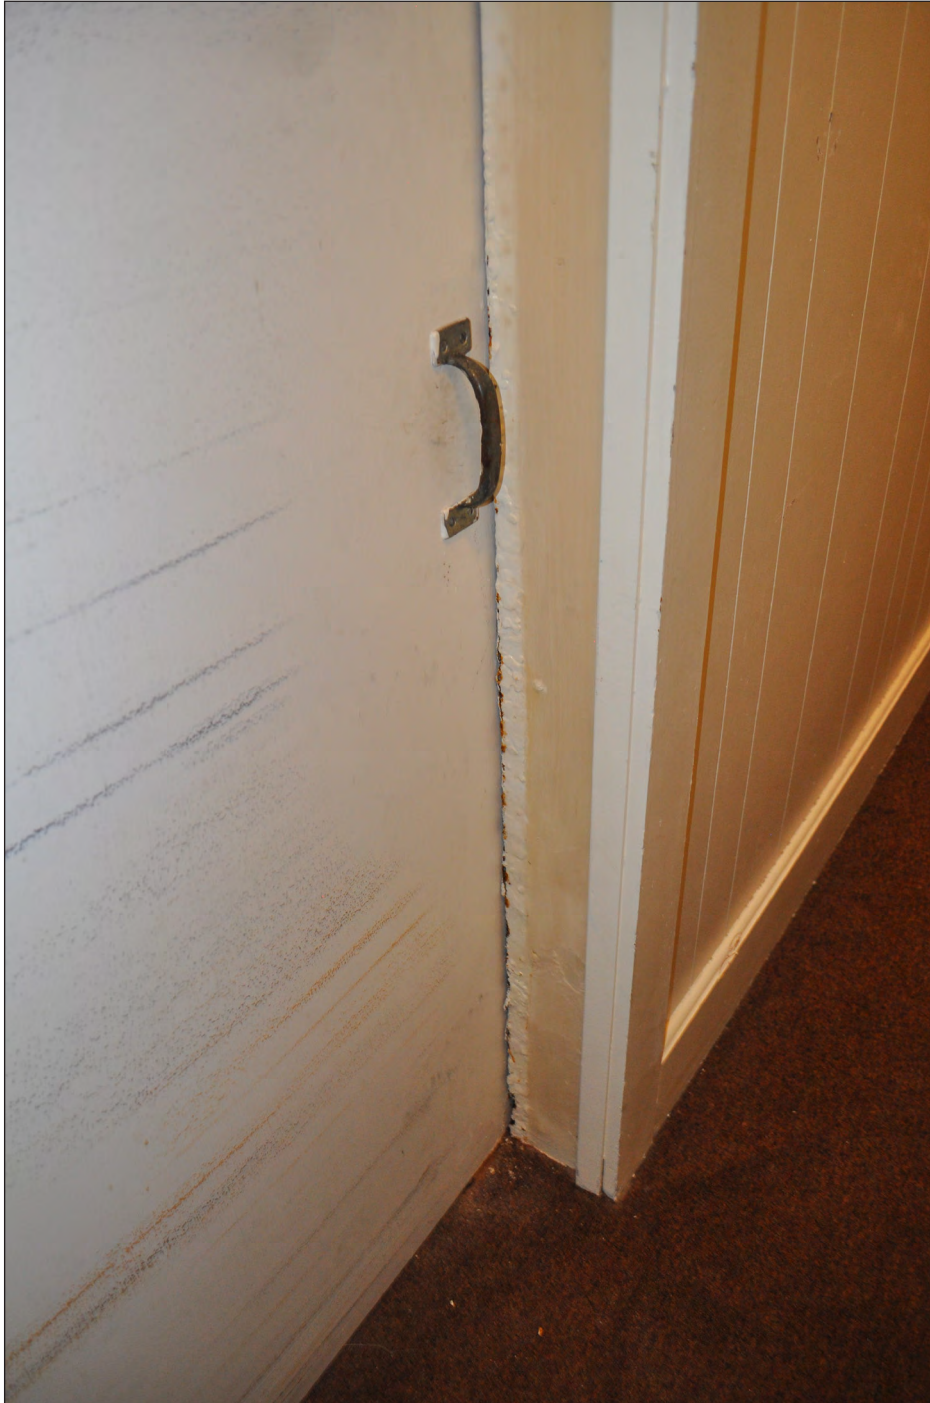
197. Basement, corridor (103), camera facing southeast toward mechanical room door.

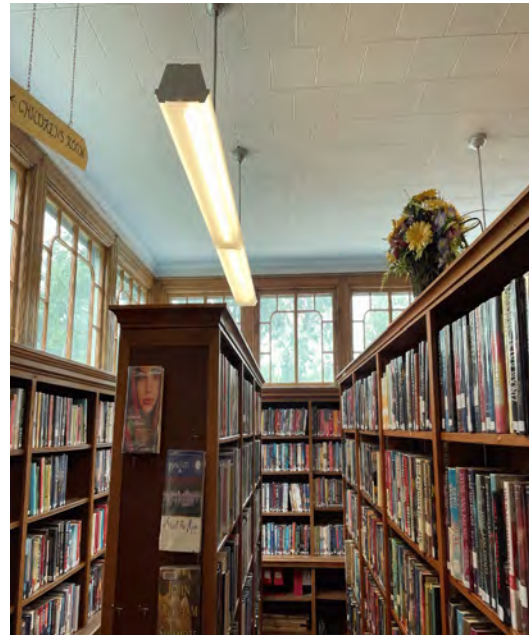
Figure 4 - Pendant Light Fixture

The lighting is primary florescent lamp pendant type on the first floor and recessed 2x4 in the basement. Lighting levels appear inadequate for recommended library lighting levels. There is a high level of ambient light and many windows. We recommend a complete fixture replacement using more energy efficient LED lamped fixtures. Emergency lighting is achieved by using battery wall pack fixtures. These fixtures are antiquated and recommended to be replaced.

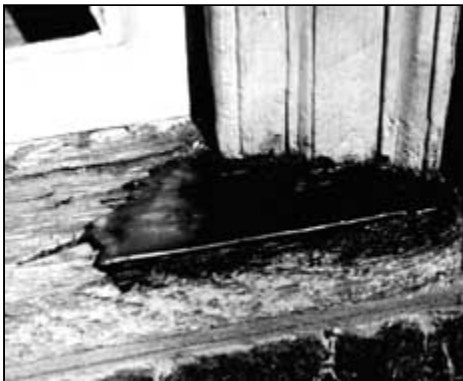
This illustrates a two-part epoxy patching compound used to fill the surface of a weathered sill and rebuild the missing edge. When the epoxy cures, it can be sanded smooth and painted to achieve a durable and waterproof repair. Photo: NPS files.

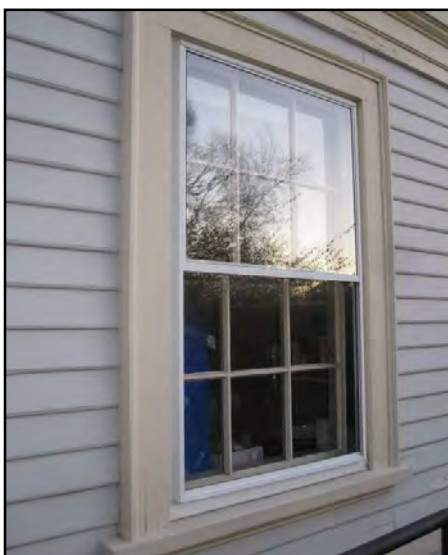
Exterior storm windows were extant on the west wing of the mansion house. The date of installation of these storm windows is unknown. The existing aluminum storm windows were white ðtriple trackö storm windows in varying degrees of functionality. In some cases, the screen and / or glass panels were missing. In other cases, the panels were no longer movable. Where screen and glass panels existed and were functional, there was no seasonal plan to appropriately set the panels.

*Example of existing exterior storm
window prior to 2011 work*

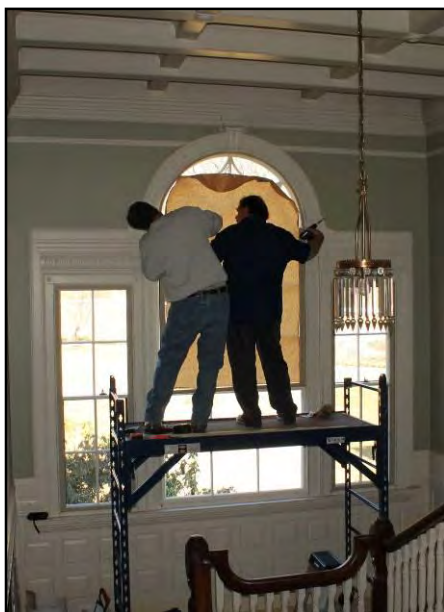
Installation of Palladian storm window

In order to establish the curve at the top of the Palladian window, a pattern was created. In the shop, a piece of curved wooden molding was fashioned to match the pattern. A piece of UV Plexiglas® was then cut to fit into this molding profile. The top section of the Palladian window has been screwed into the jambs to prevent the falling of this component. The bottom section is easily removable and installed in the same manner as the other interior storm windows.

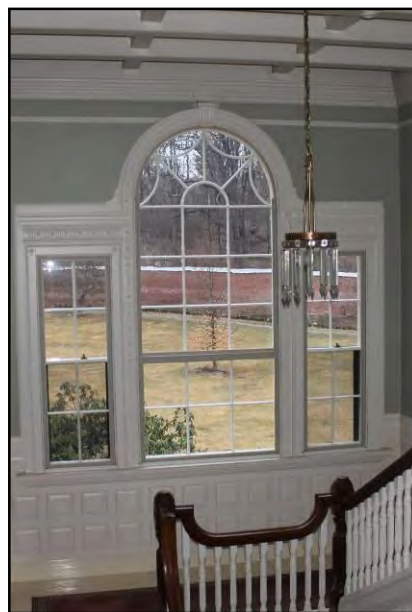
Palladian storm window installed

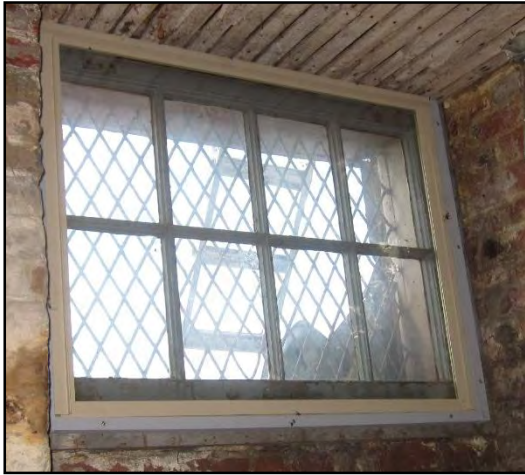
*Basement window installation
of storm window sash.*

Interior storm windows were also installed in the basement openings where windows were currently installed. Some openings had previously been blocked up over the years and had no windows. These openings were left blocked. As the basement windows were mounted flush with the basement walls, a wooden frame had to be built to hold the storm window. These frames were fabricated on site from poplar and painted grey to match the existing grey sash. The new storm window units were then secured to these frames. This installation process allows can be easily reversed by simply unscrewing the storm window frames.

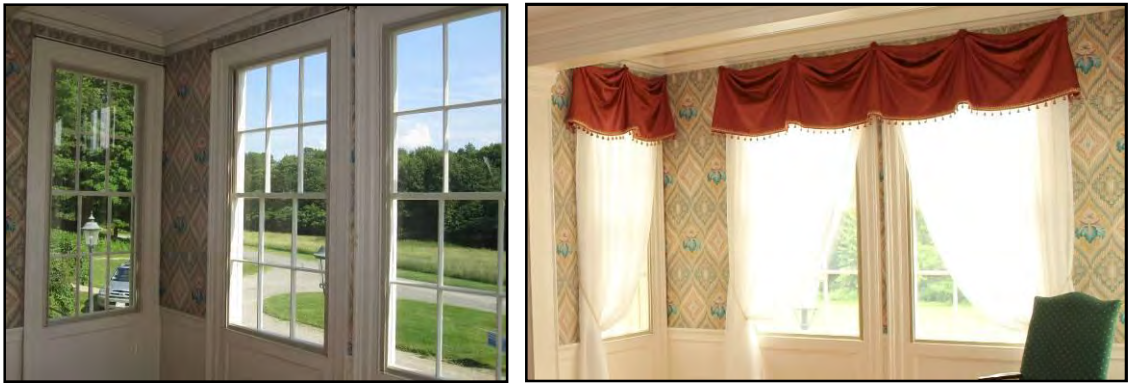
The key issue with the interior storm windows is that the color for the frames was not matched to the paint color of the interior. An alternative product could have been selected that would have been color matched, but the expense of that would have resulted in cuts in other energy efficient strategies. As most windows have (or will have) interior textile treatments this color difference is somewhat minimized.

Interior storm windows installed

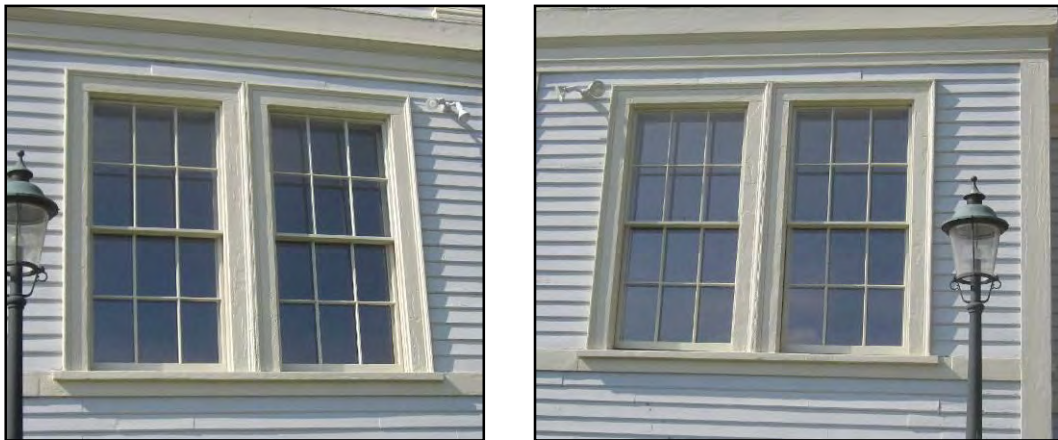
It should also be noted that while the interior storm windows are invisible when viewed from the exterior, they do have a reflective component such that when viewed closely one can see the reflection of the muntins. One would have to be very sensitive to this detail to truly observe it, but it is there.

*Interior storm windows installed
Note muntin reflection in top sash*
