Survey and Planning Grant

Application

The Aldrich Free Public Library Planning and Survey Grant Application 2022

**G. Long Term Preservation Plan/Conditions Assessment completed in
October 2021 by Crosskey Architects**

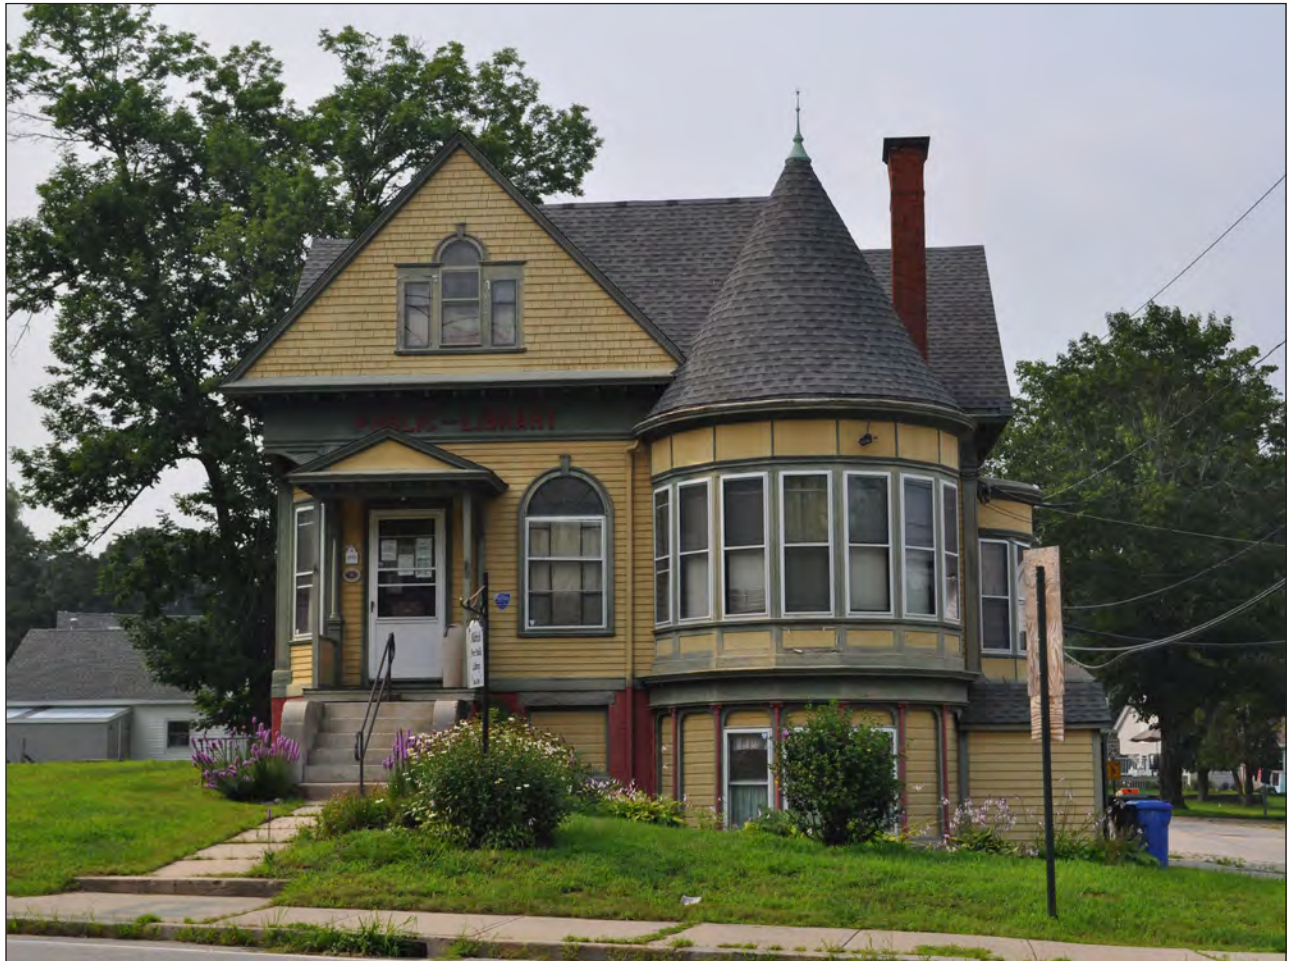
1. South elevation, camera facing north.

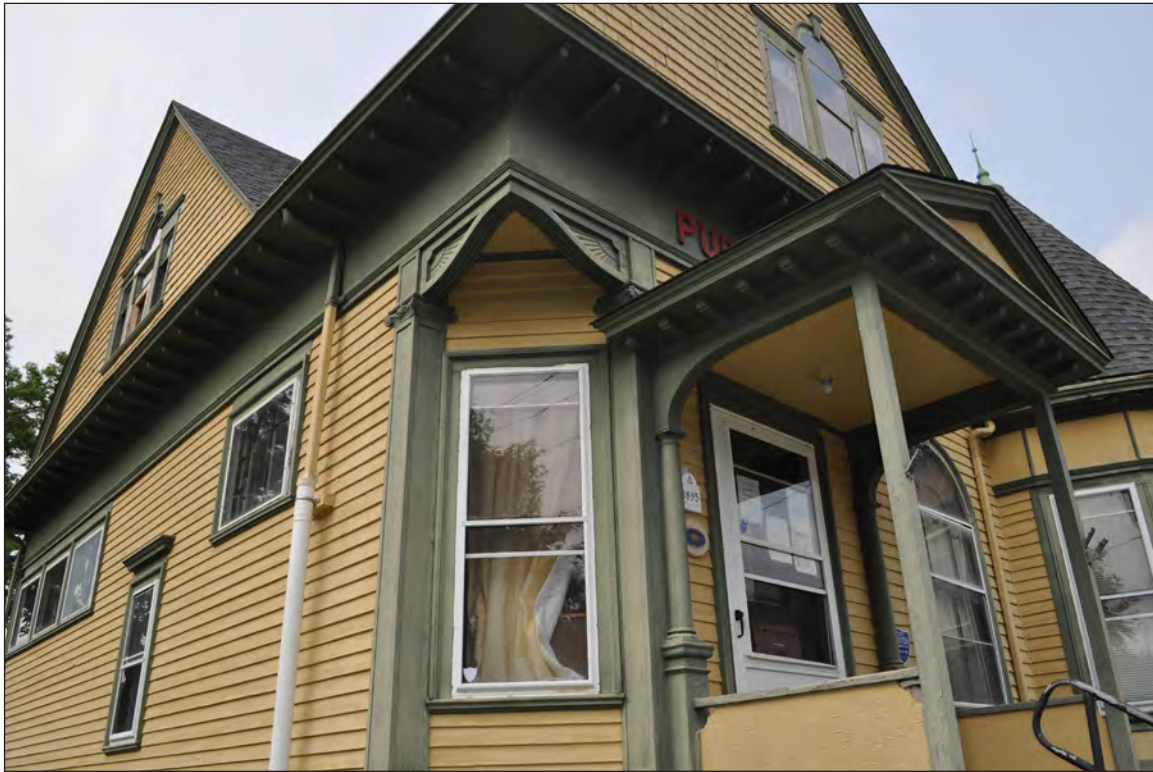
2. South elevation, southwest corner, camera facing up and northeast.

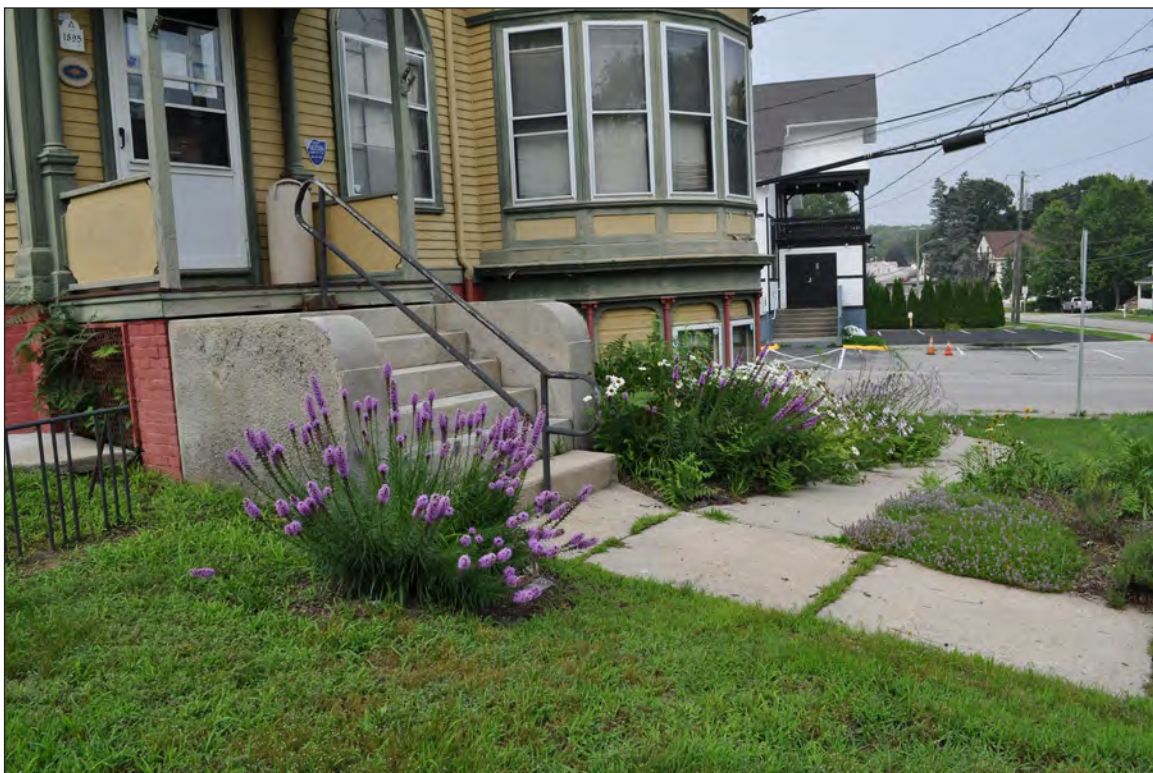
3. South elevation, front entry steps, camera facing northeast.

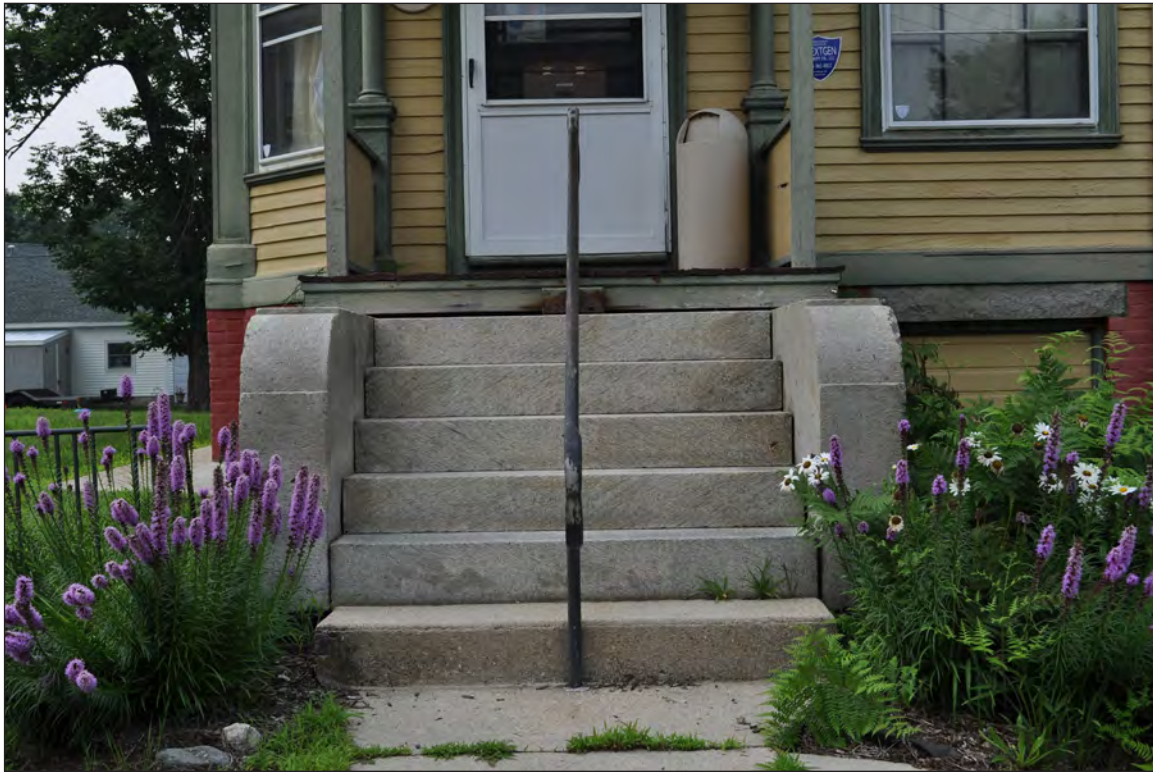
4. South elevation, front entry steps, camera facing north.

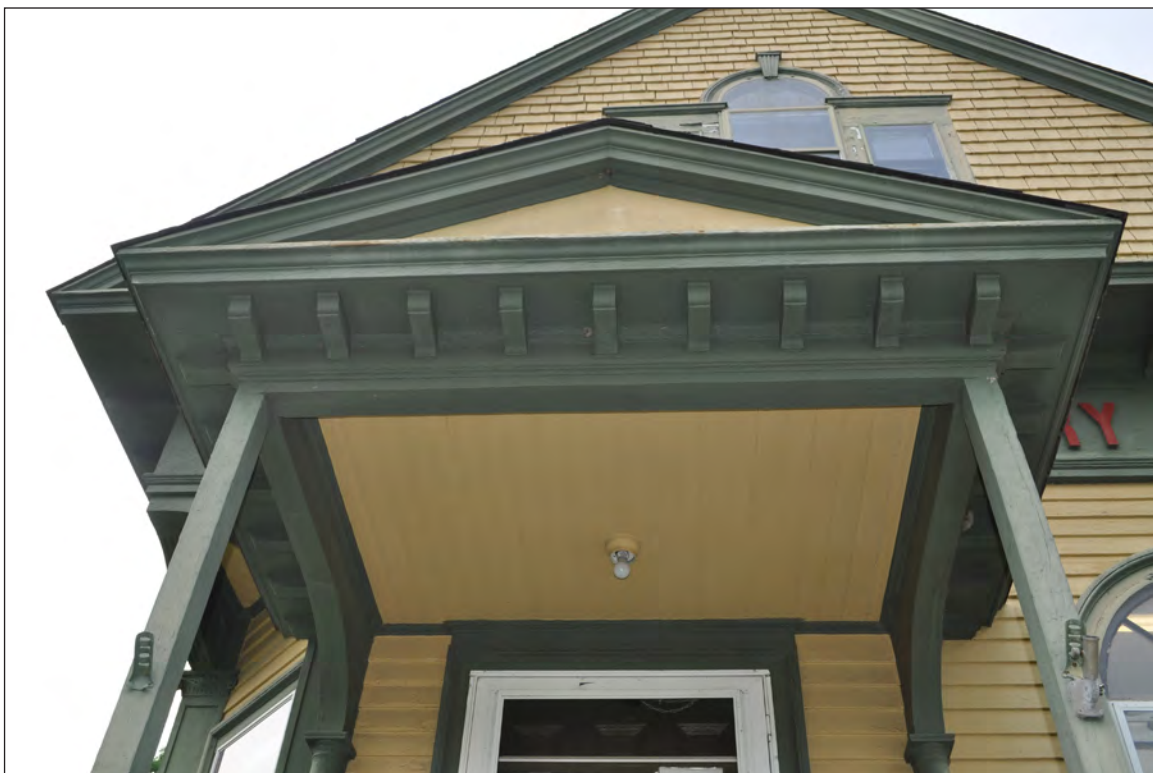
5. South elevation, underside of portico roof, camera facing up and north.

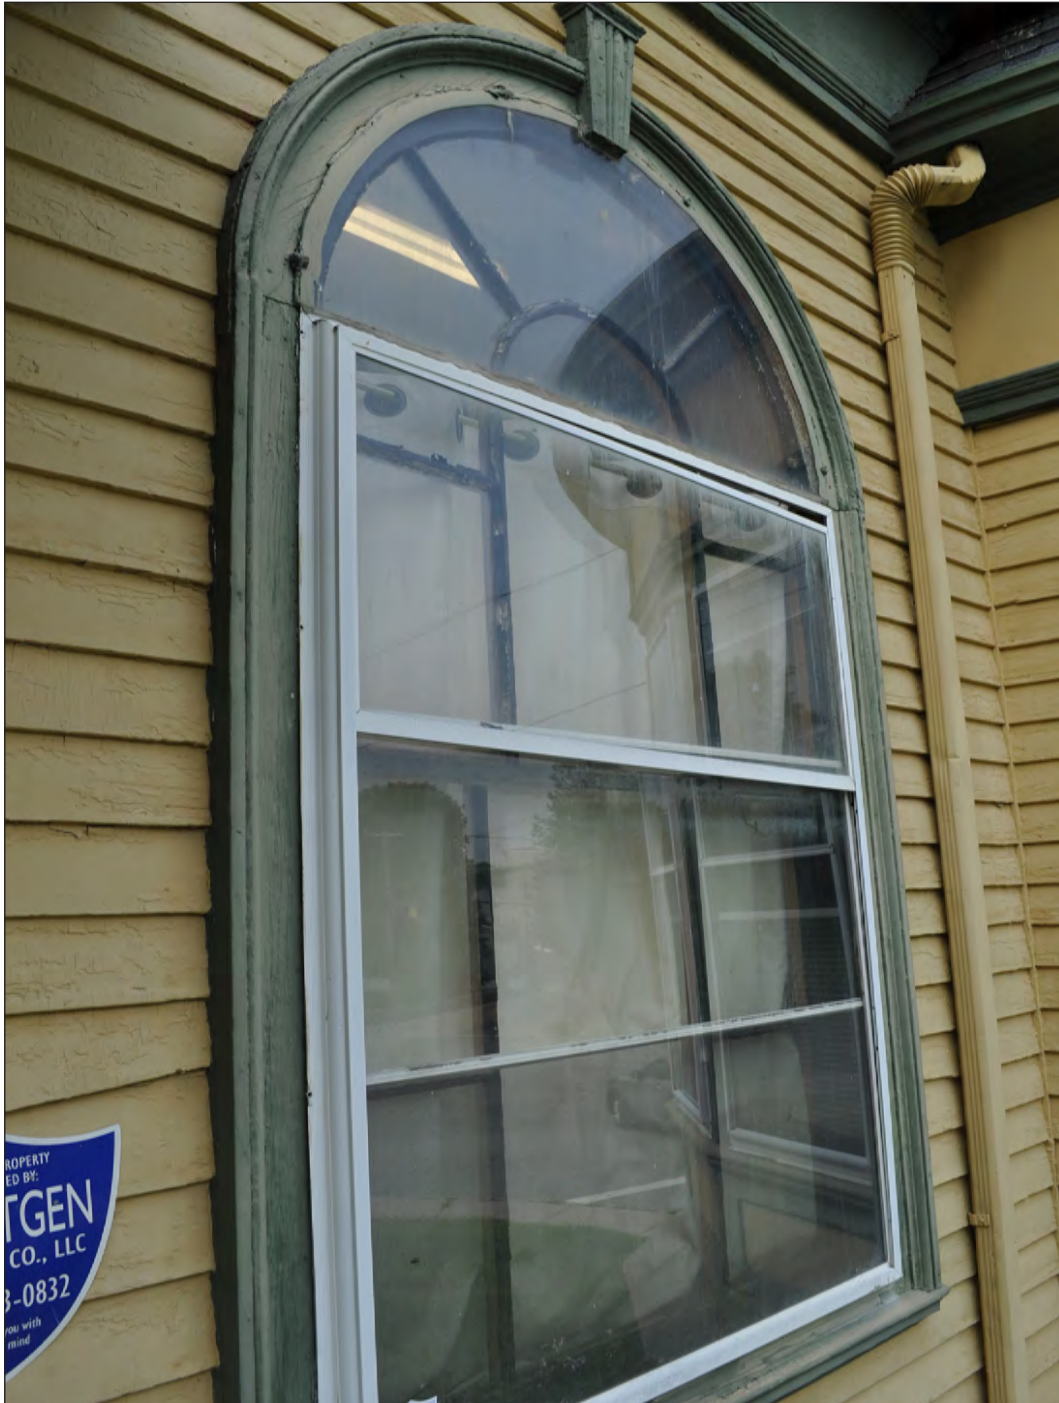
8. South elevation, close-up of window with exterior storm.

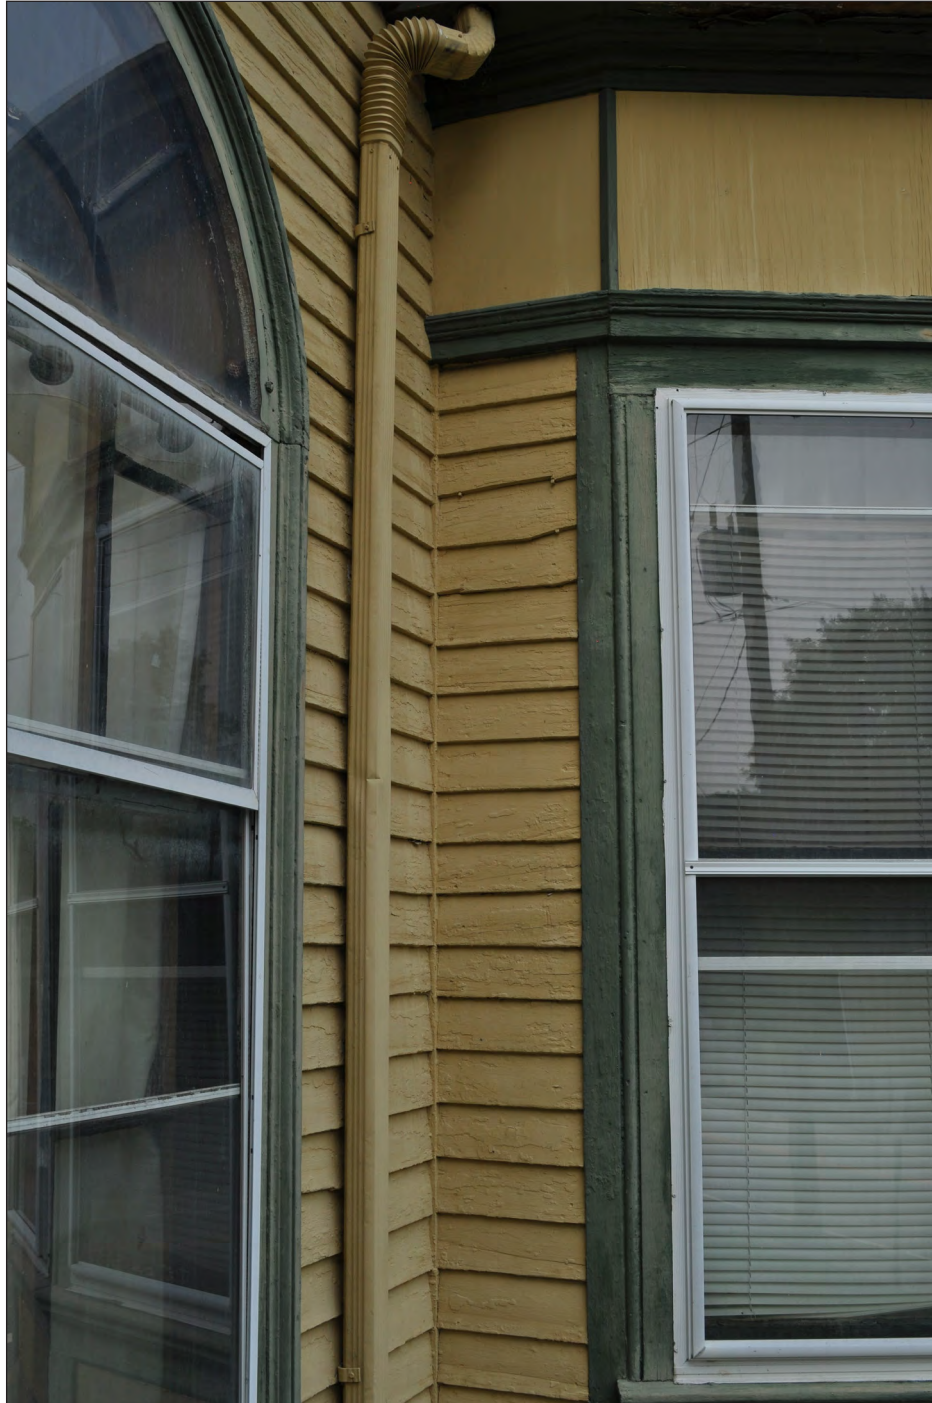
11. South elevation, west elevation of tower, camera facing northeast.

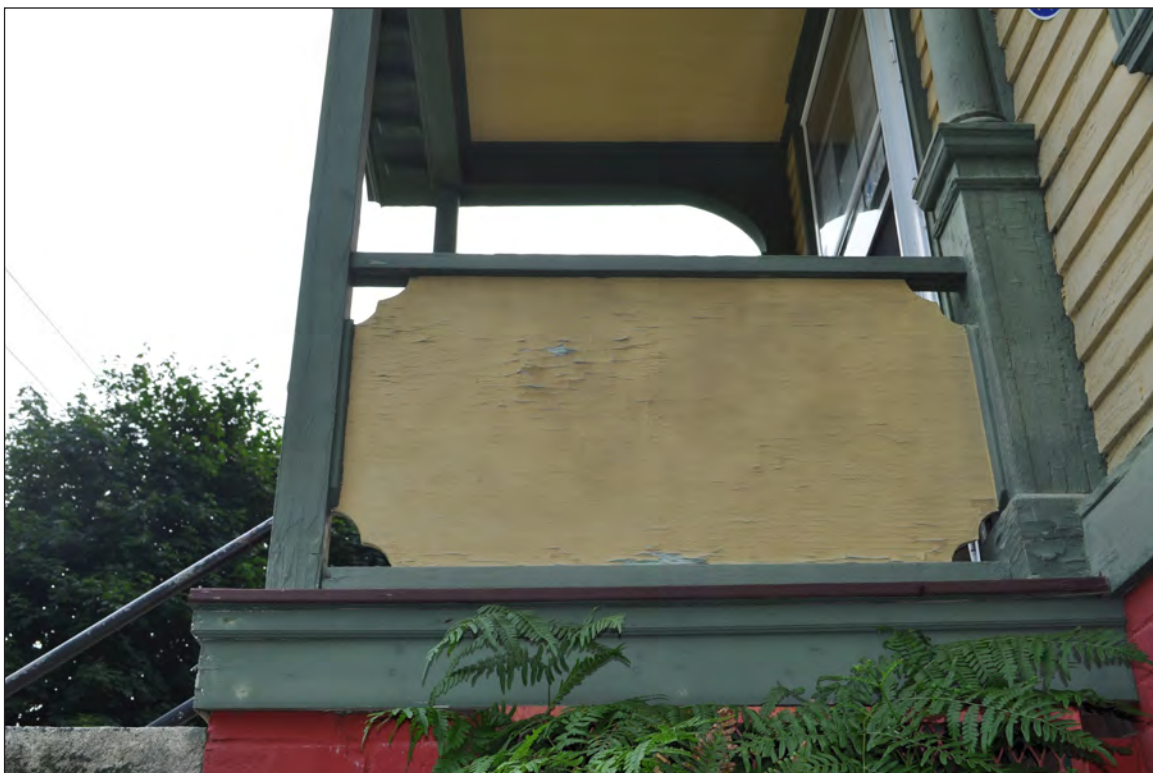
18. South elevation, east elevation of porch guardrail and railing, camera facing west.

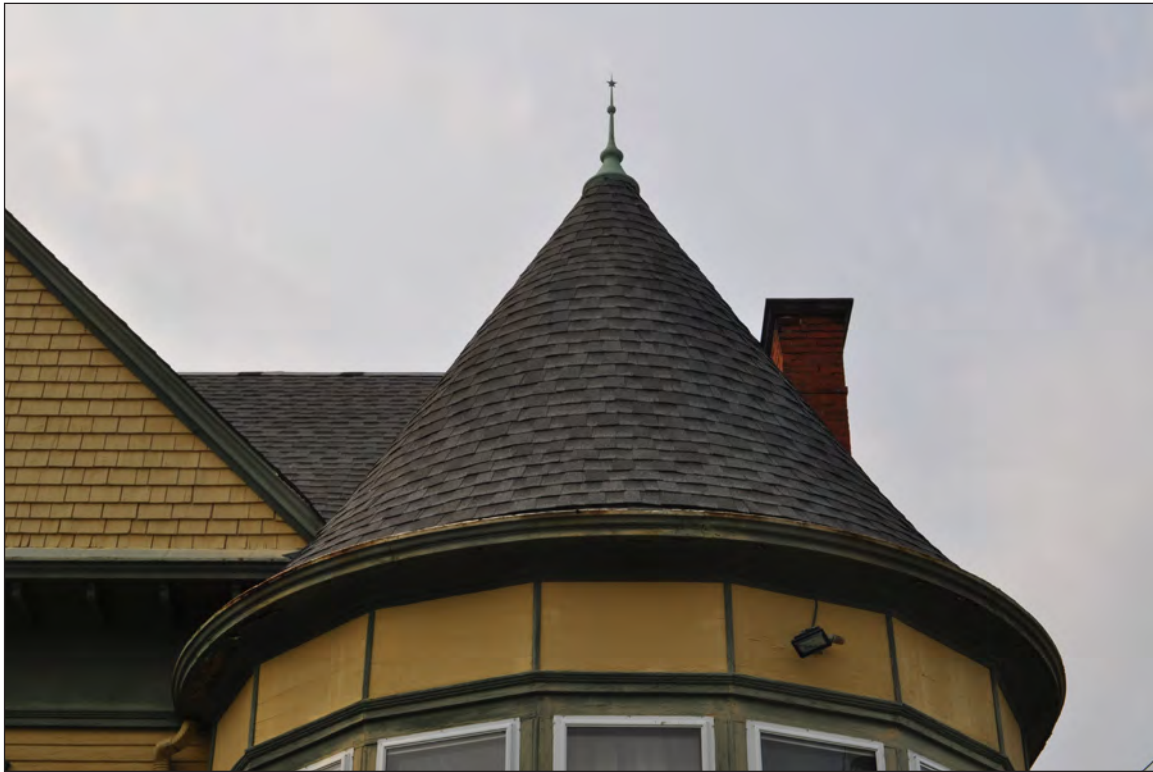
19. South elevation, tower roof and integrated gutter camera facing north.

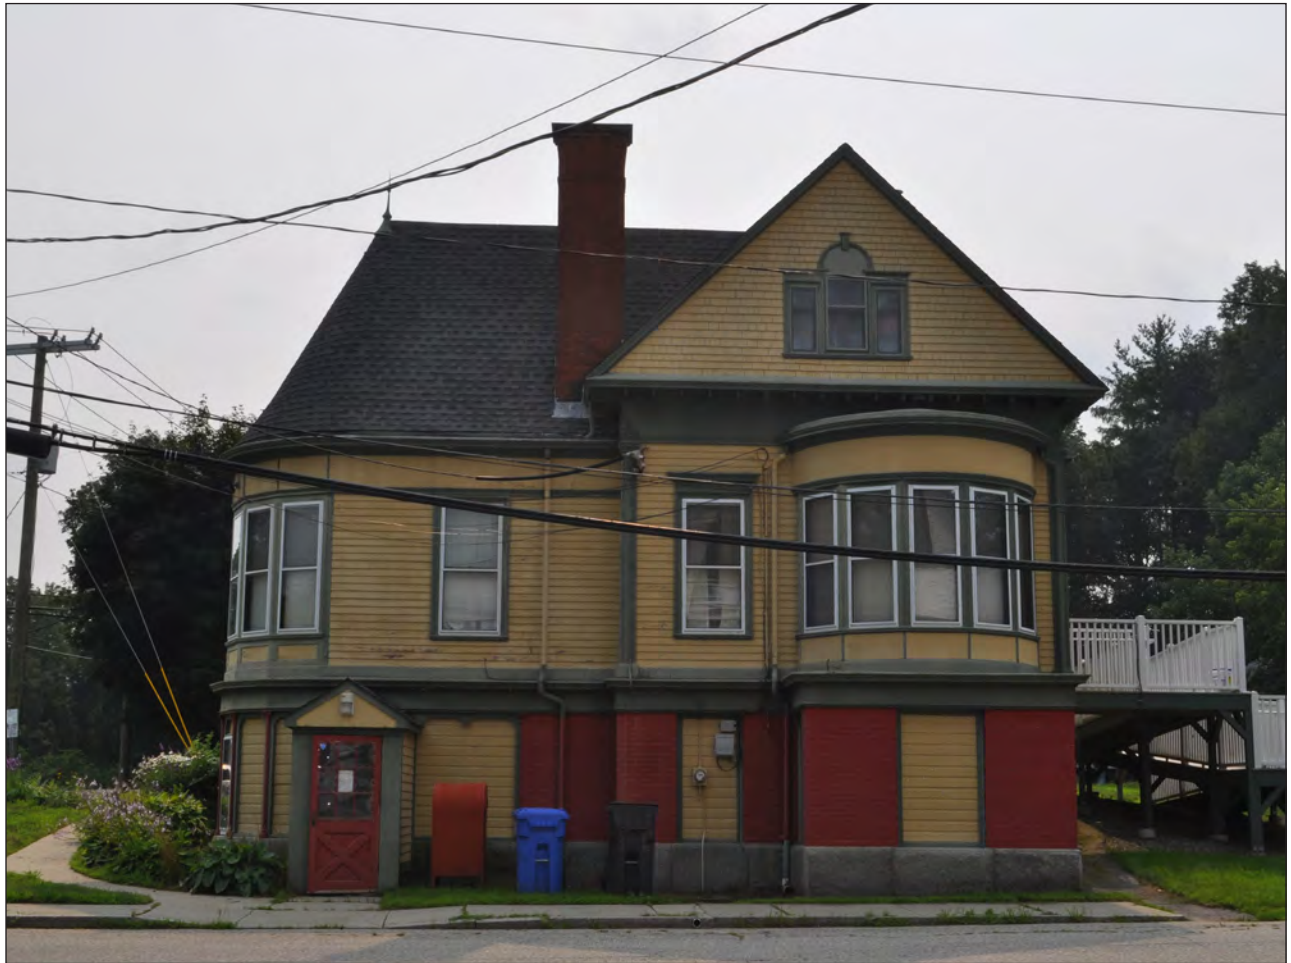
25. East elevation, camera facing west.

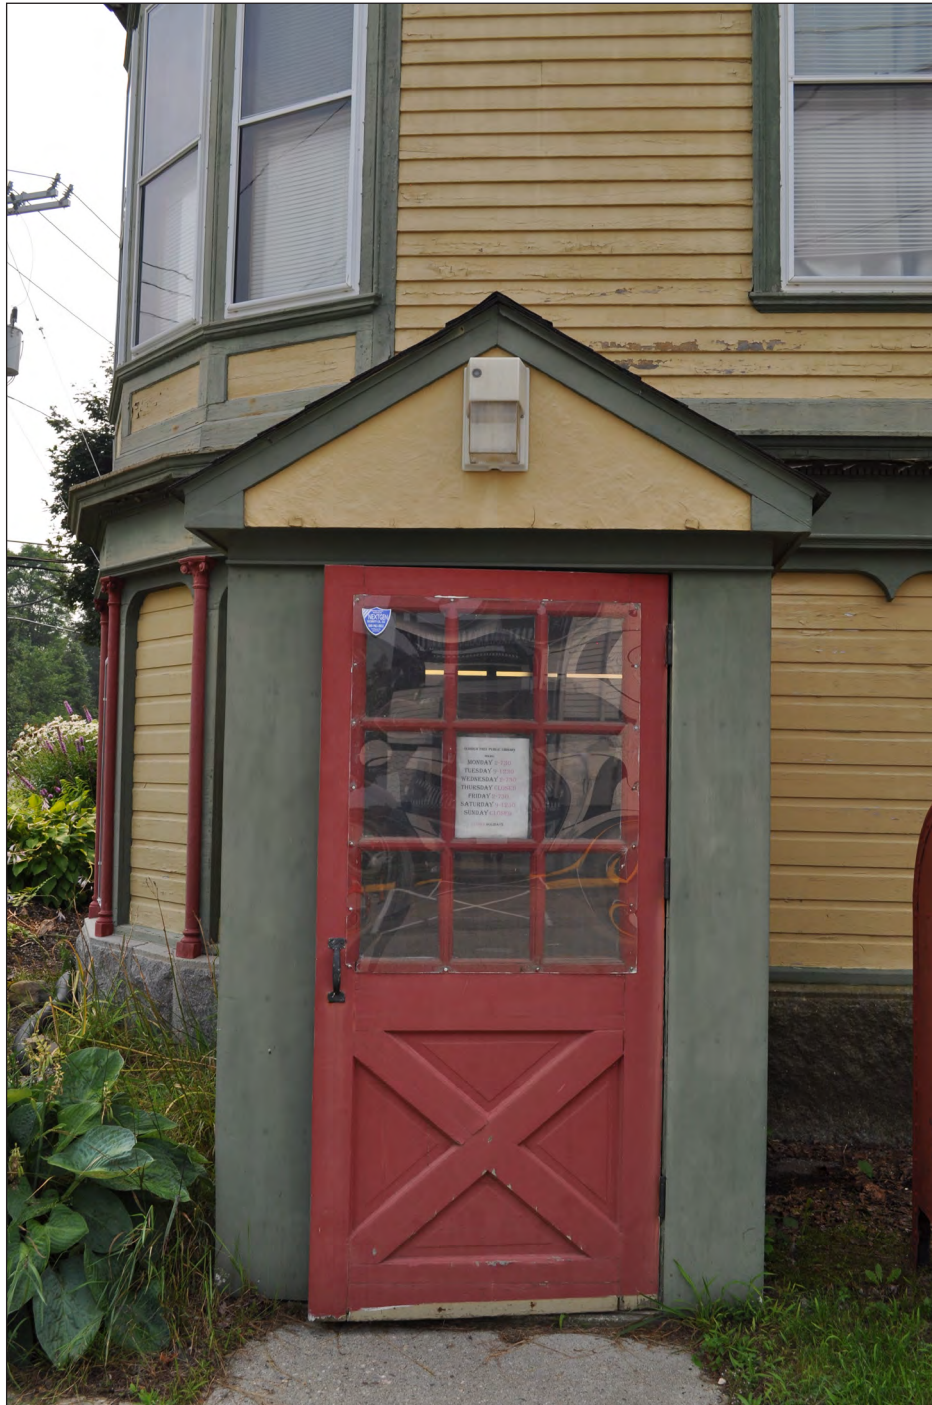
26. East elevation, exterior vestibule, camera facing west.

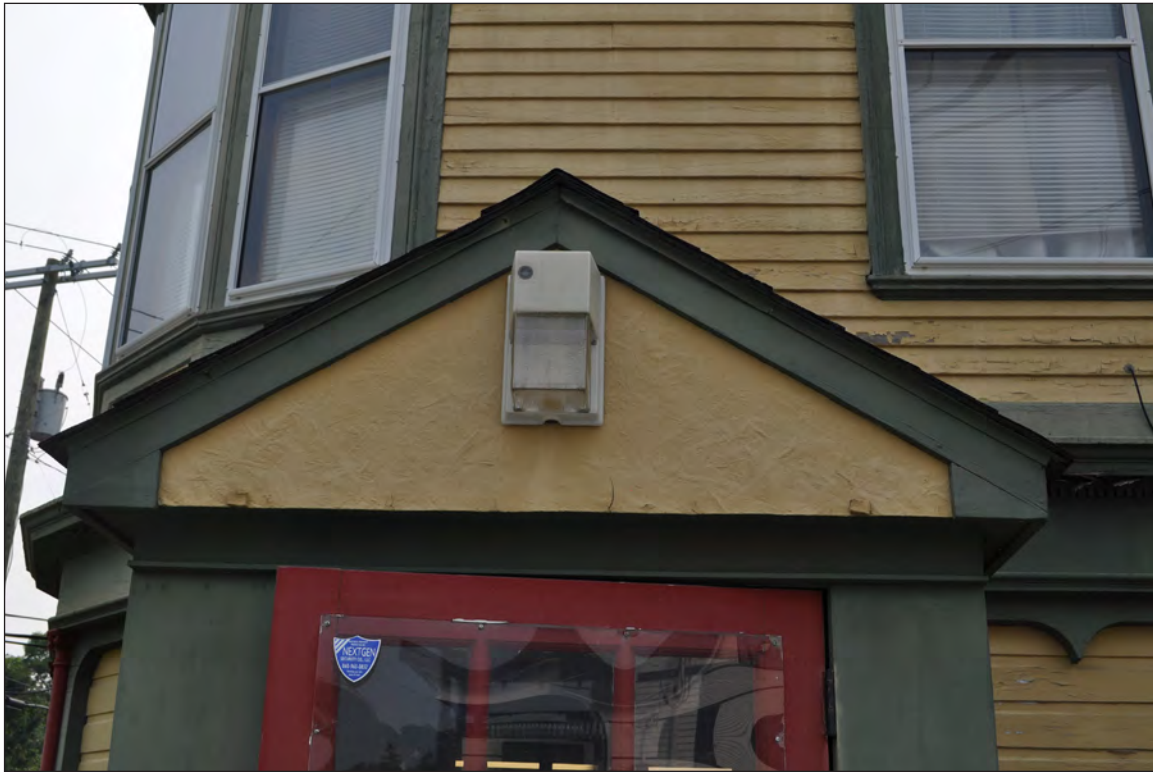
27. East elevation, gable end roof with particle board and light, camera facing west.

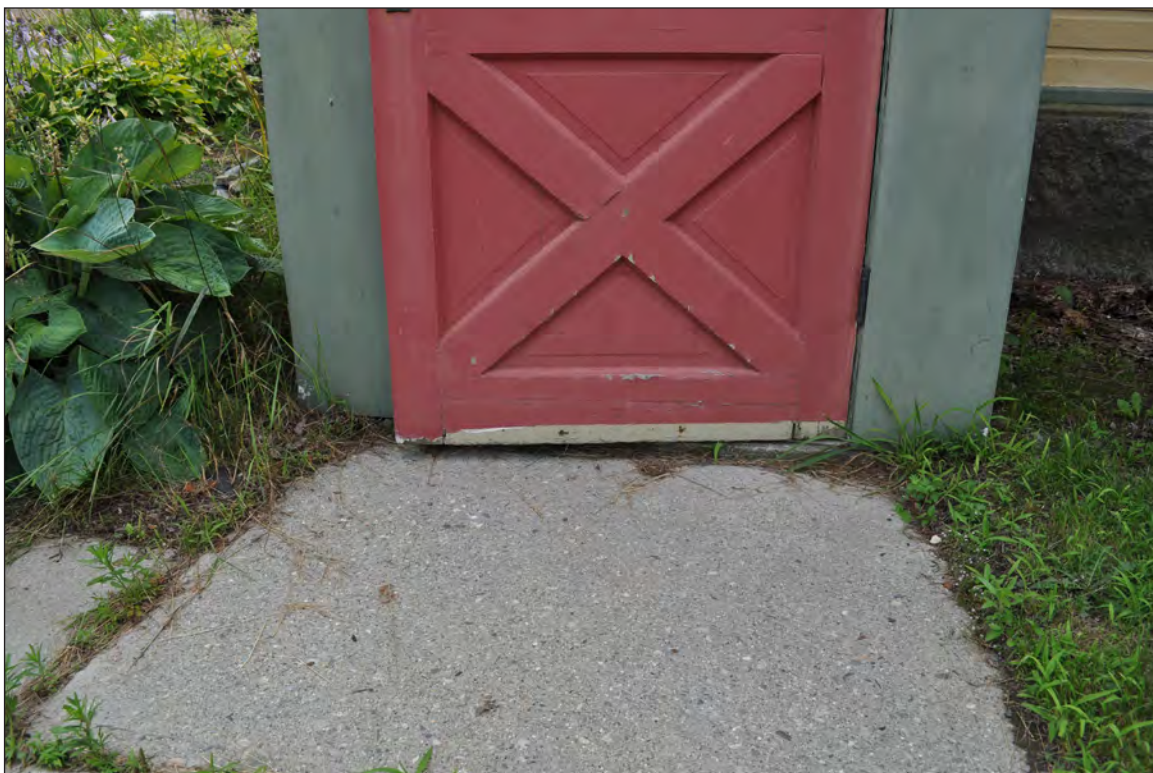
28. East elevation, exterior vestibule, bottom of door, camera facing west.

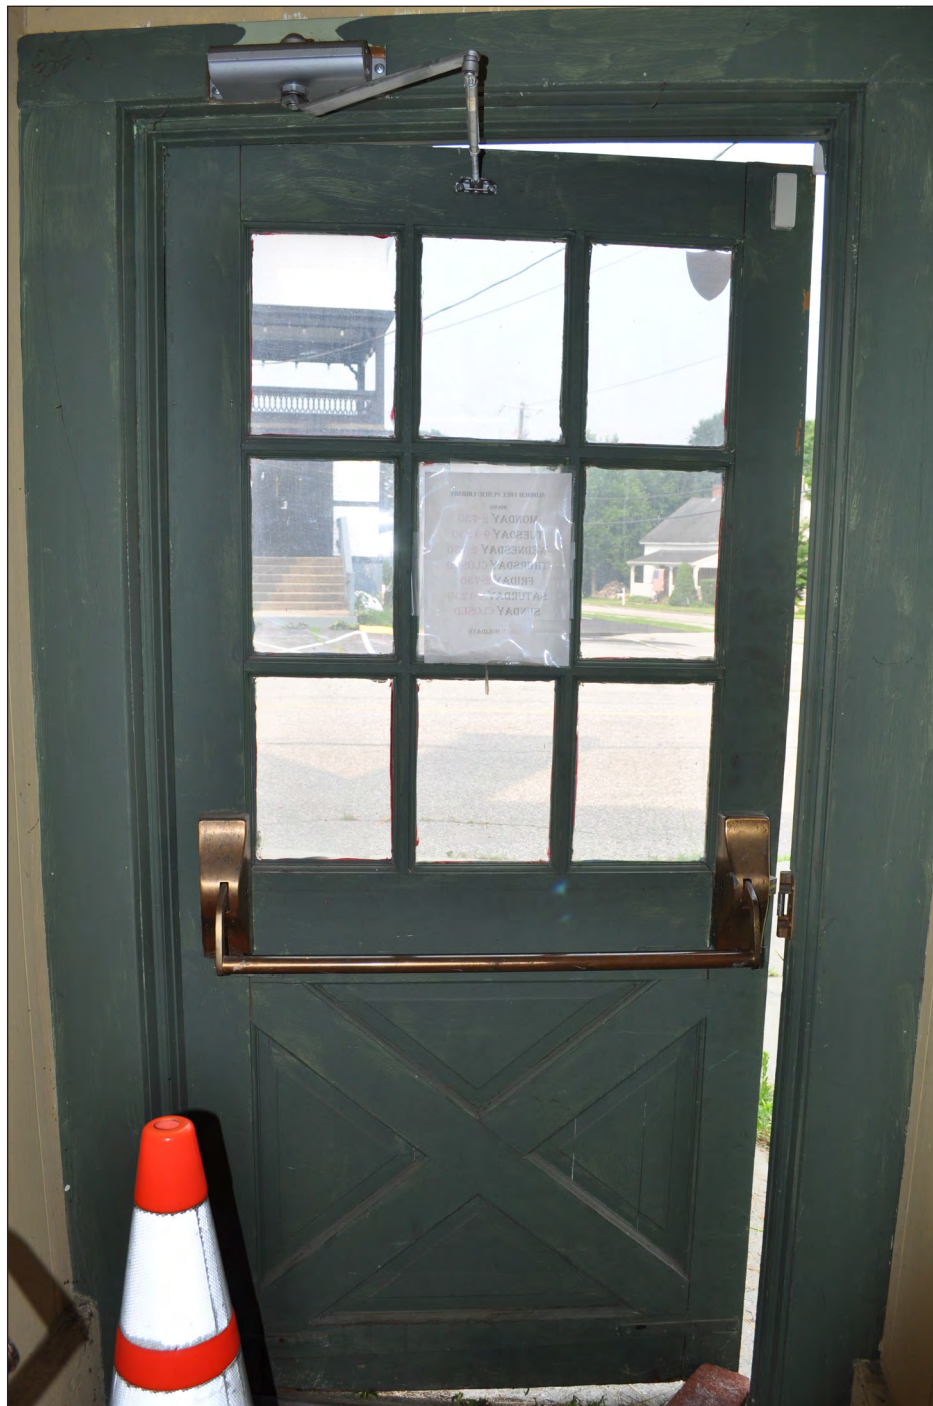
29. East elevation, interior of exterior vestibule, camera facing east.

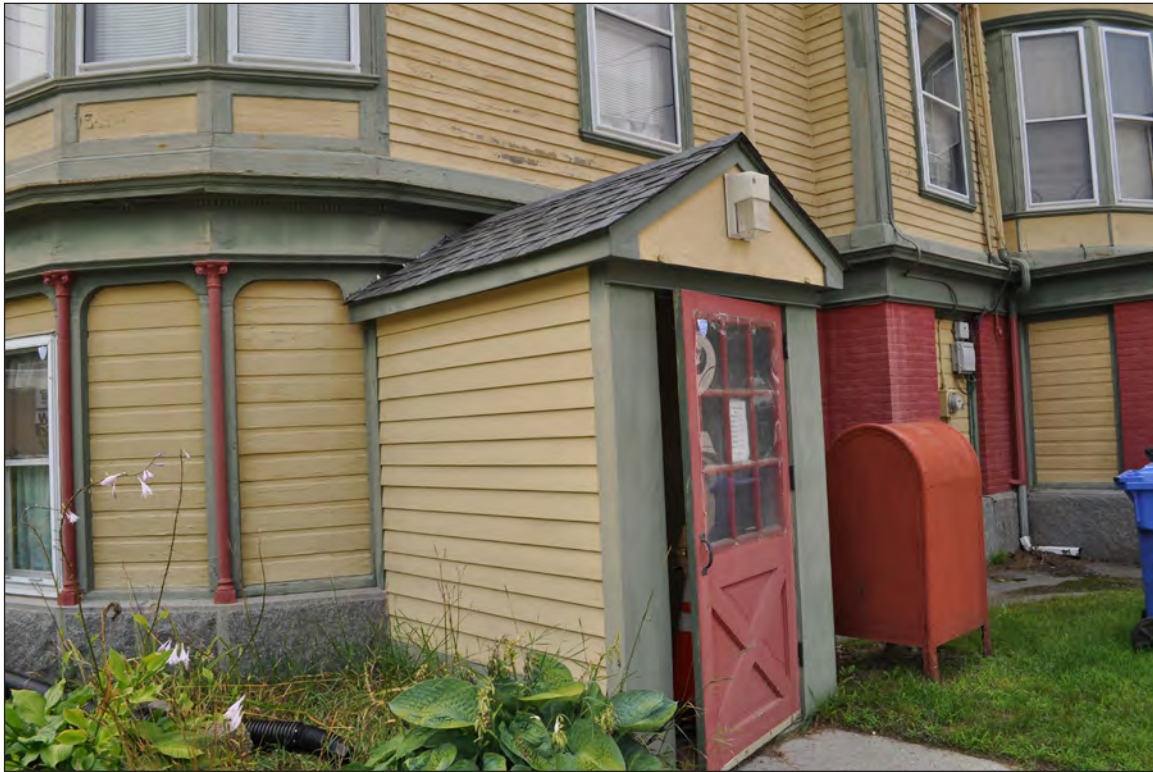
30. Southeast building perspective, exterior vestibule, camera facing northwest.

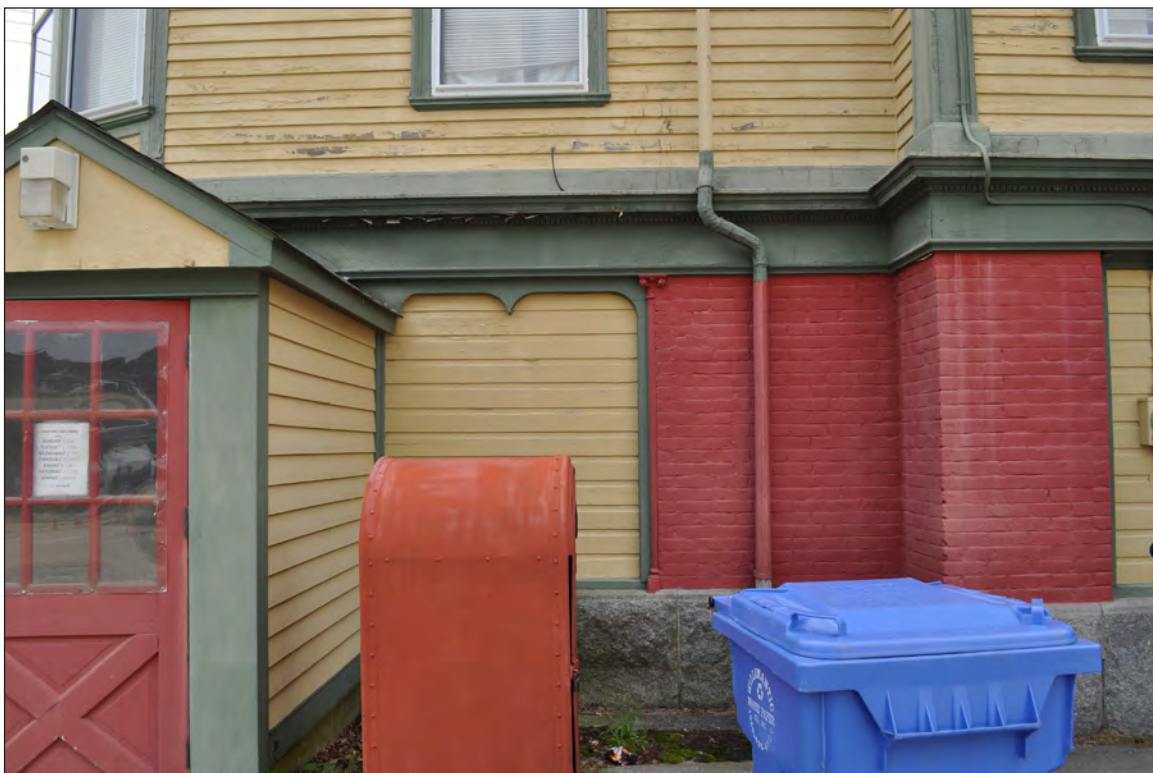
31. East elevation, infilled windows, camera facing west.

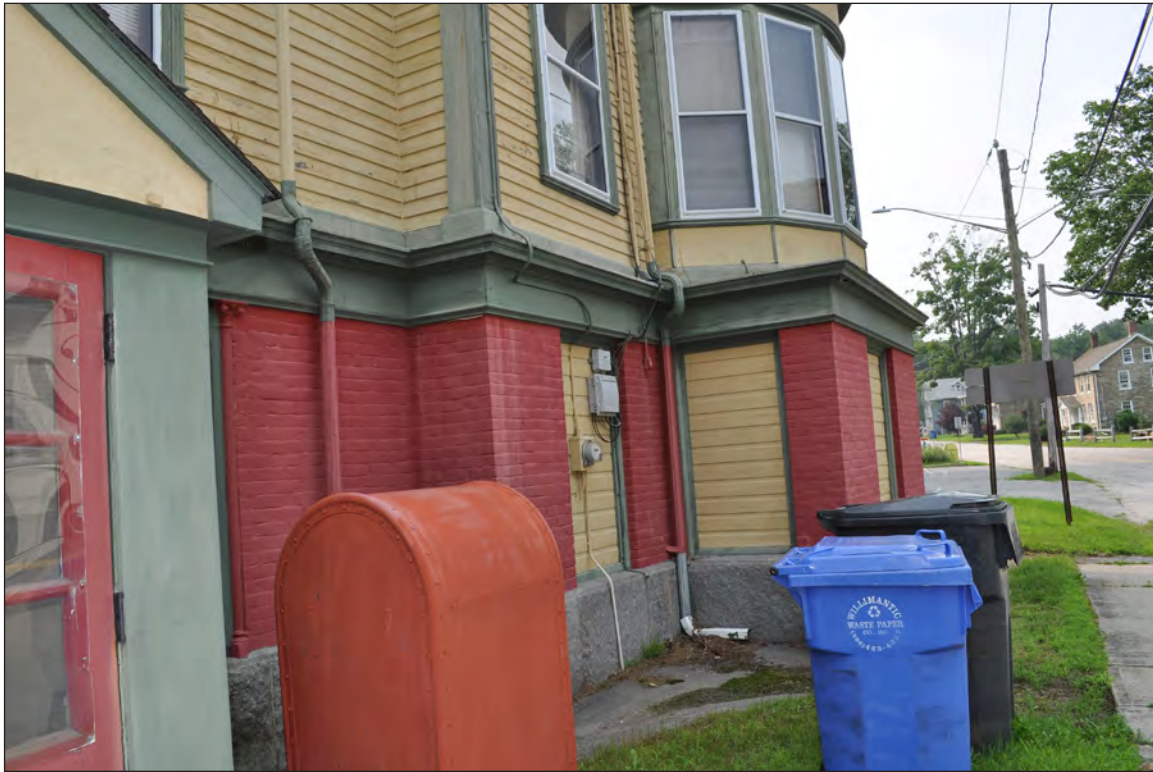
32. East elevation, camera facing northwest.

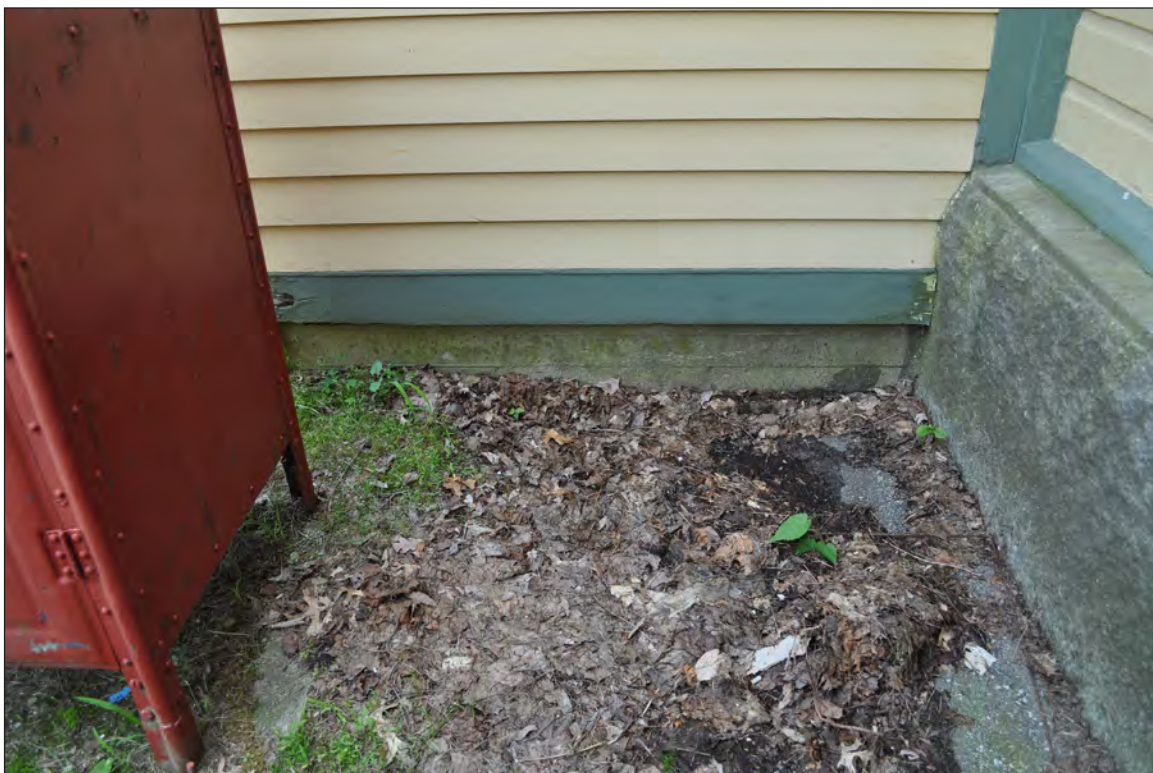
33. East elevation, camera facing down and west.

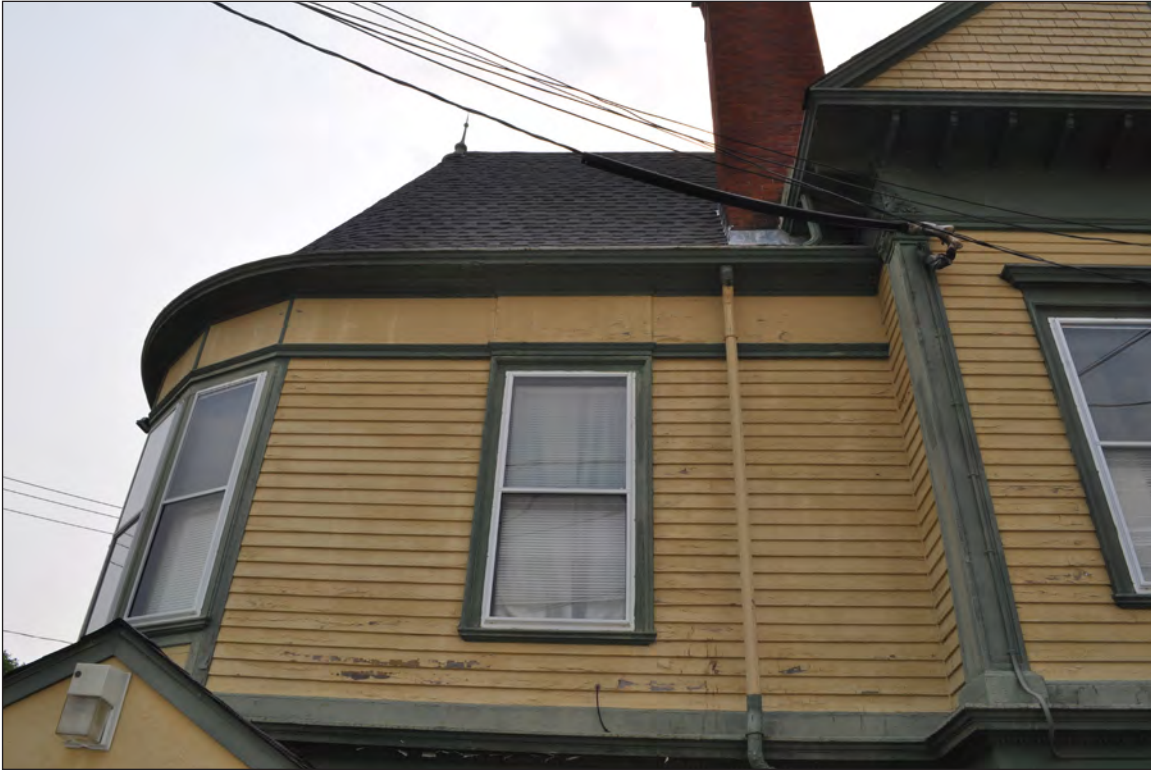
34. East elevation, camera facing up and west. Note condition of clapboards.

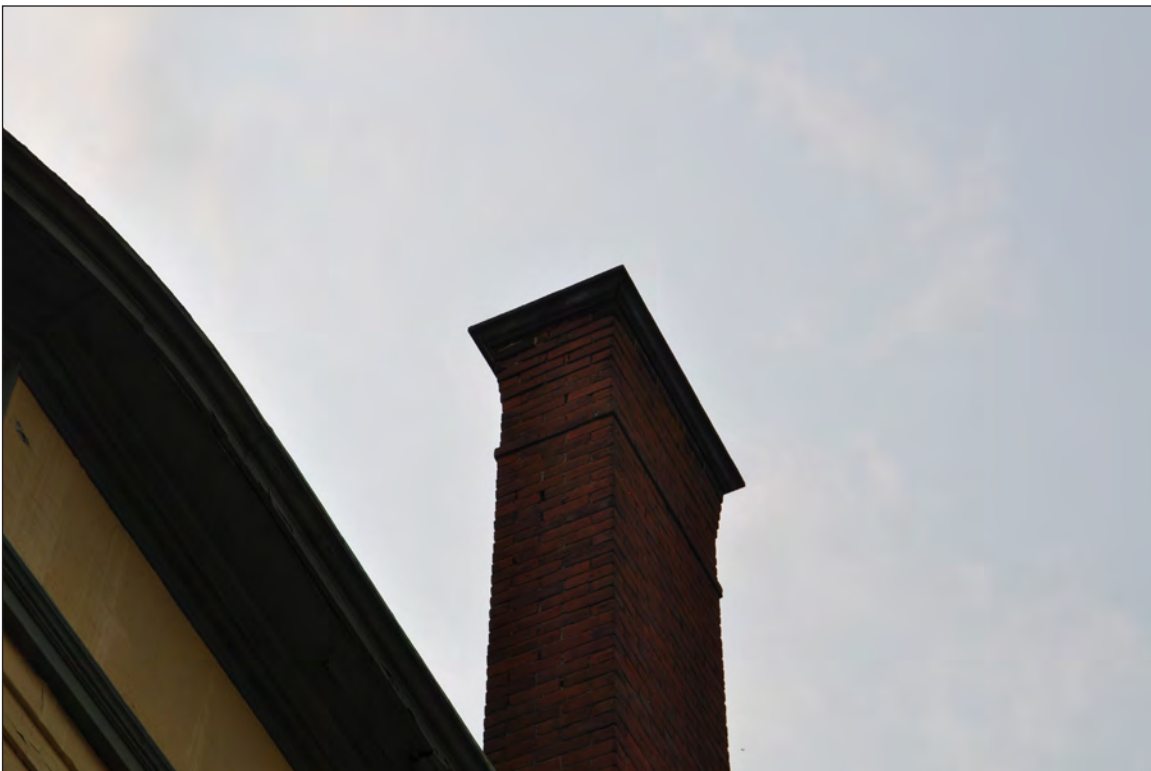
35. East elevation, southeast perspective of chimney, camera facing up and northwest.

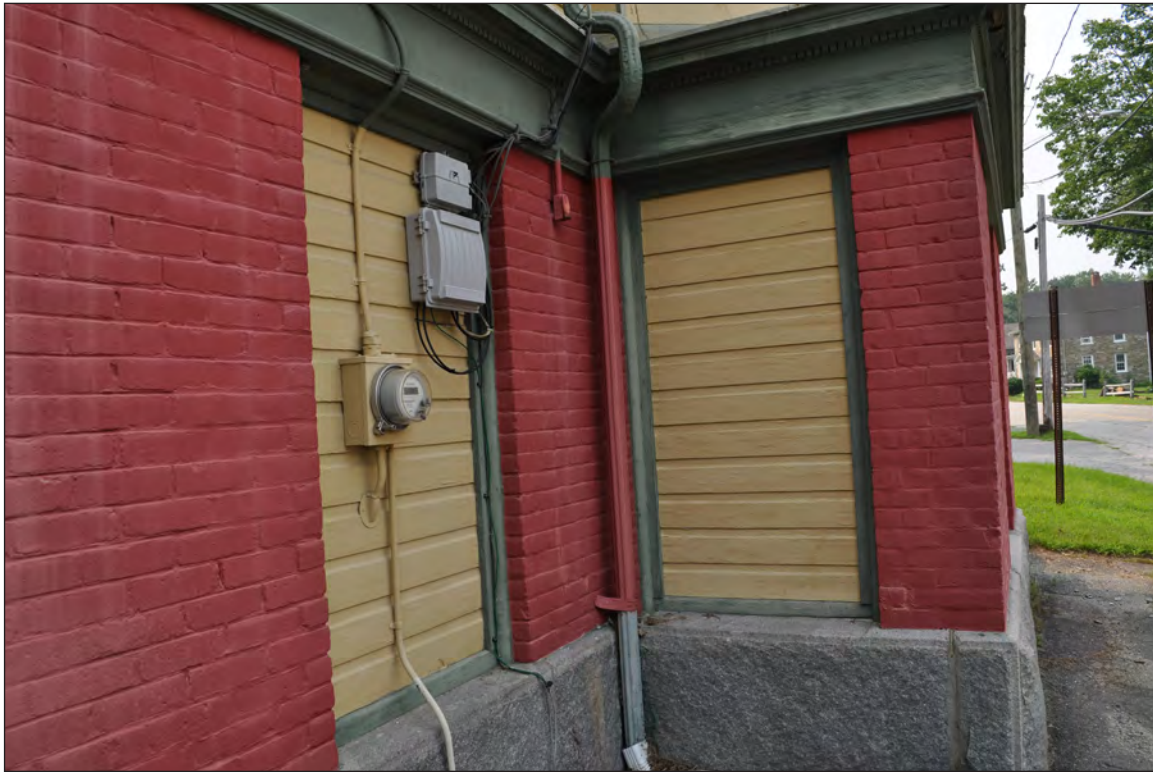
39. East elevation, camera facing northwest.

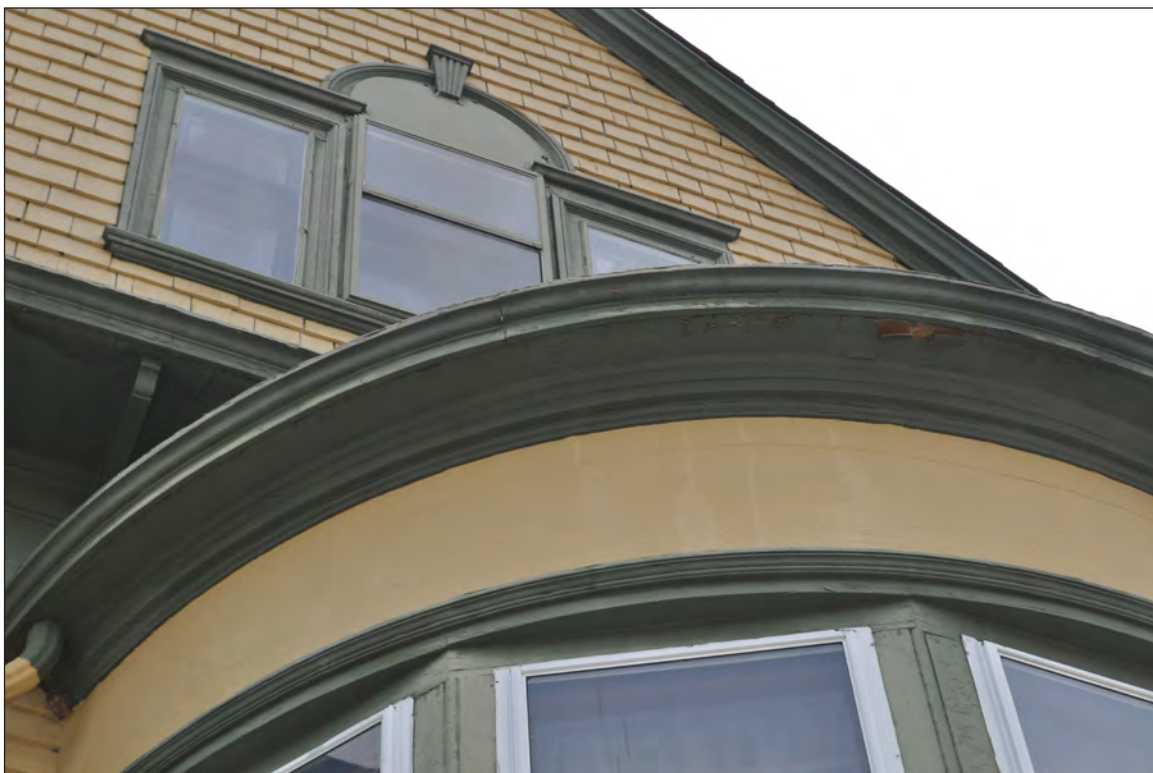
40. East elevation, underside of integrated gutter, camera facing northwest.
