Survey and Planning Grant

Application

The Aldrich Free Public Library Planning and Survey Grant Application 2022

**G. Long Term Preservation Plan/Conditions Assessment completed in
October 2021 by Crosskey Architects**

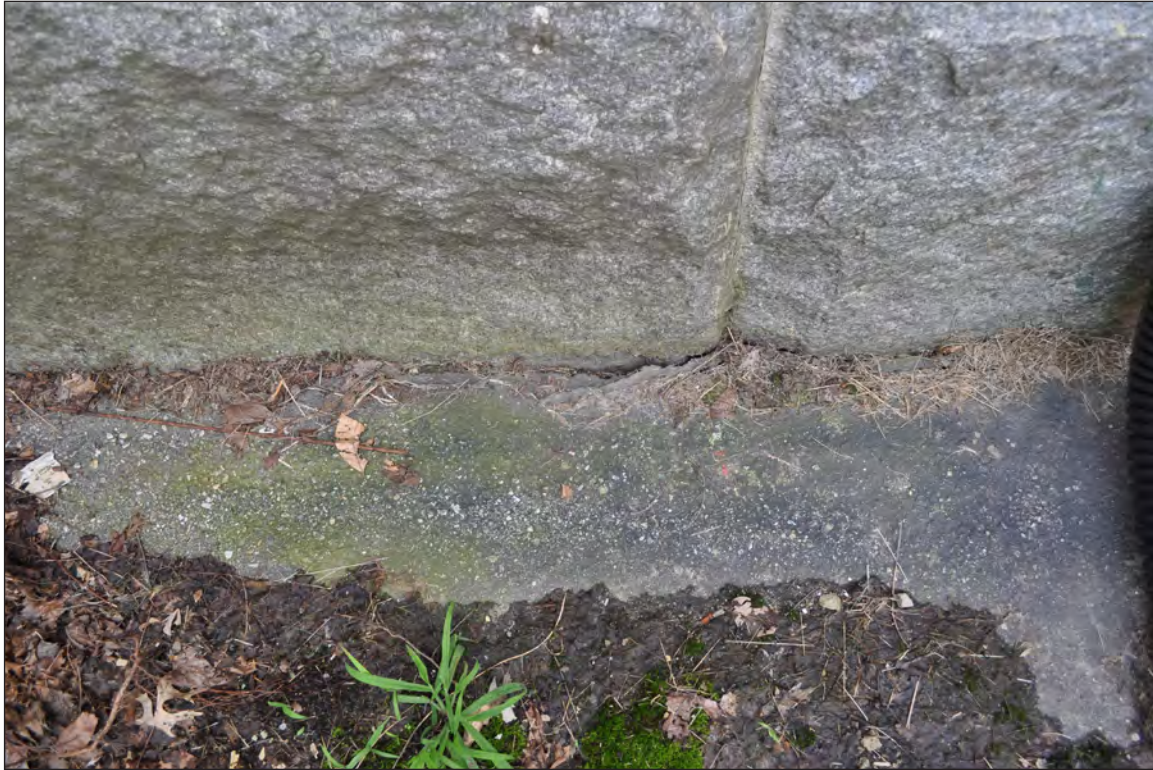
41. East elevation, grade at foundation, camera facing west.

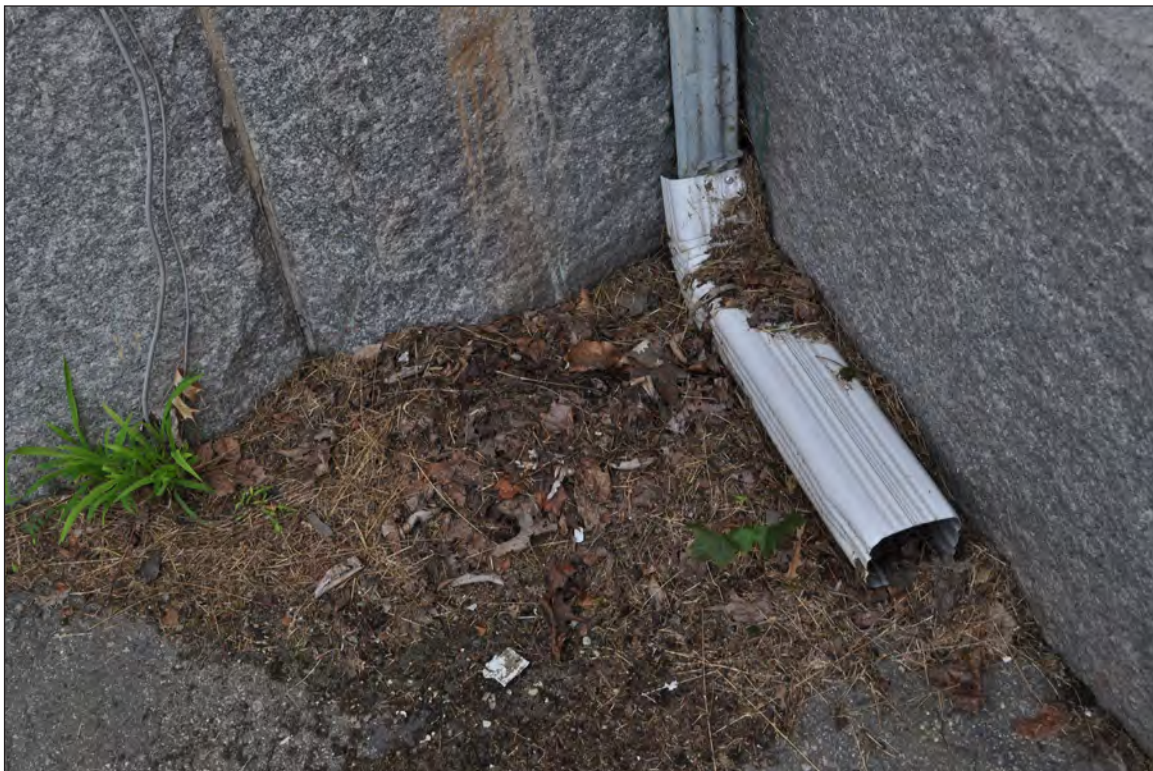
42. East elevation, grade at foundation, camera facing northwest.

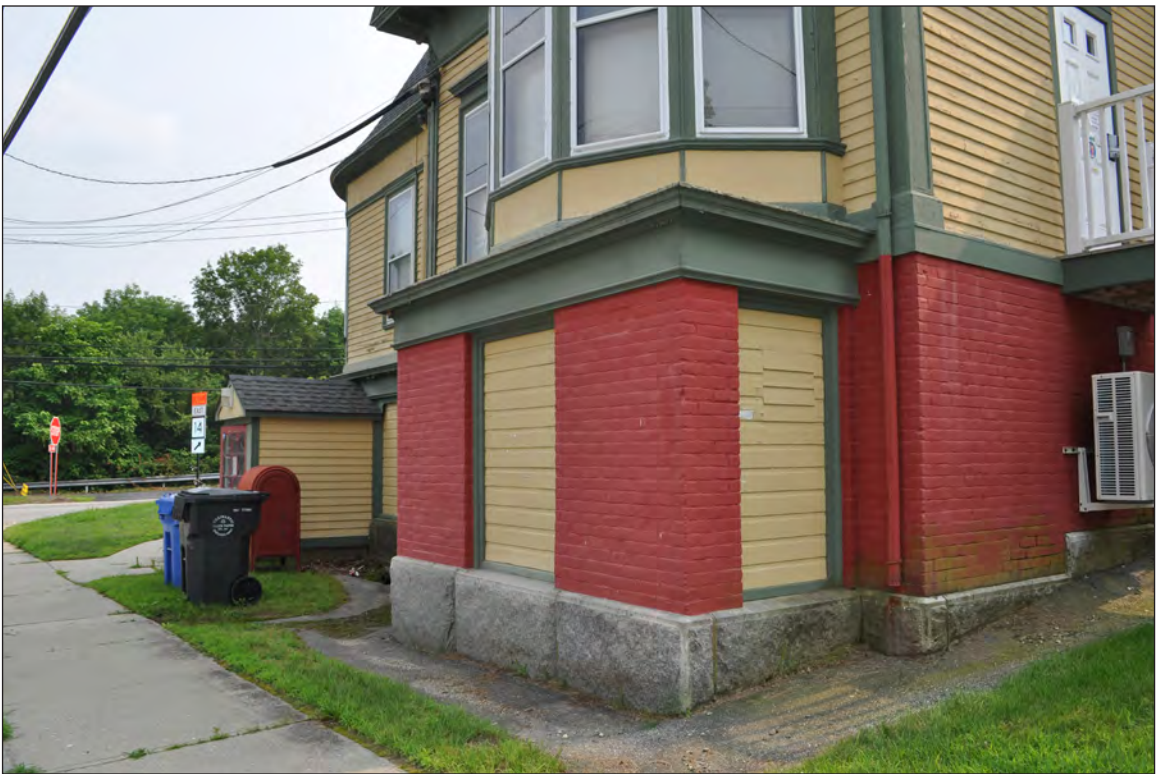
45. Northeast building perspective, camera facing down and southwest.

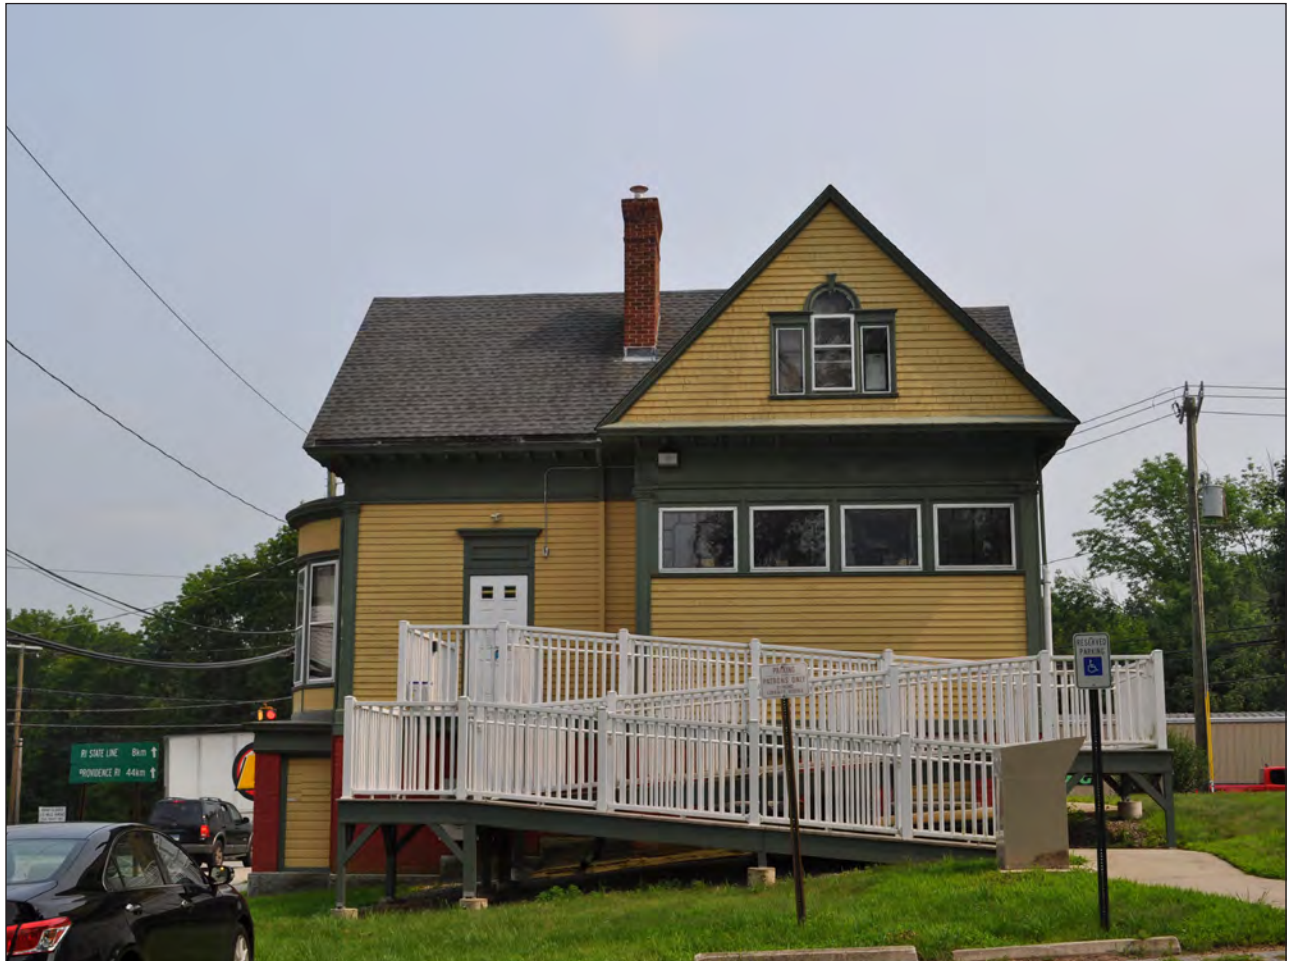
46. North elevation, camera facing south.

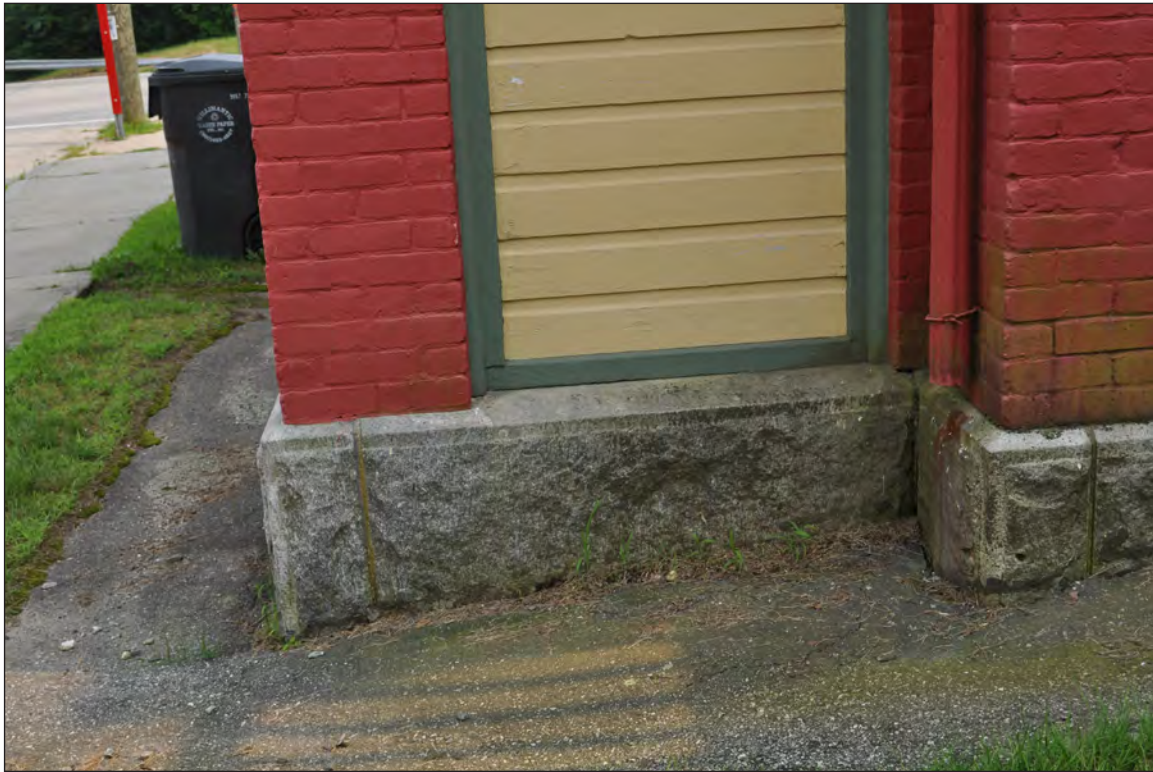
47. North elevation, camera facing down and south.

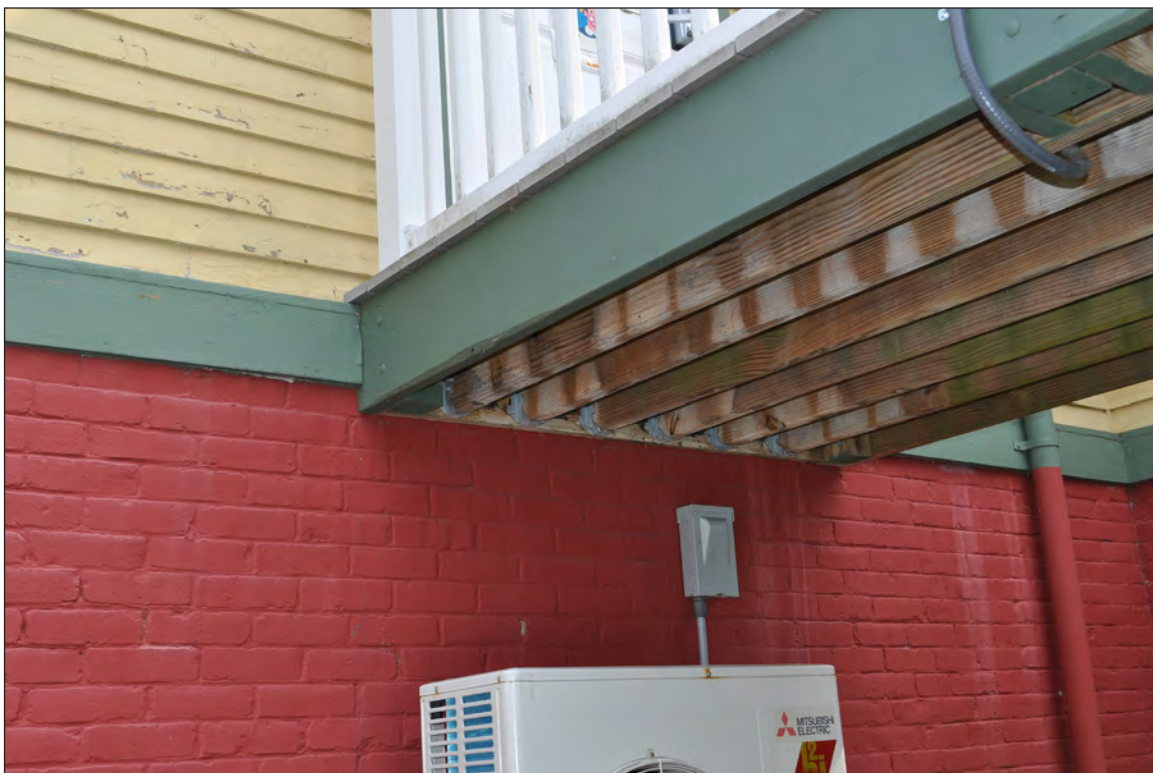
50. North elevation, camera facing southwest. Underside of deck, note bio growth.

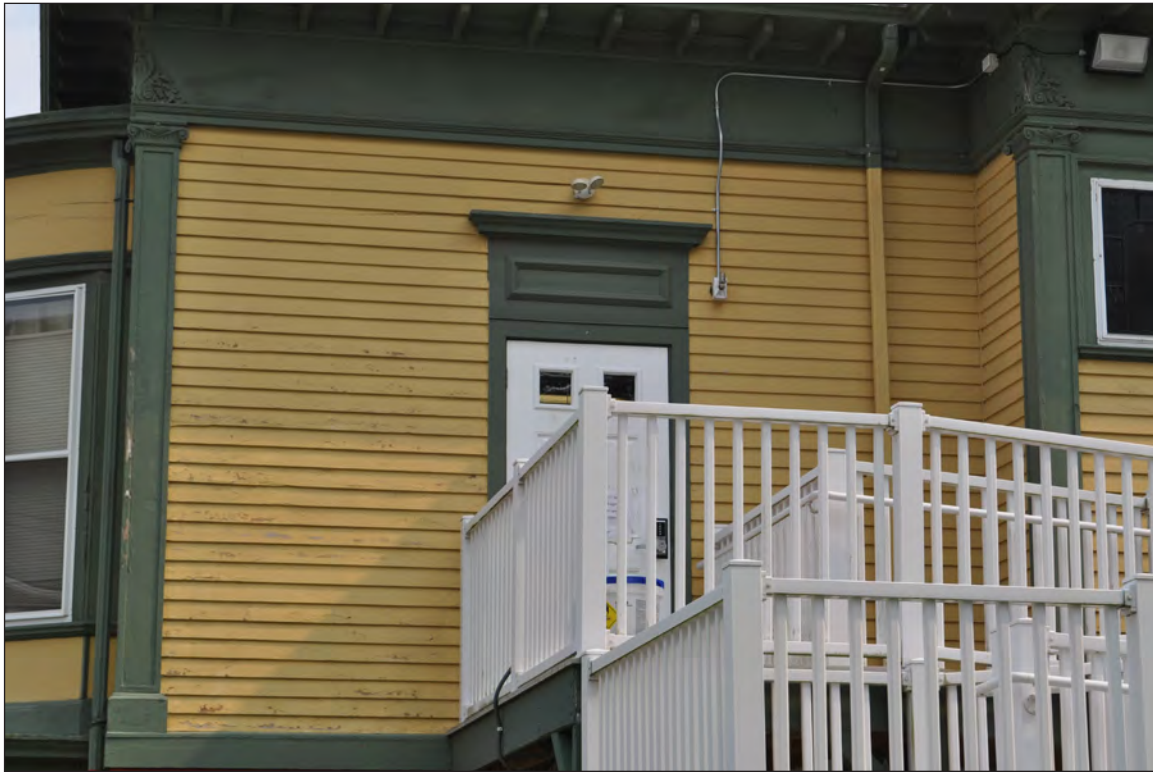
51. North elevation, camera facing south.

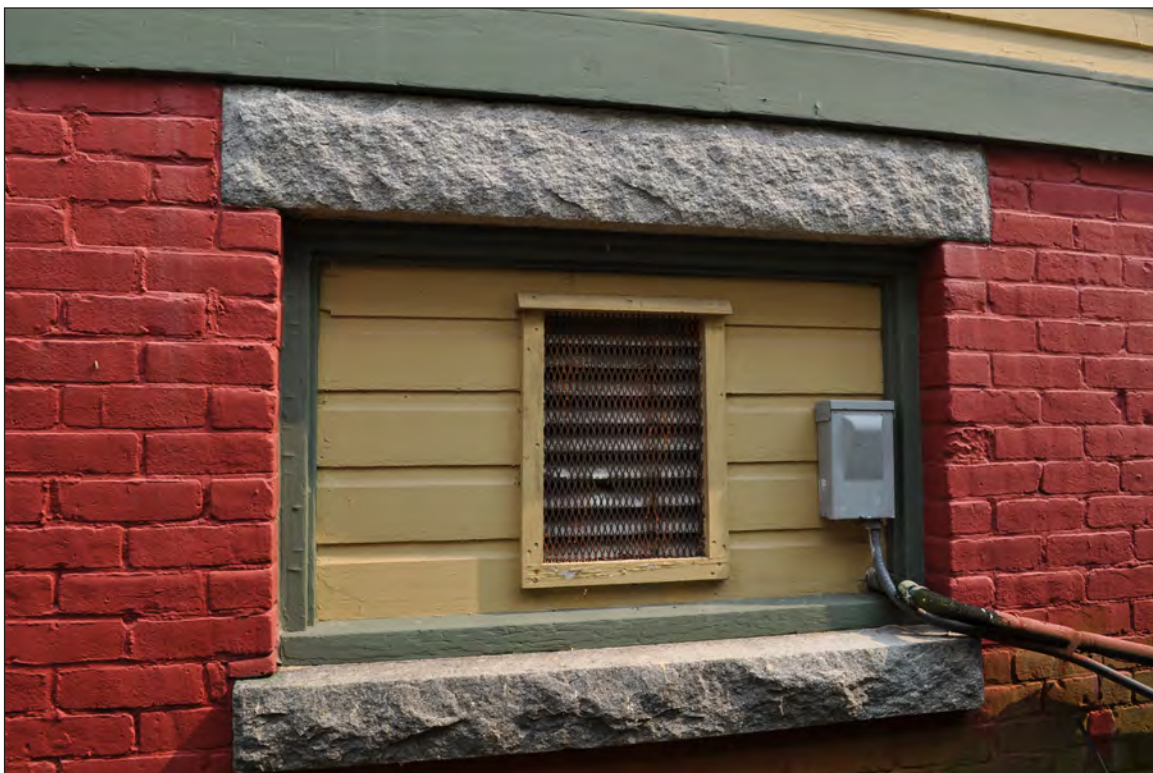
52. North elevation, camera facing south.

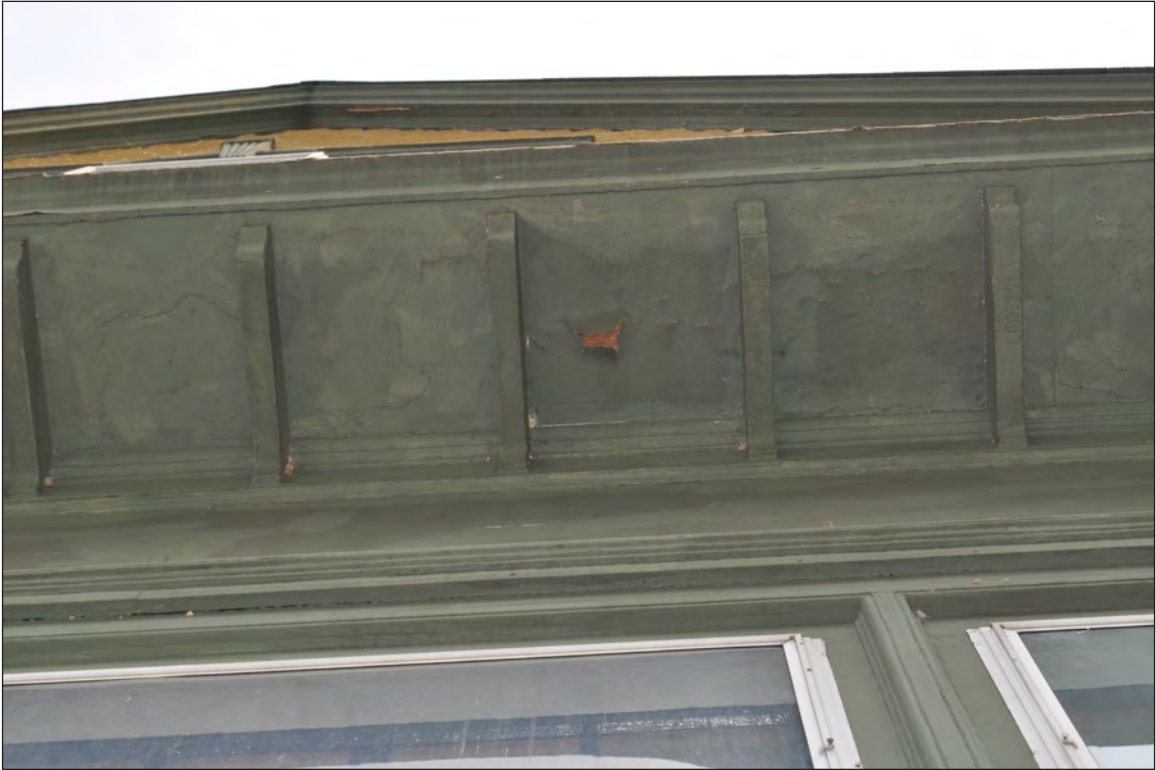
53. North elevation, underside of soffit, camera facing up and south.

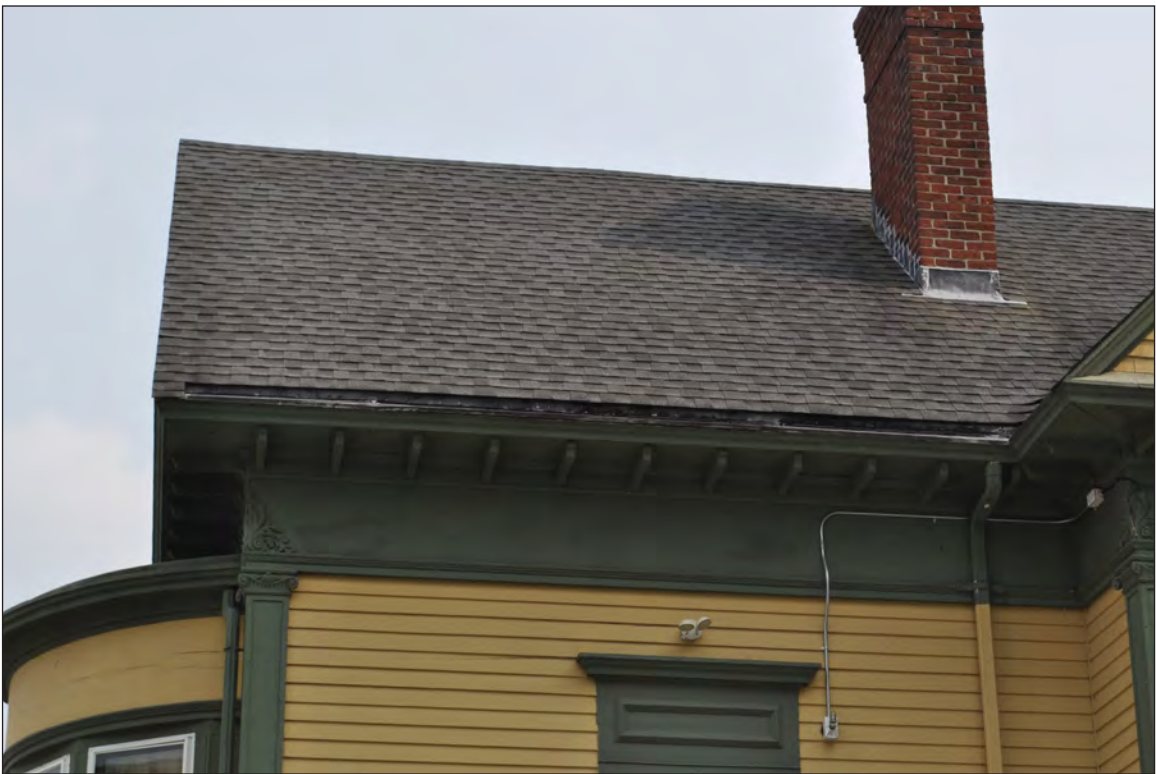
54. North elevation, camera facing up and south.

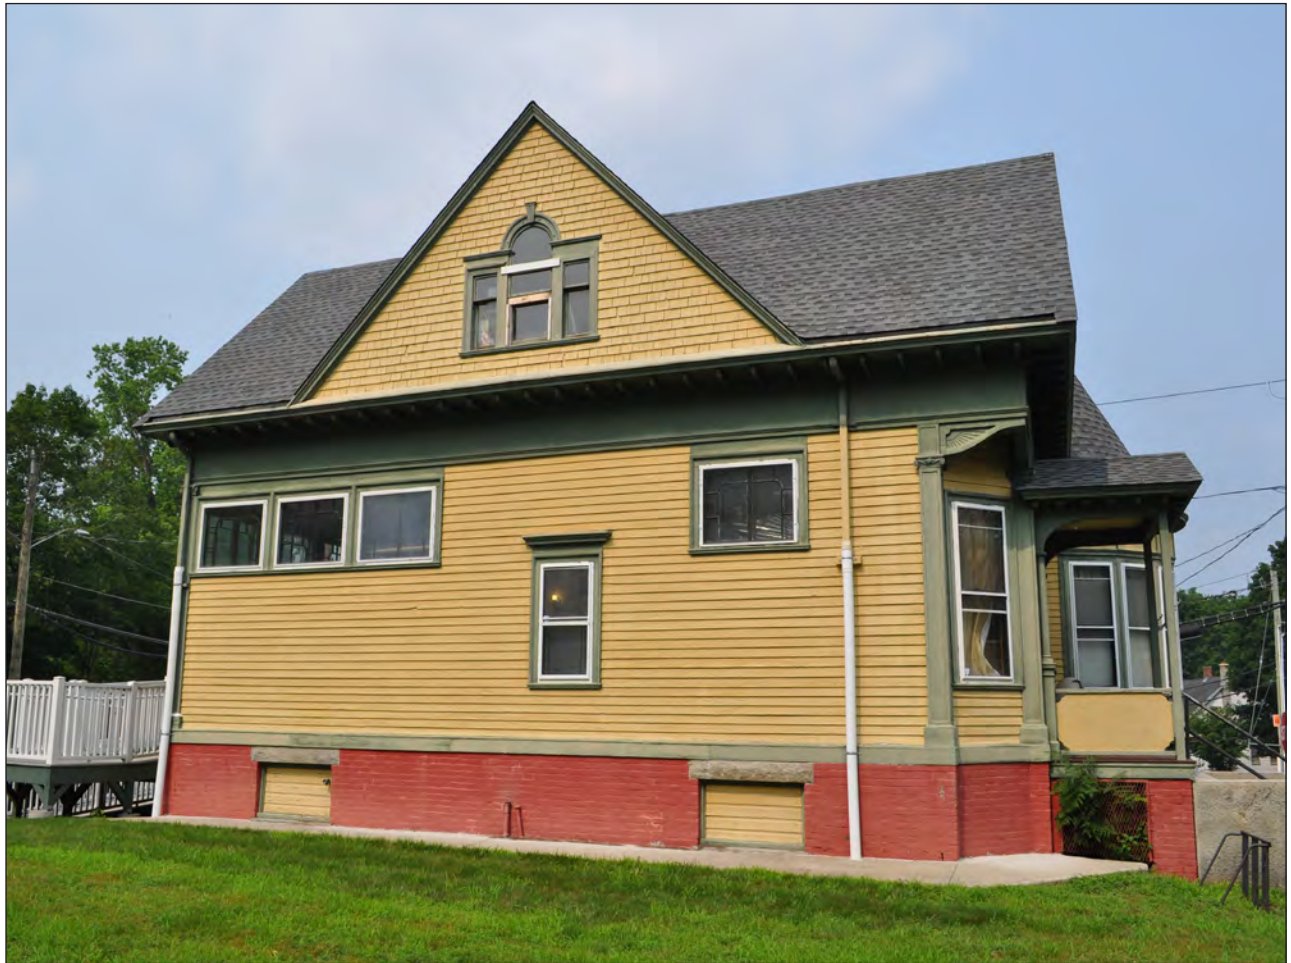
55. West elevation, camera facing northwest.

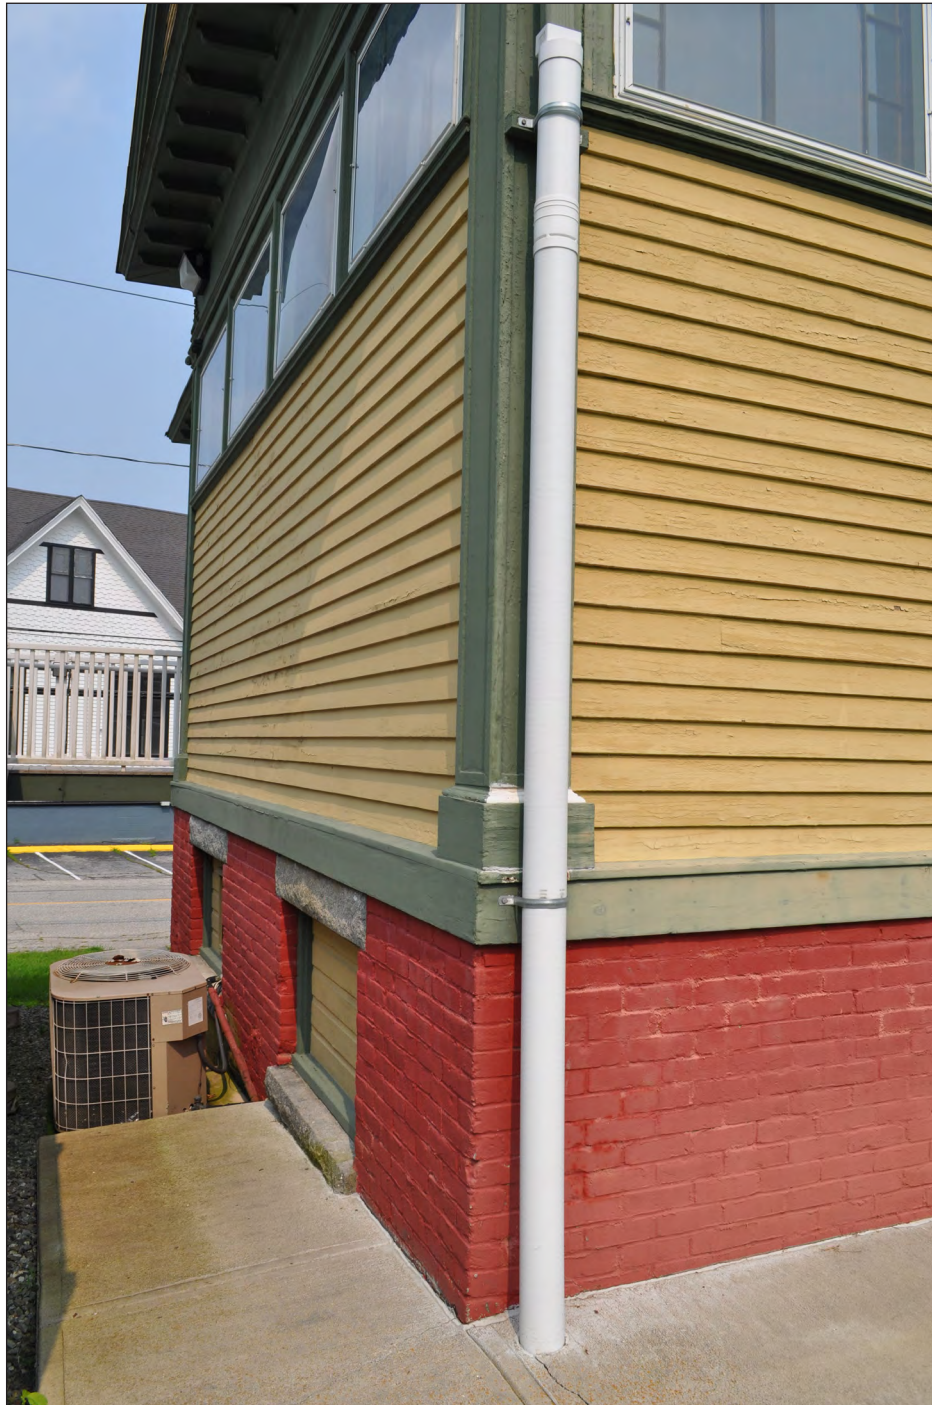
56. Northwest building corner, camera facing southeast.

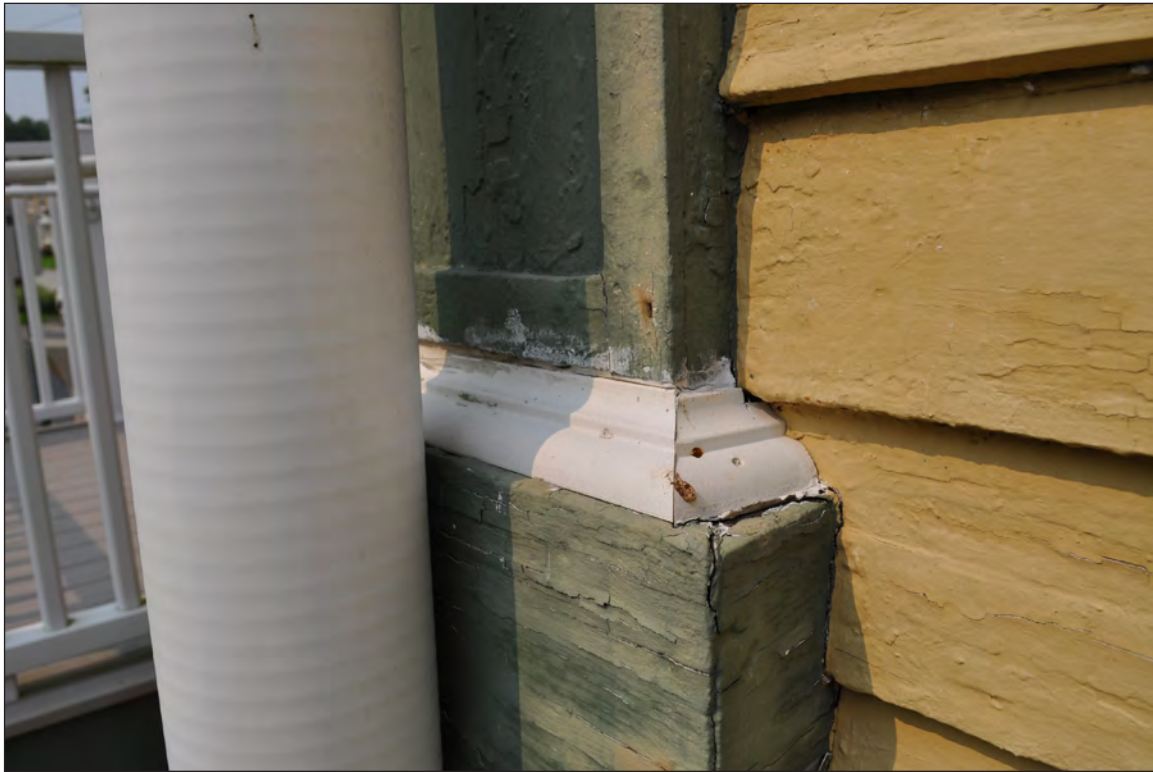
57. West elevation, replacement trim, camera facing northeast.

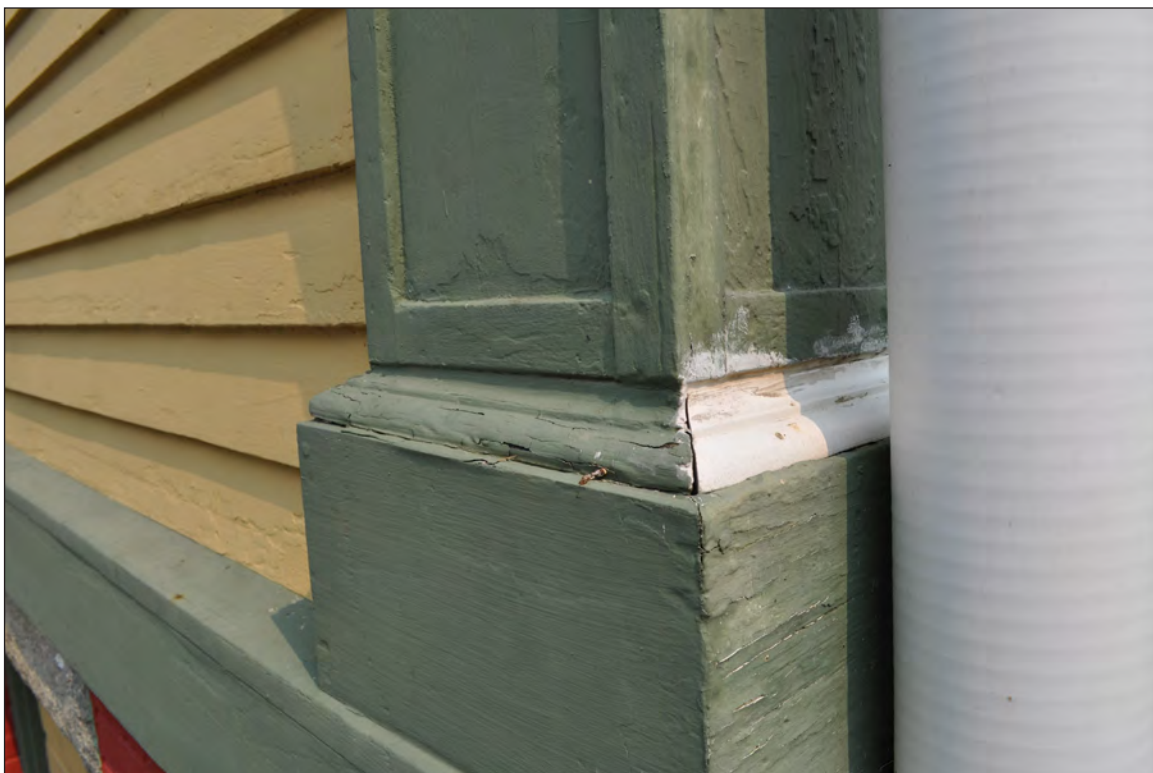
58. Northwest building corner, replacement trim, camera facing southeast.

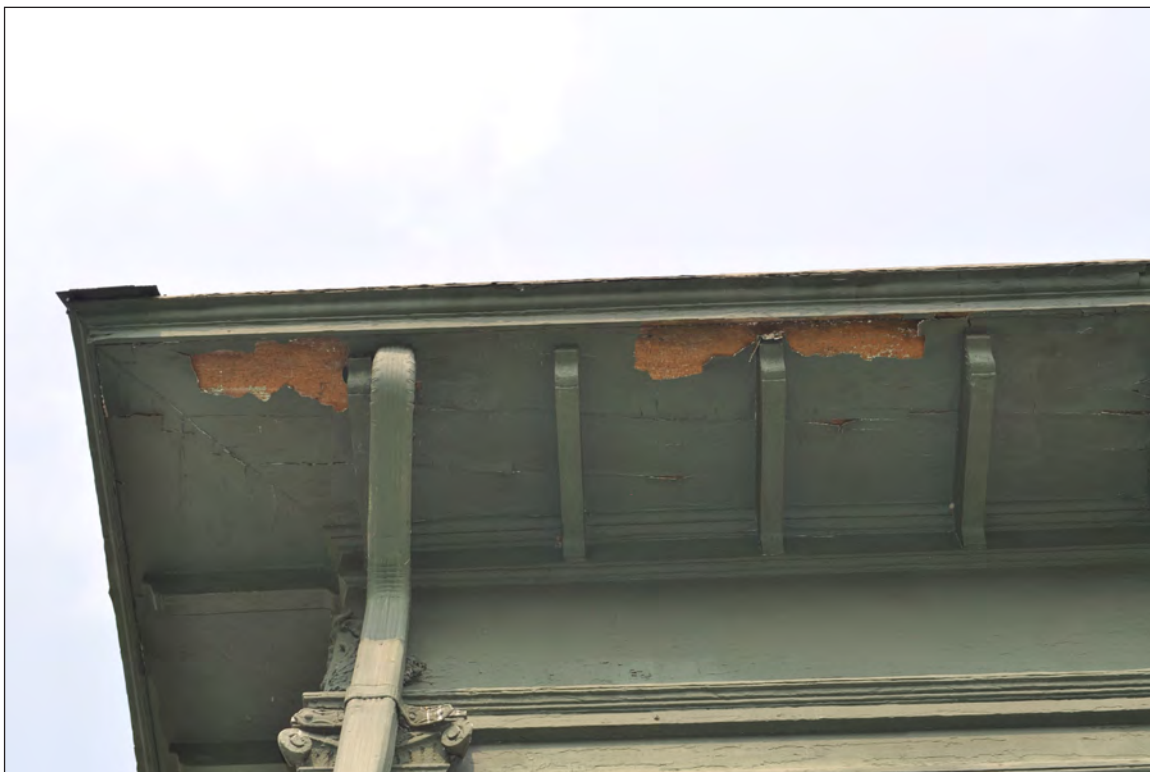
59. West elevation, underside of soffit below integrated gutter, camera facing up and southeast.

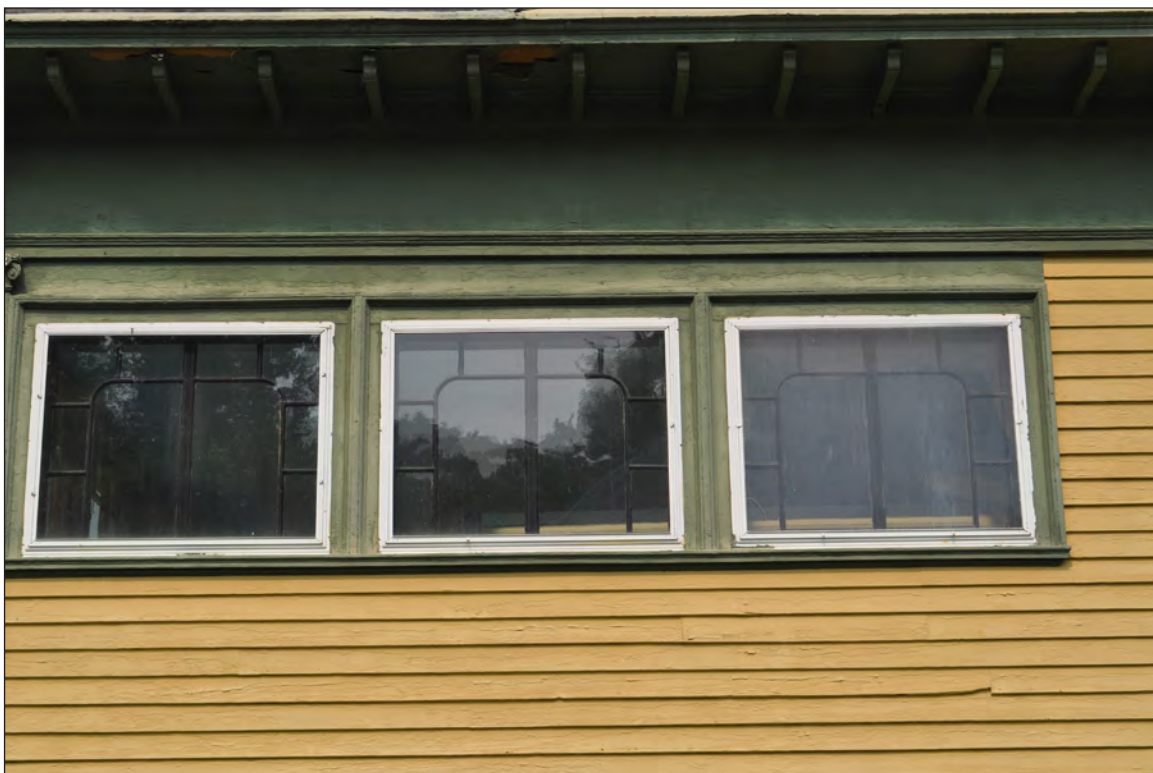
62. West elevation, windows, camera facing east.

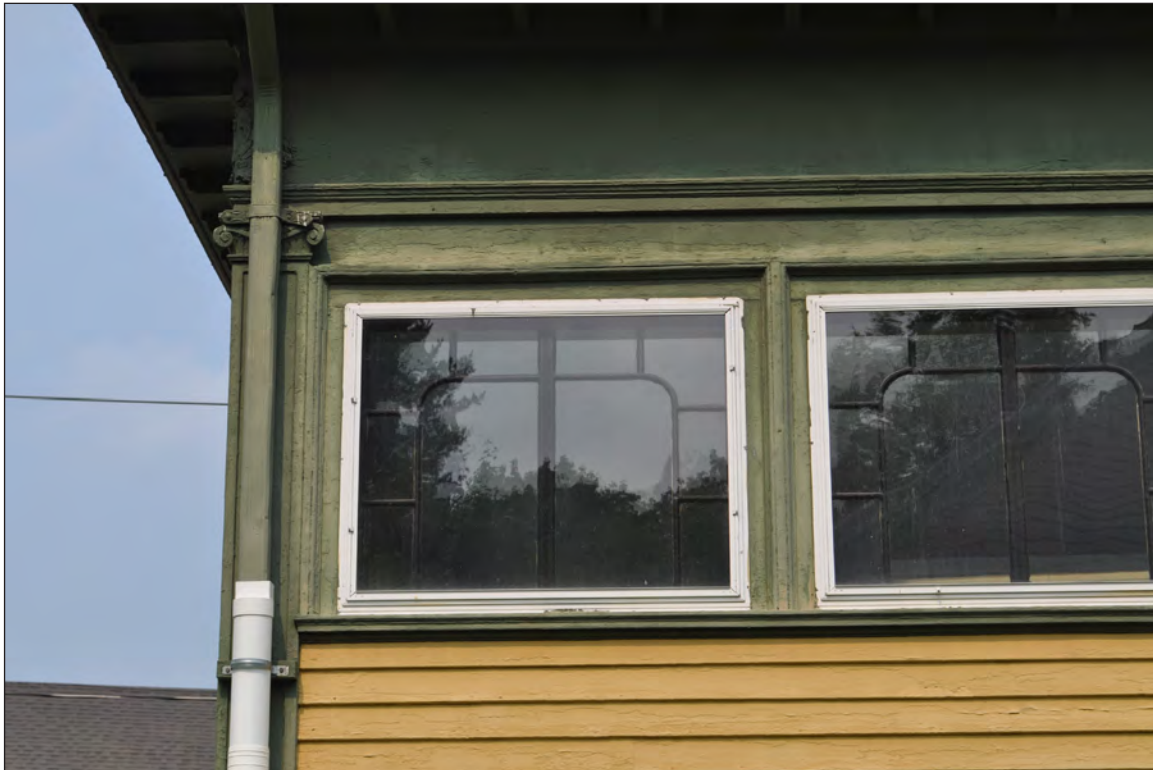
63. West elevation, close-up of window, camera facing east.

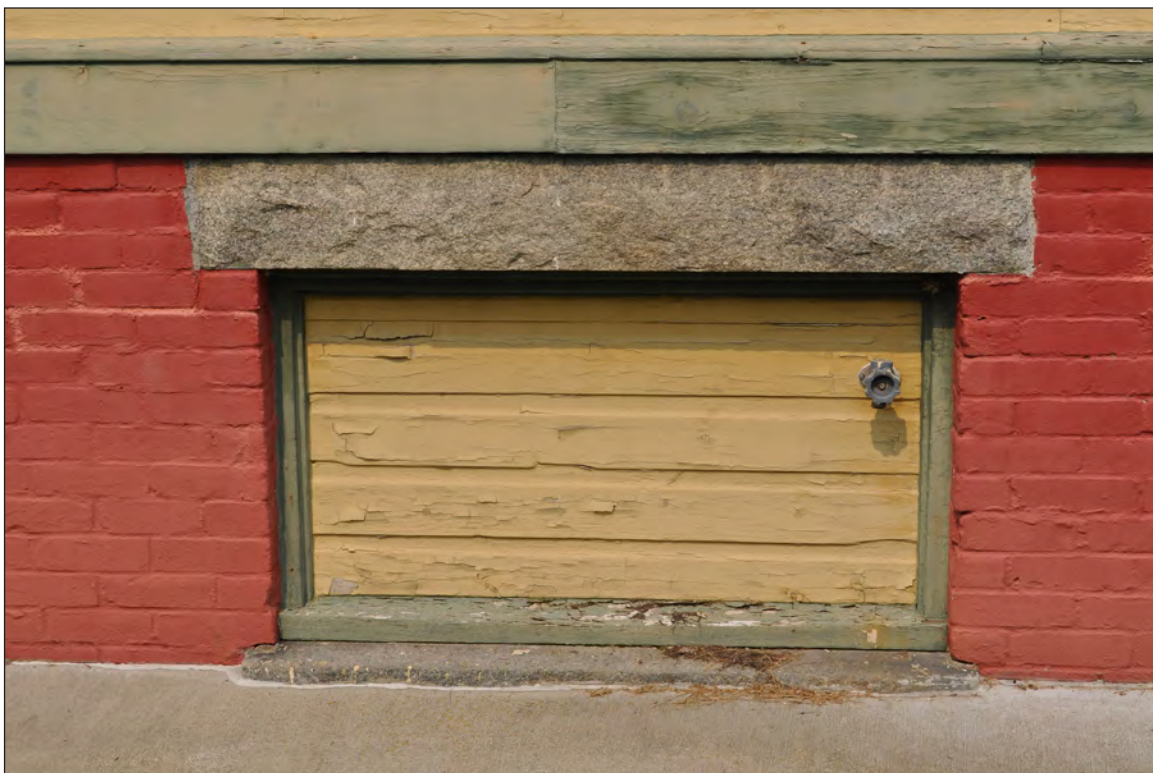
64. West elevation, infilled window, camera facing down and east.

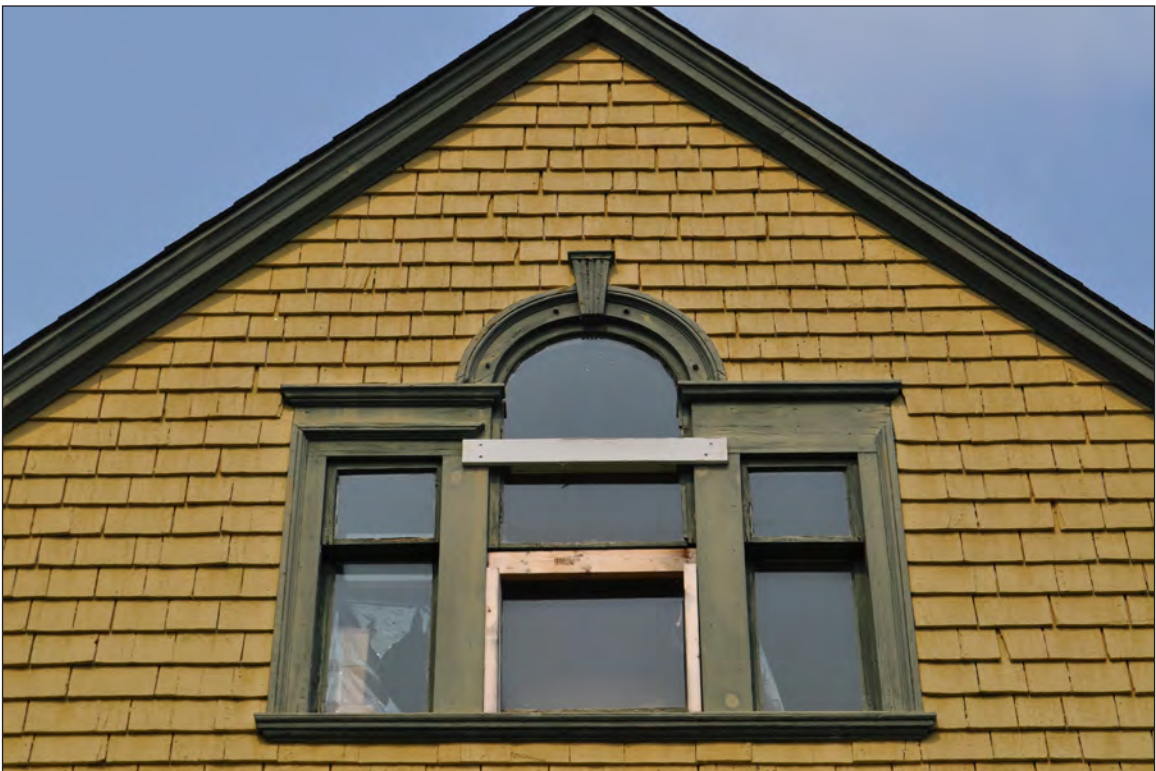
66. West elevation, Palladian window, camera facing up and east.

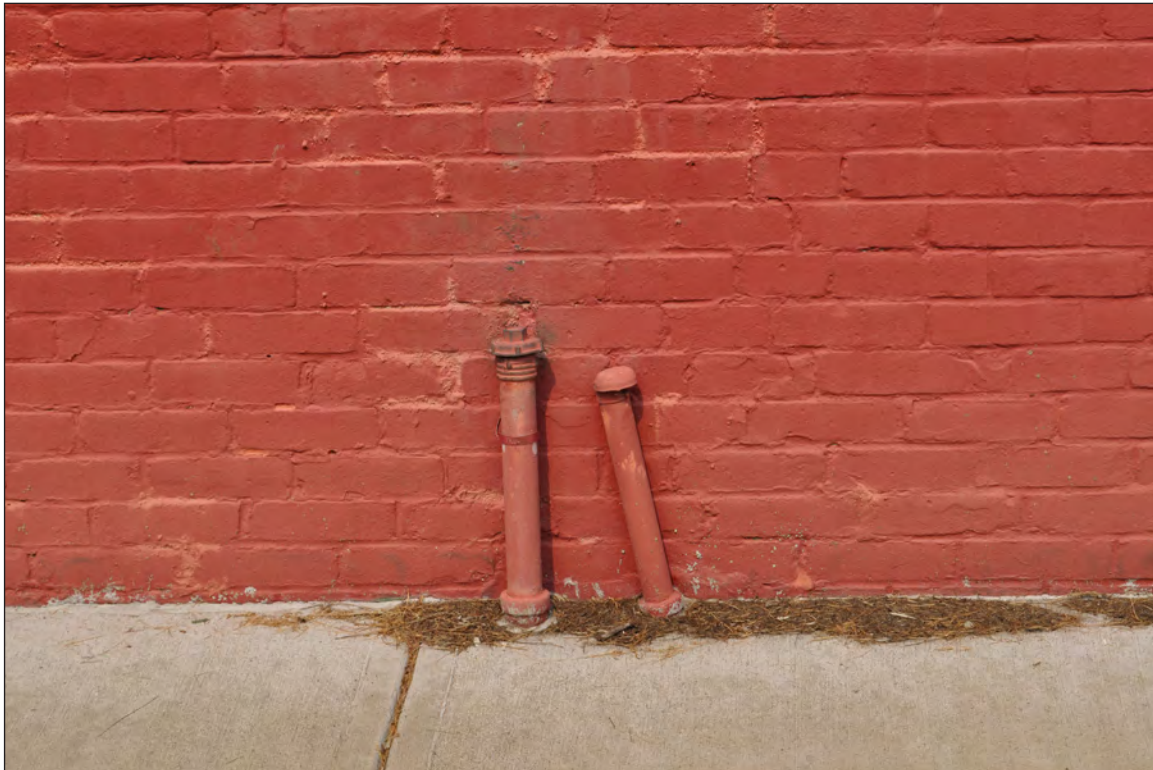
67. West elevation, oil tank piping, camera facing down and east.

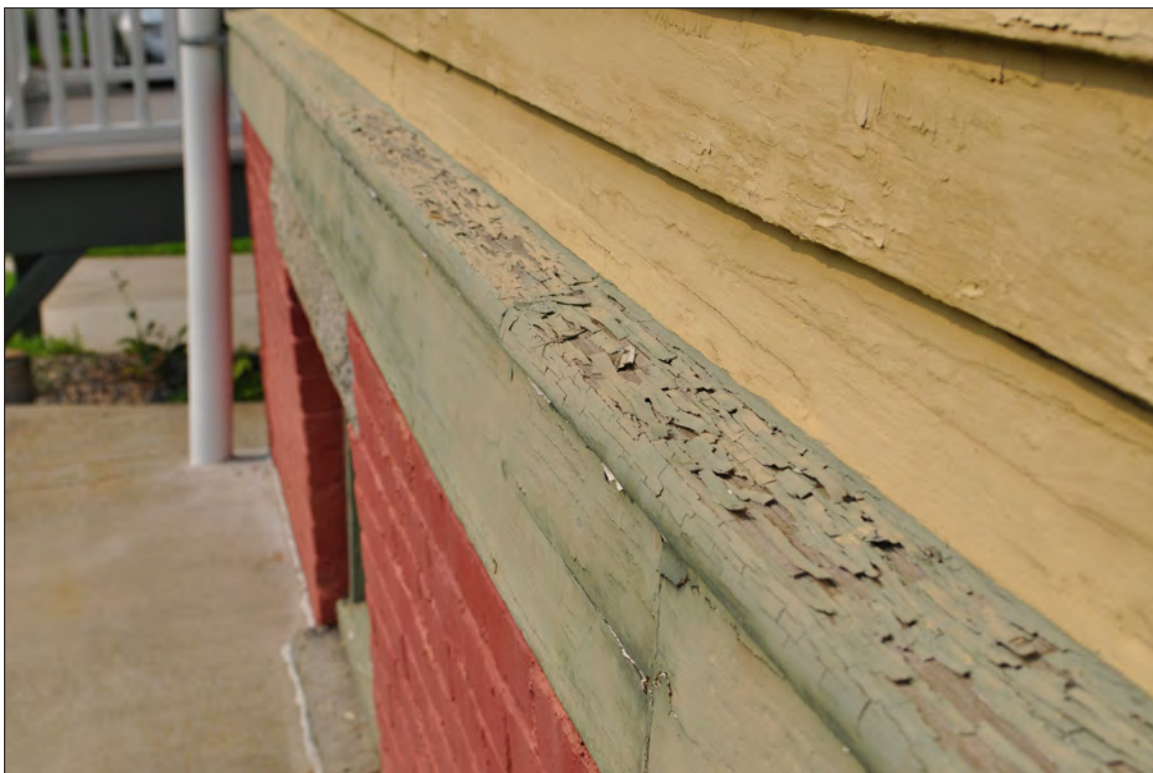
68. West elevation, wood trim at water table, camera facing northeast.

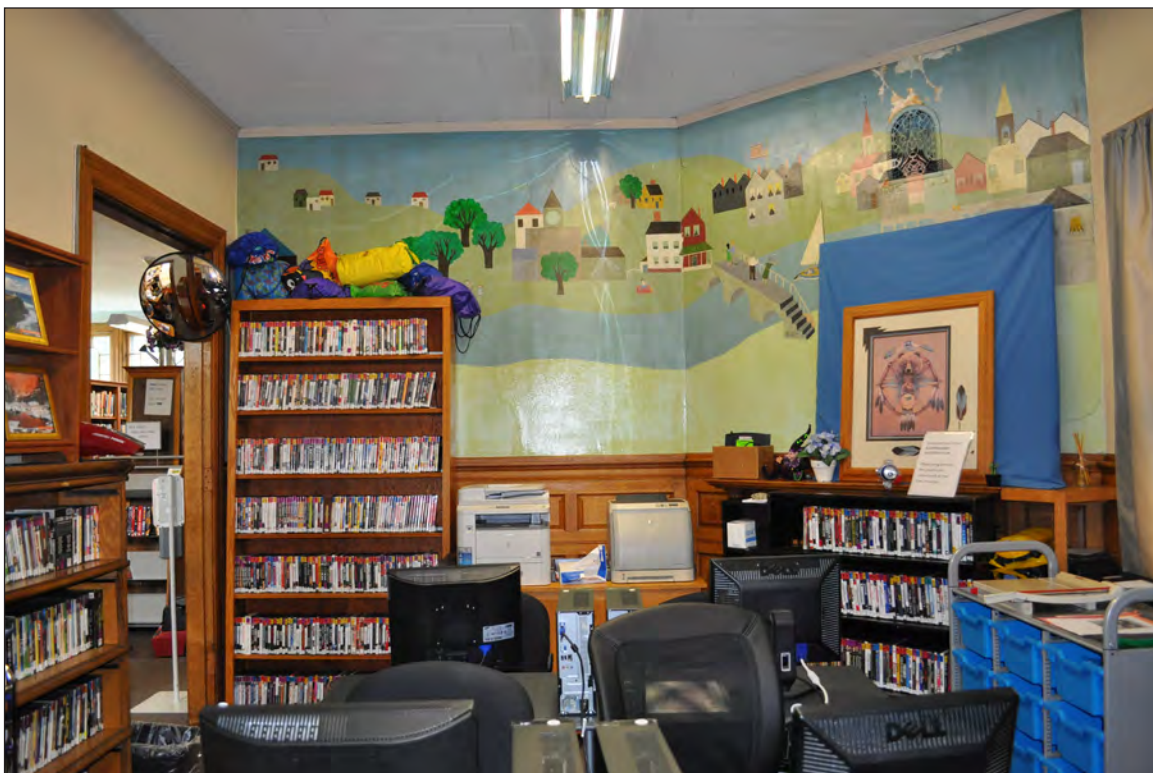
89. First-floor, computer room (201), camera facing southeast.

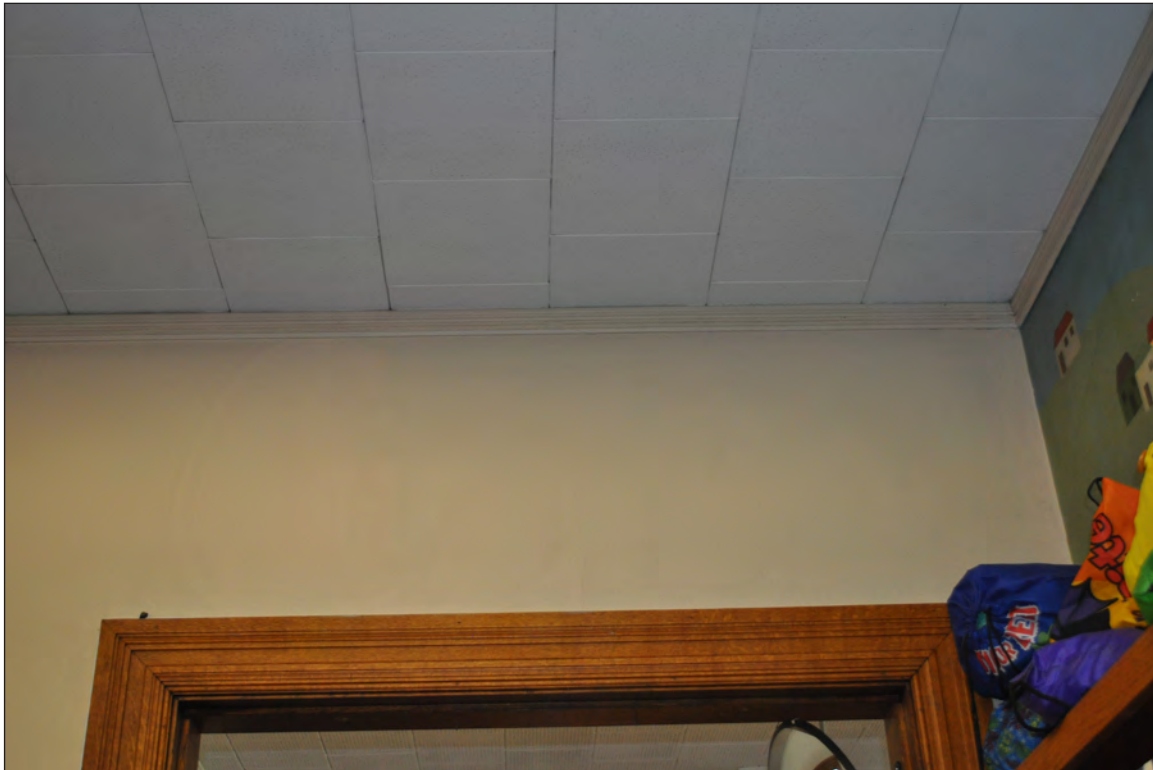
90. First-floor, computer room (201), camera facing north.

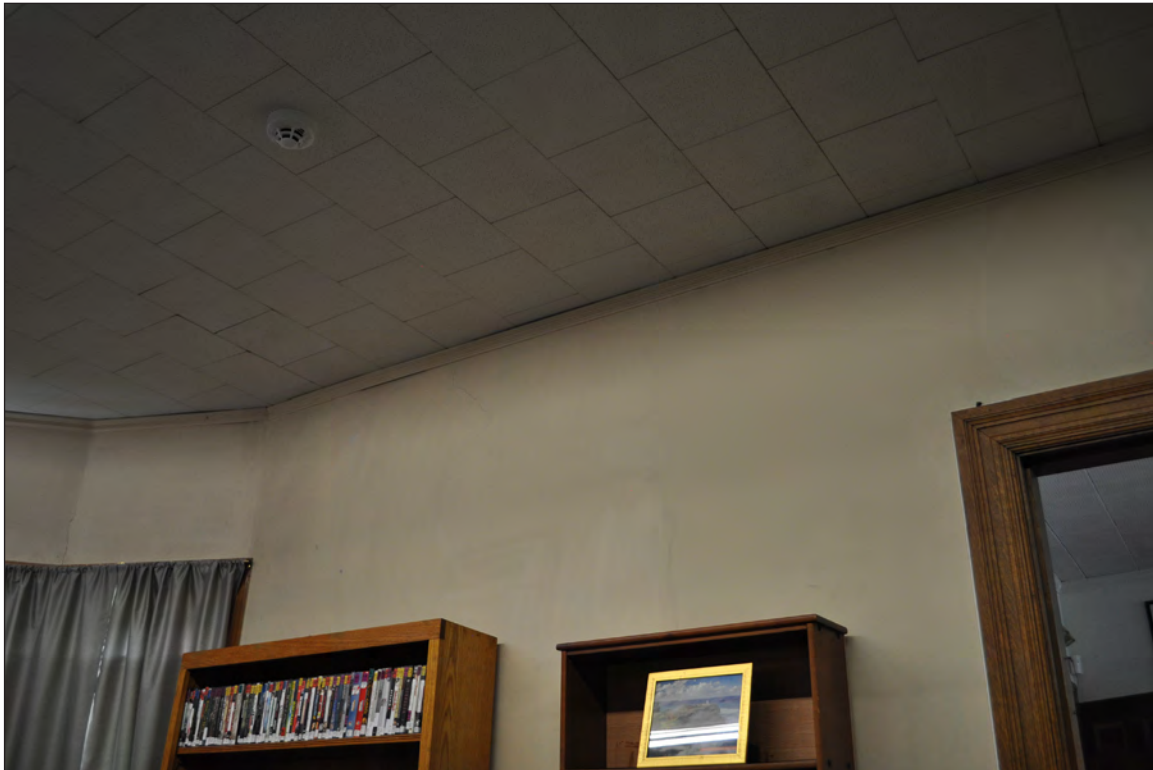
94. First-floor, computer room (201), camera facing east.
