Survey and Planning Grant

Application

The Aldrich Free Public Library Planning and Survey Grant Application 2022

**G. Long Term Preservation Plan/Conditions Assessment completed in
October 2021 by Crosskey Architects**

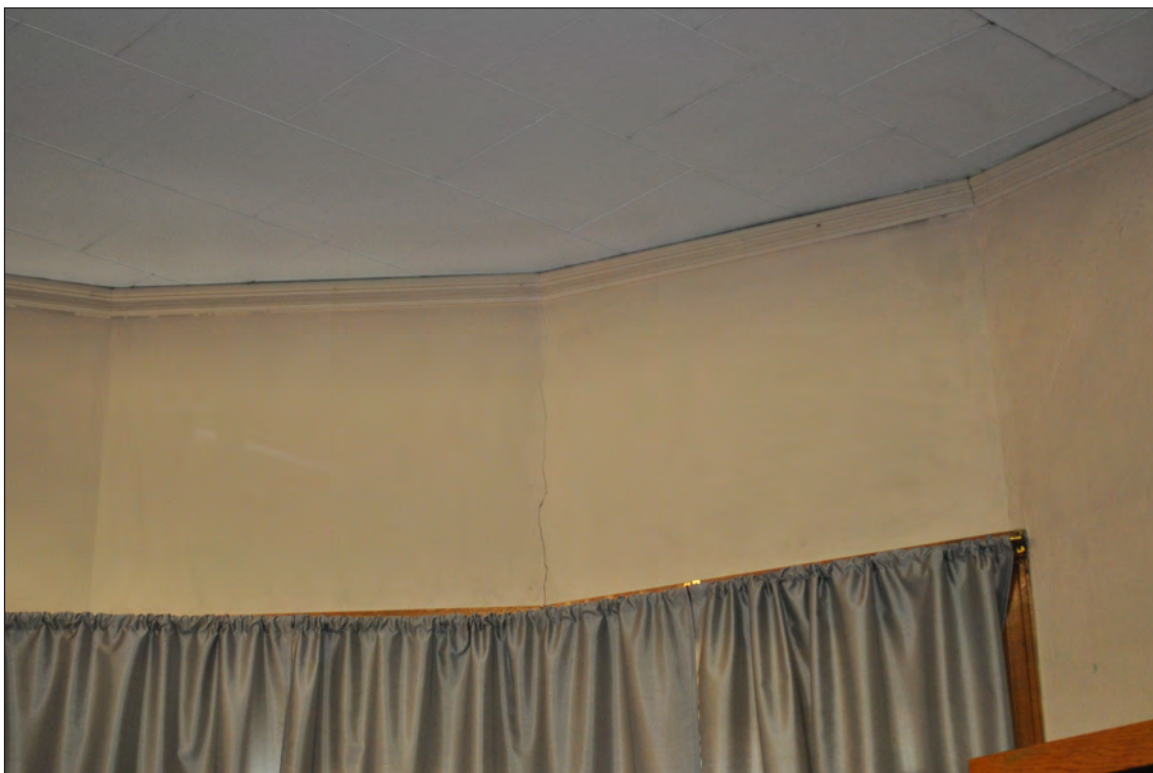
95. First-floor, computer room (201), camera facing up and southwest.

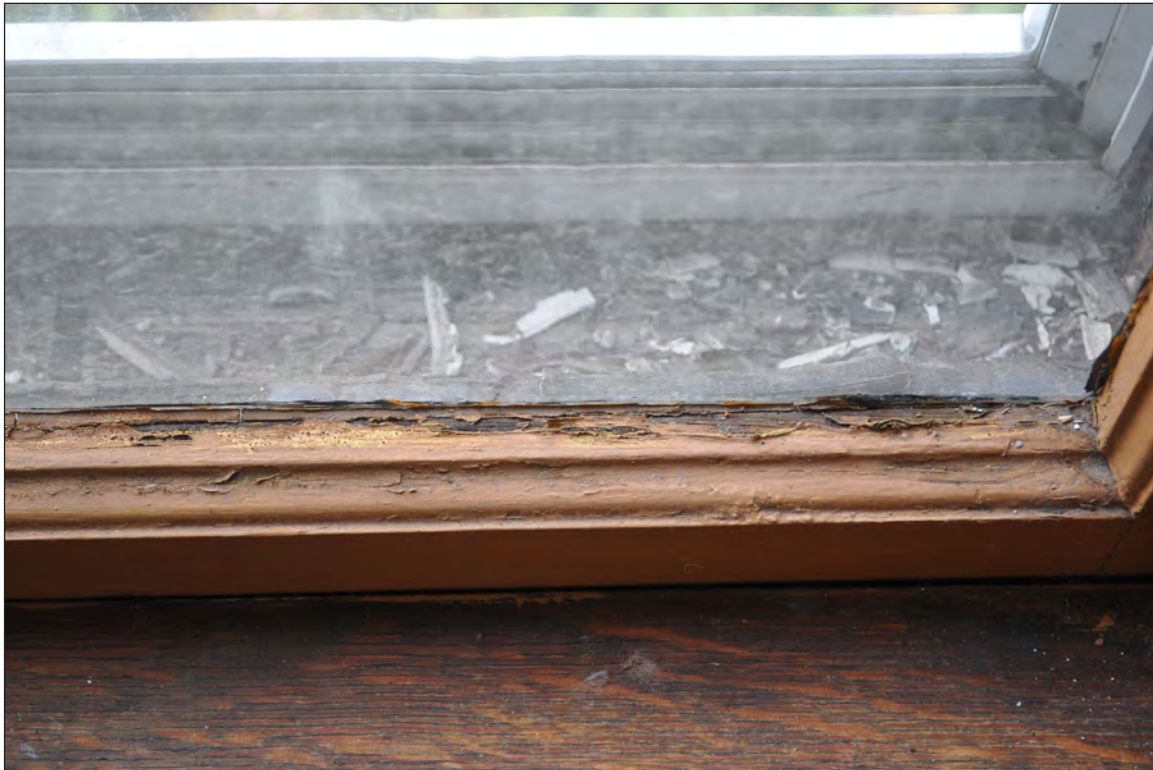
96. First-floor, computer room (201), camera facing south.

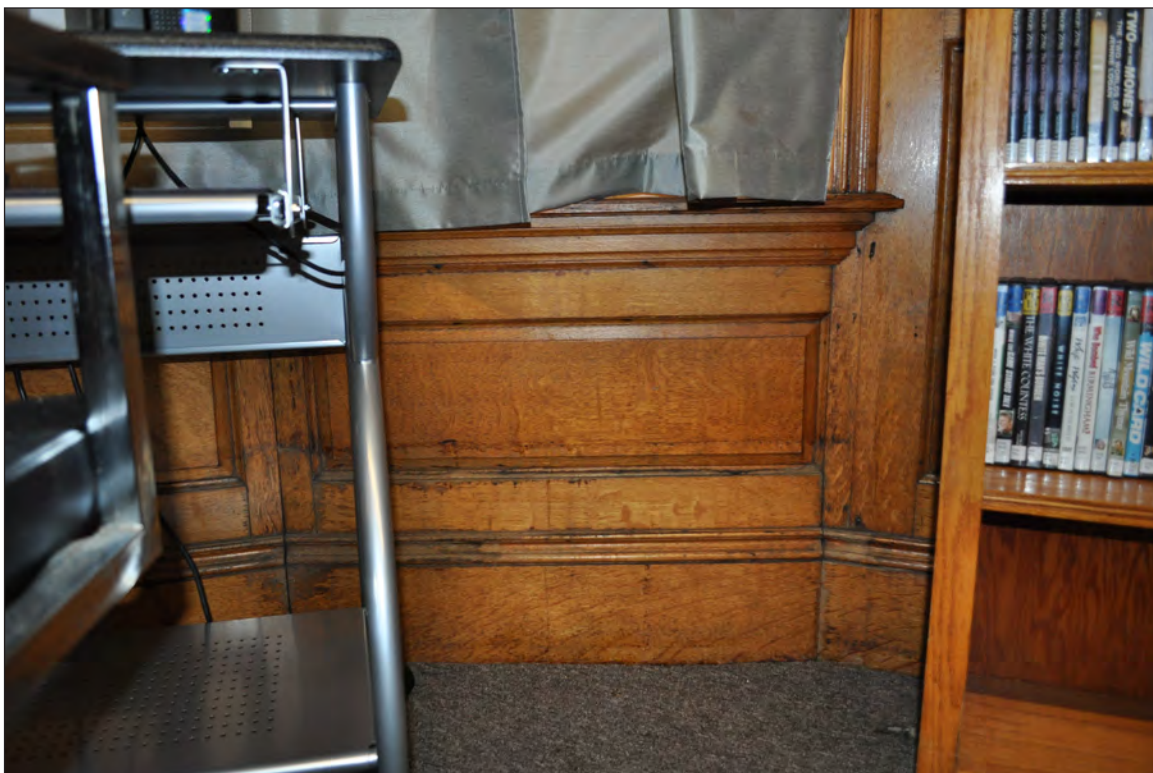
97. First-floor, computer room (201), example condition of bottom rail of window, camera facing south.

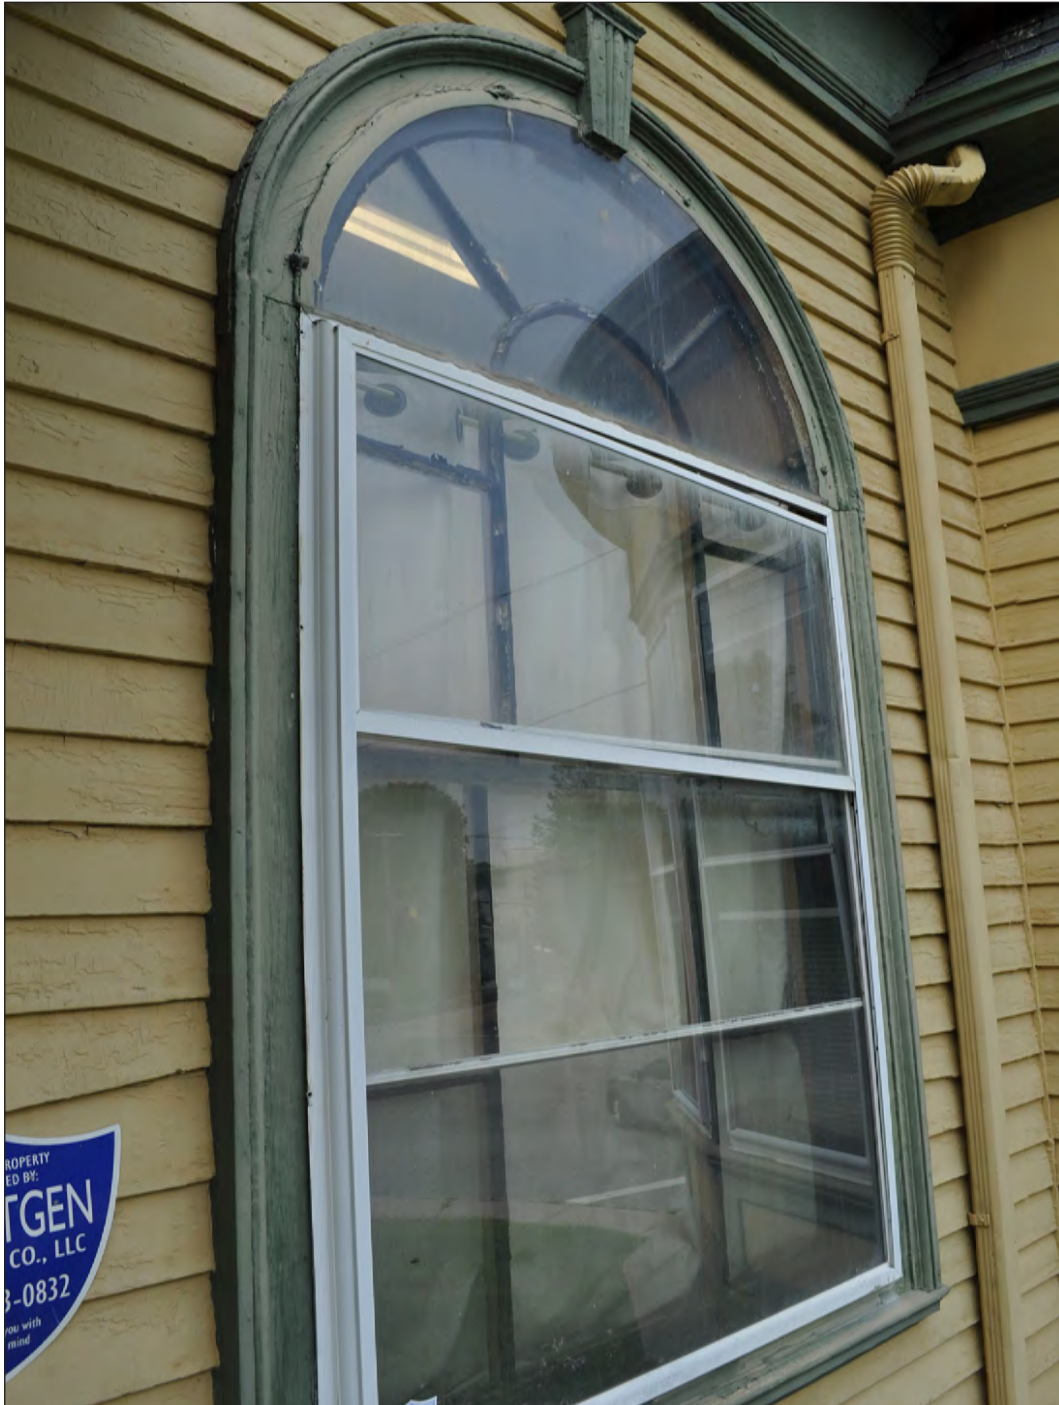
8. South elevation, close-up of window with exterior storm.

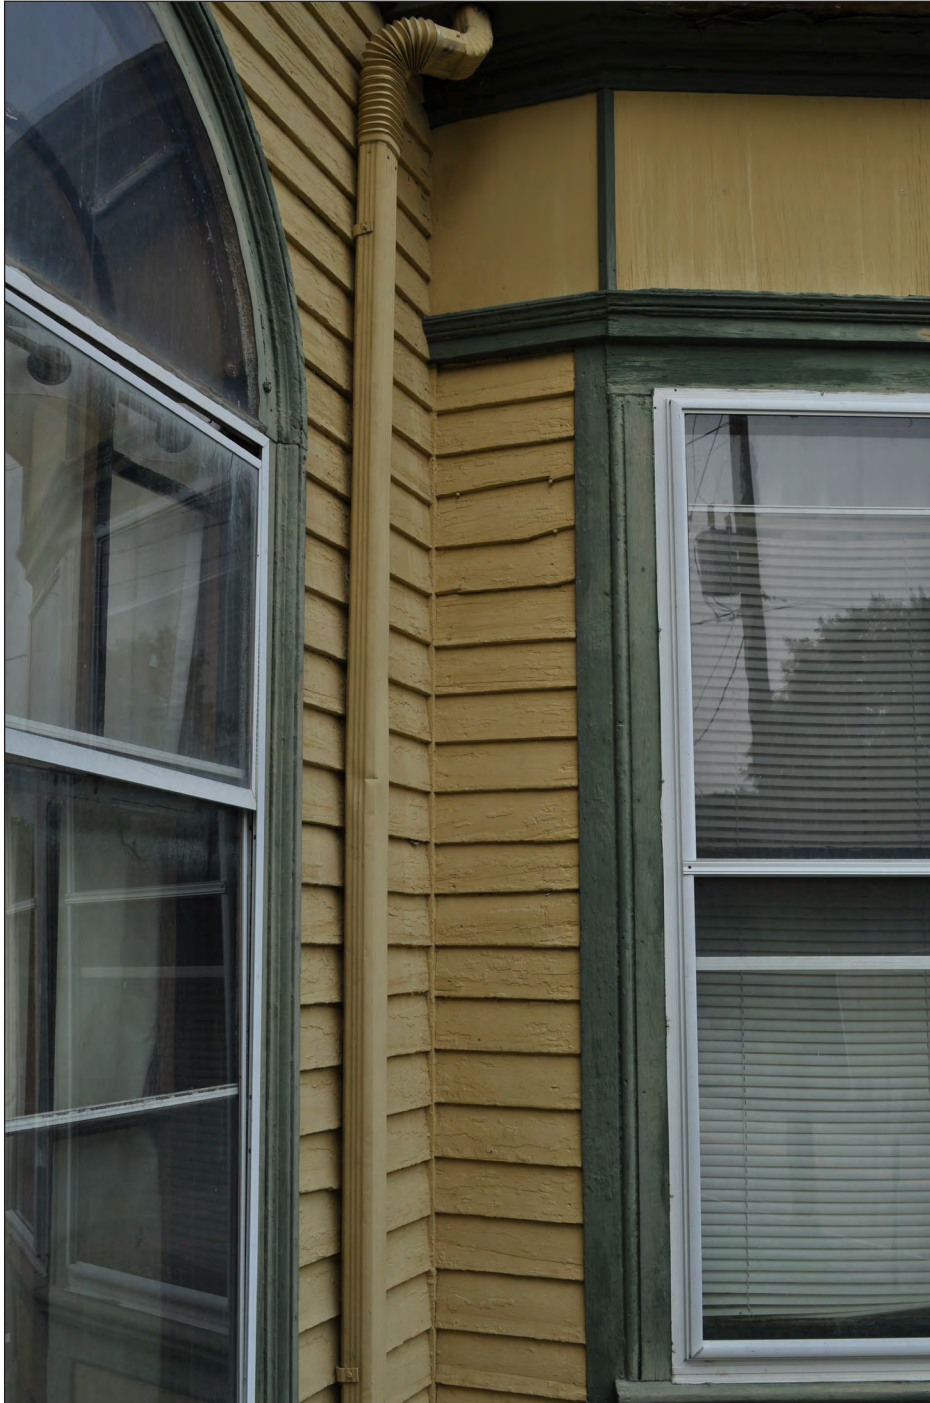
11. South elevation, west elevation of tower, camera facing northeast.

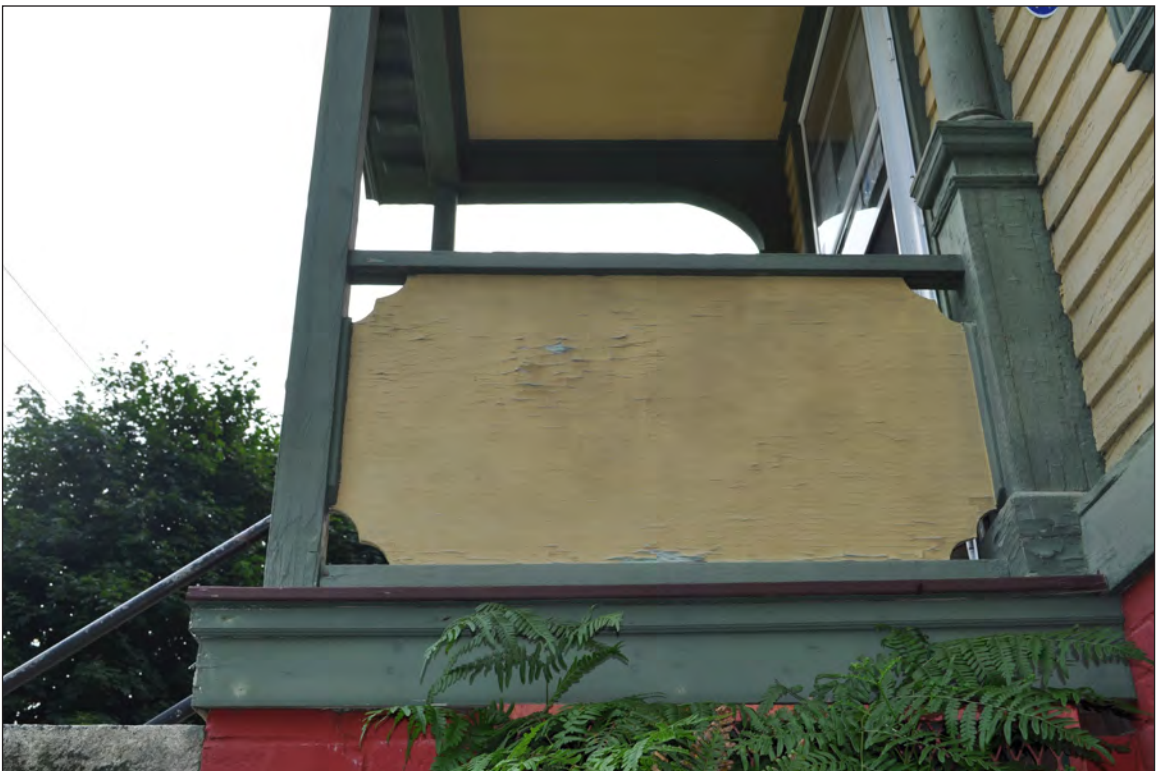
18. South elevation, east elevation of porch guardrail and railing, camera facing west.

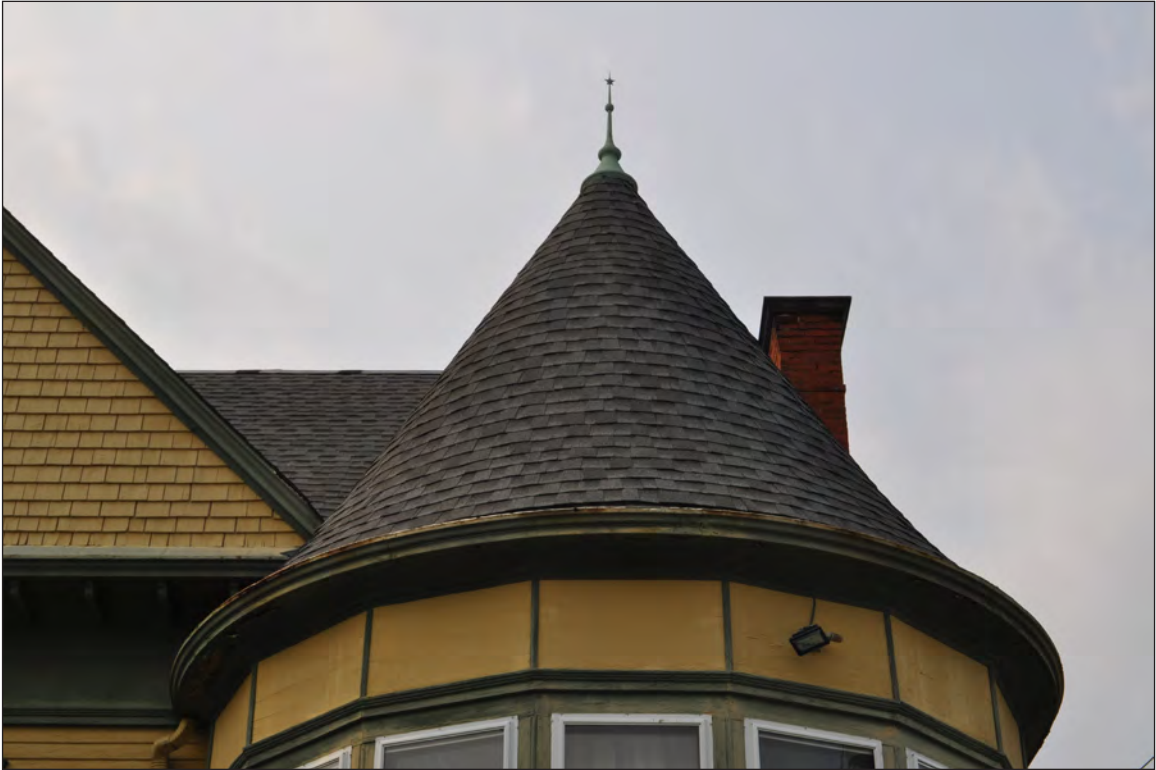
19. South elevation, tower roof and integrated gutter camera facing north.

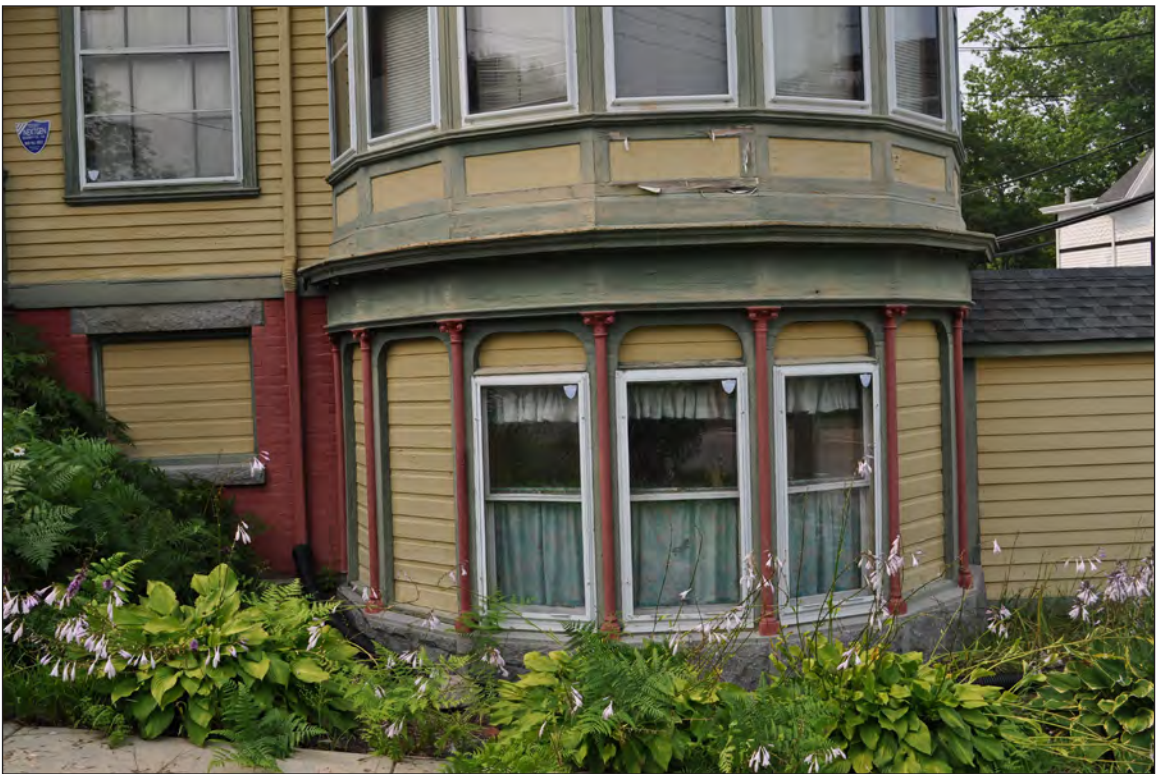
20. South elevation, tower, camera facing north. Note deteriorated of bulkheads below first-floor windows.

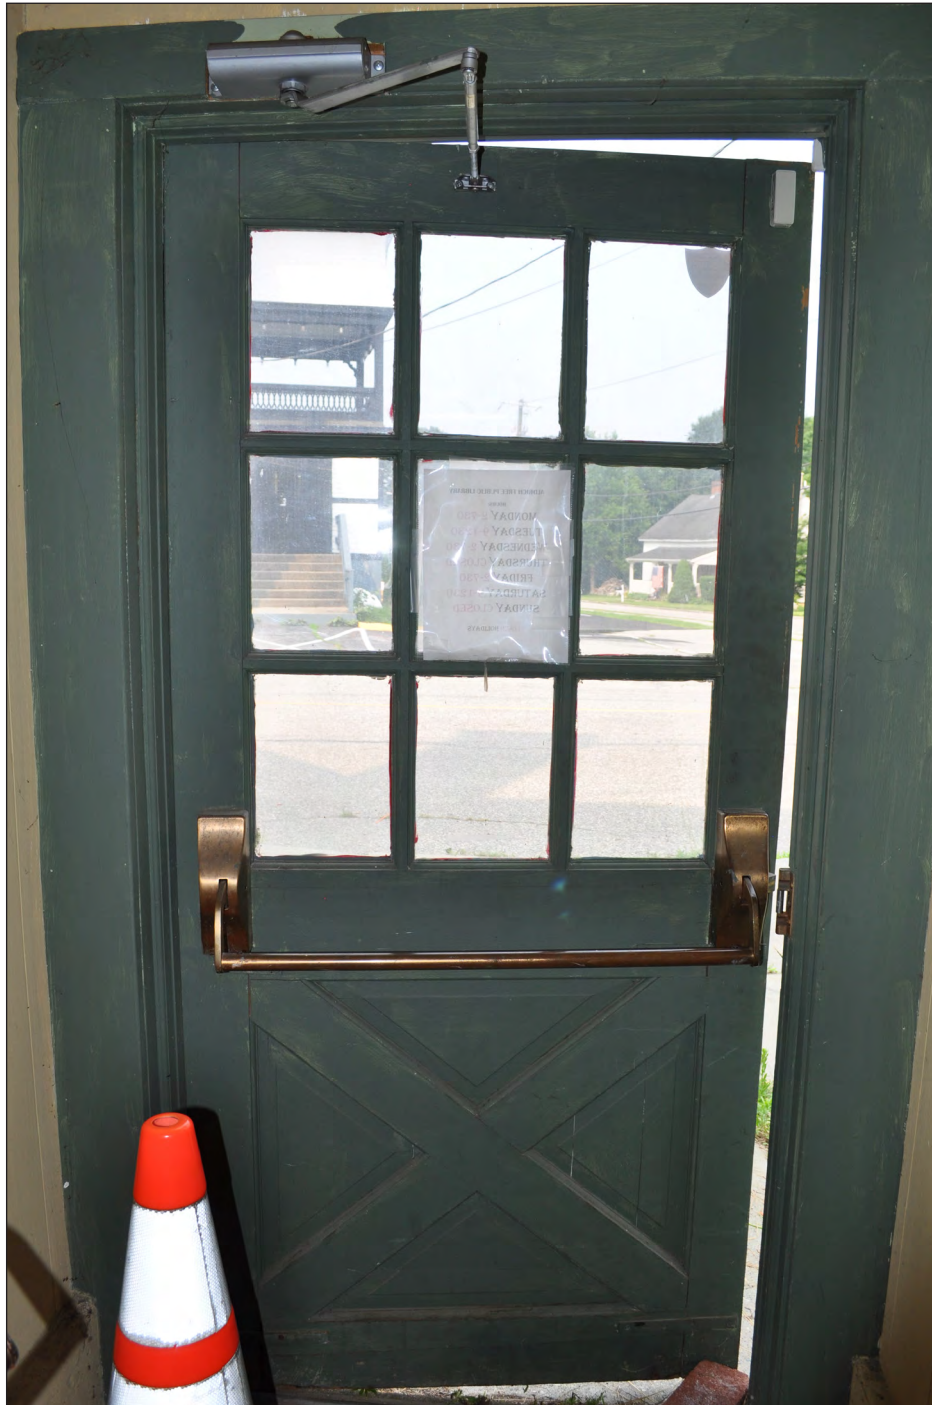
29. East elevation, interior of exterior vestibule, camera facing east.

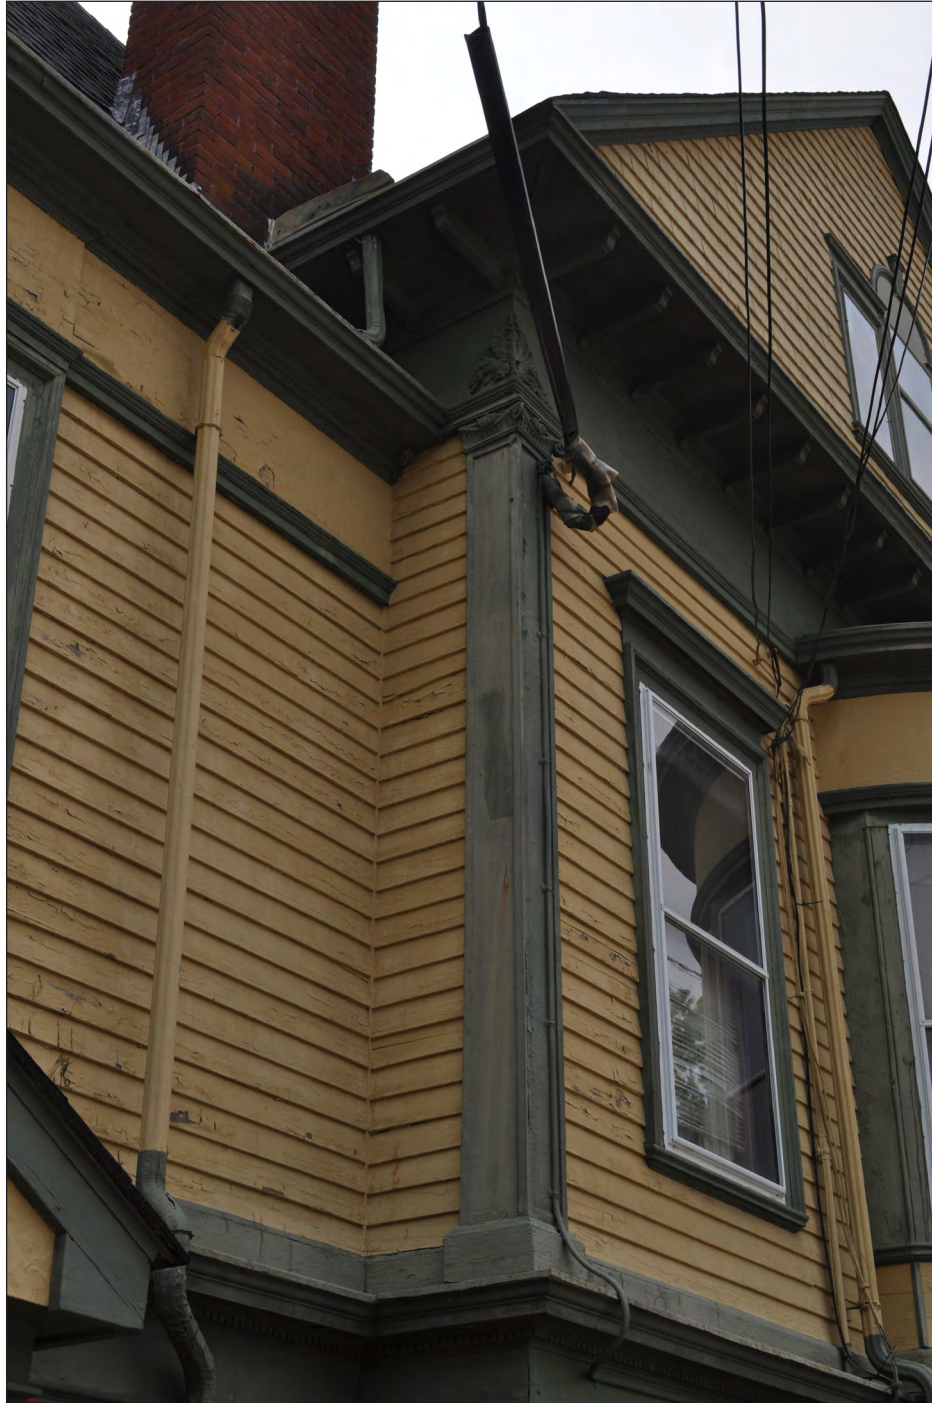
36. East elevation, camera facing northwest. Note condition of clapboards and corner pilasters.

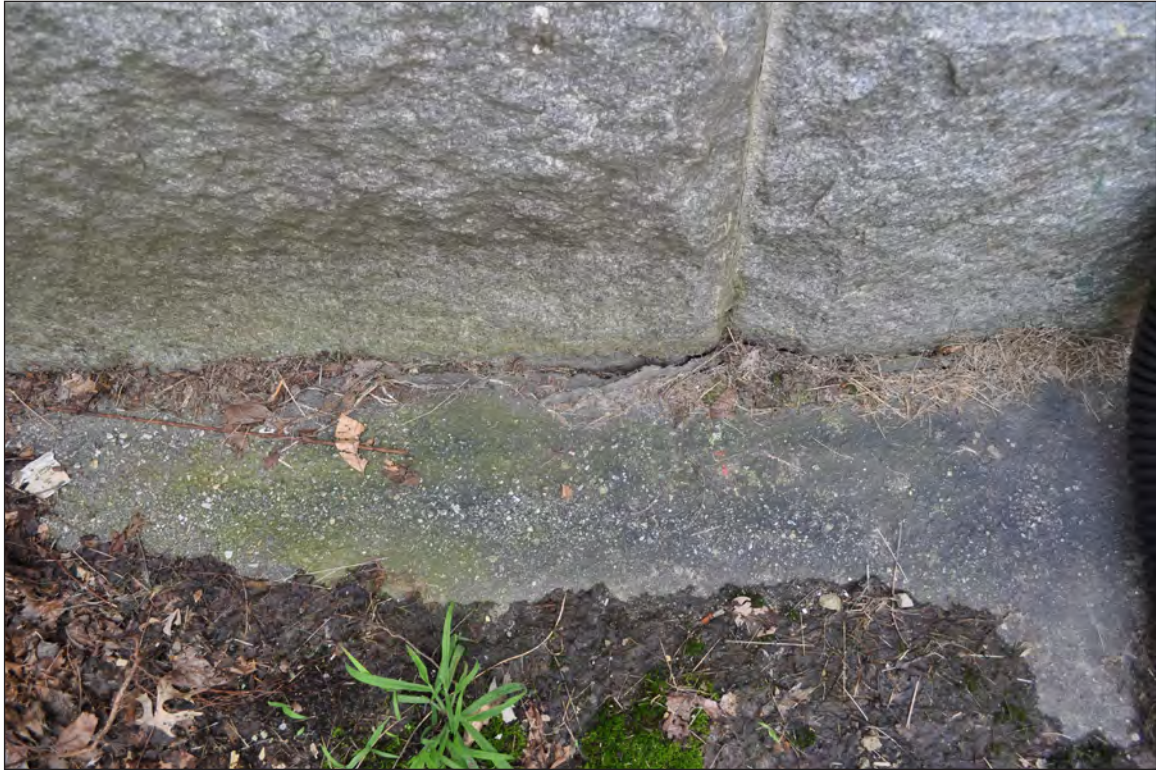
41. East elevation, grade at foundation, camera facing west.

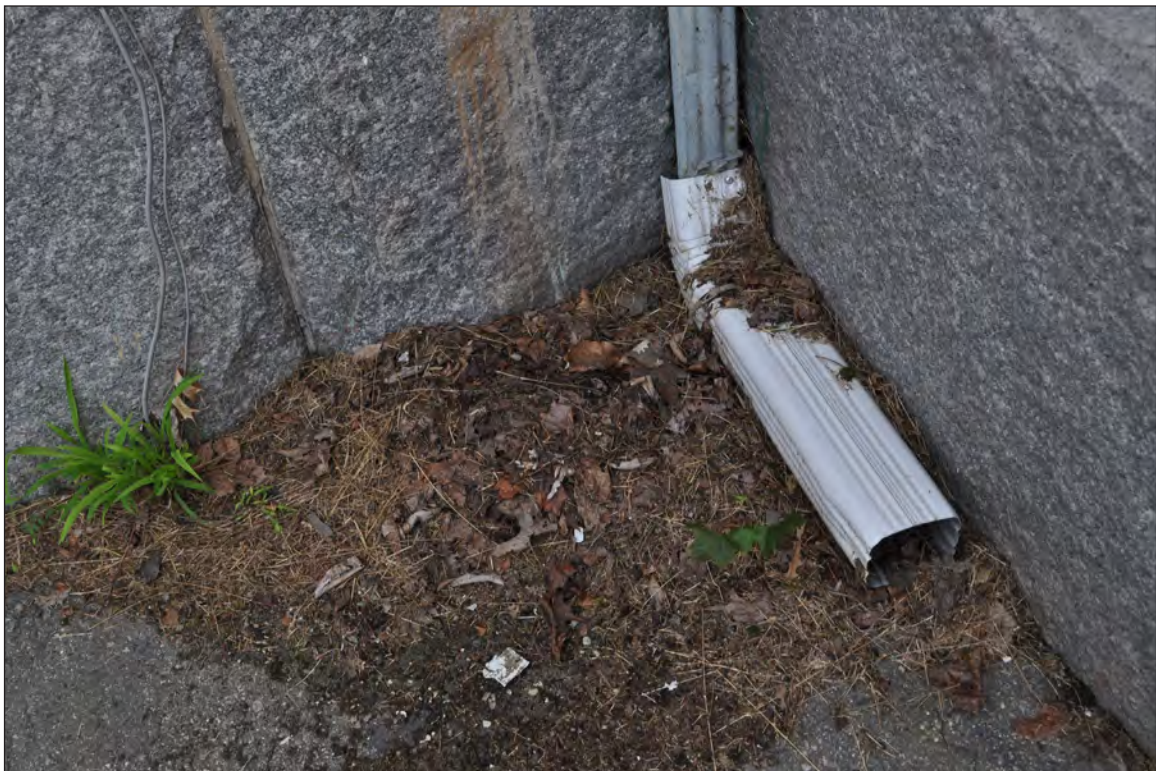
42. East elevation, grade at foundation, camera facing northwest.

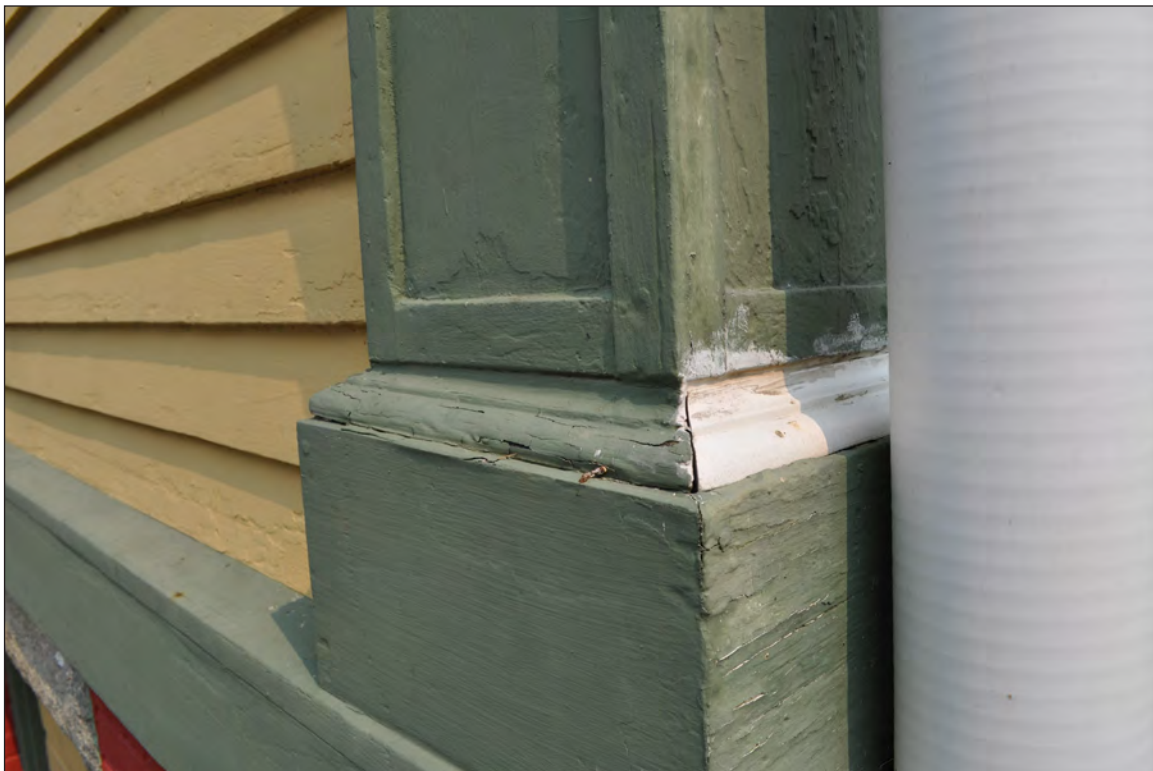
58. Northwest building corner, replacement trim, camera facing southeast.

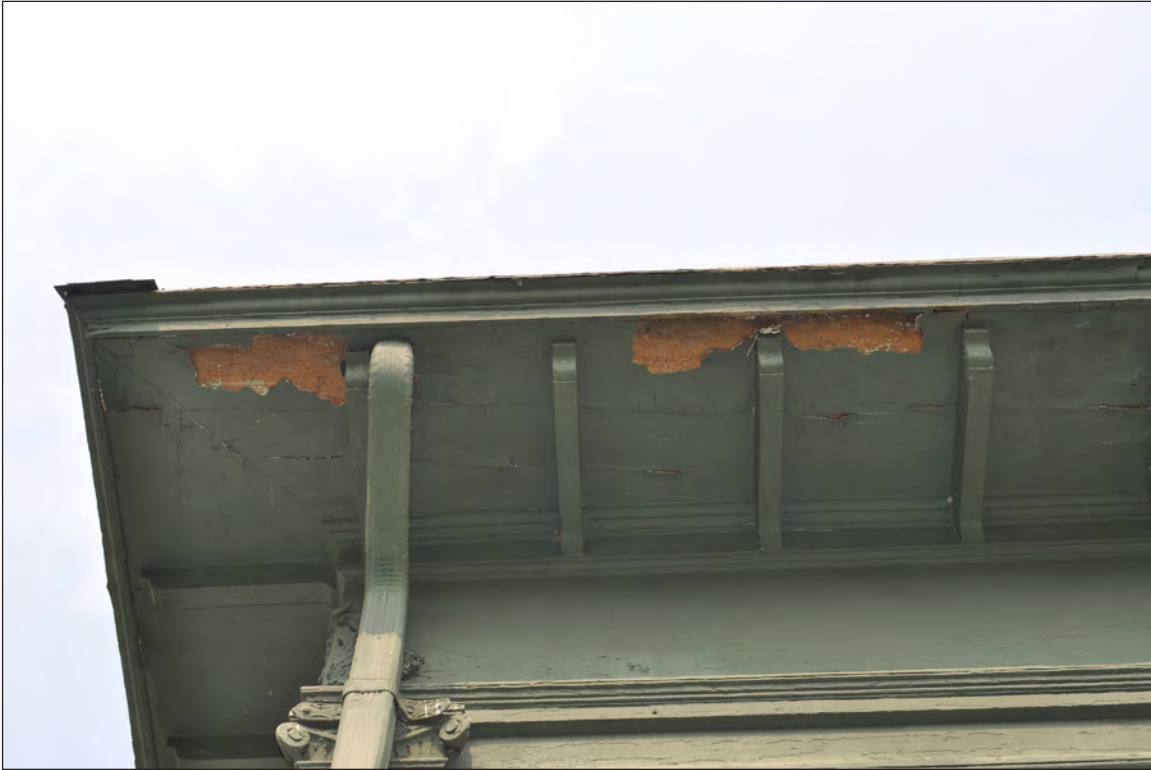
59. West elevation, underside of soffit below integrated gutter, camera facing up and southeast.

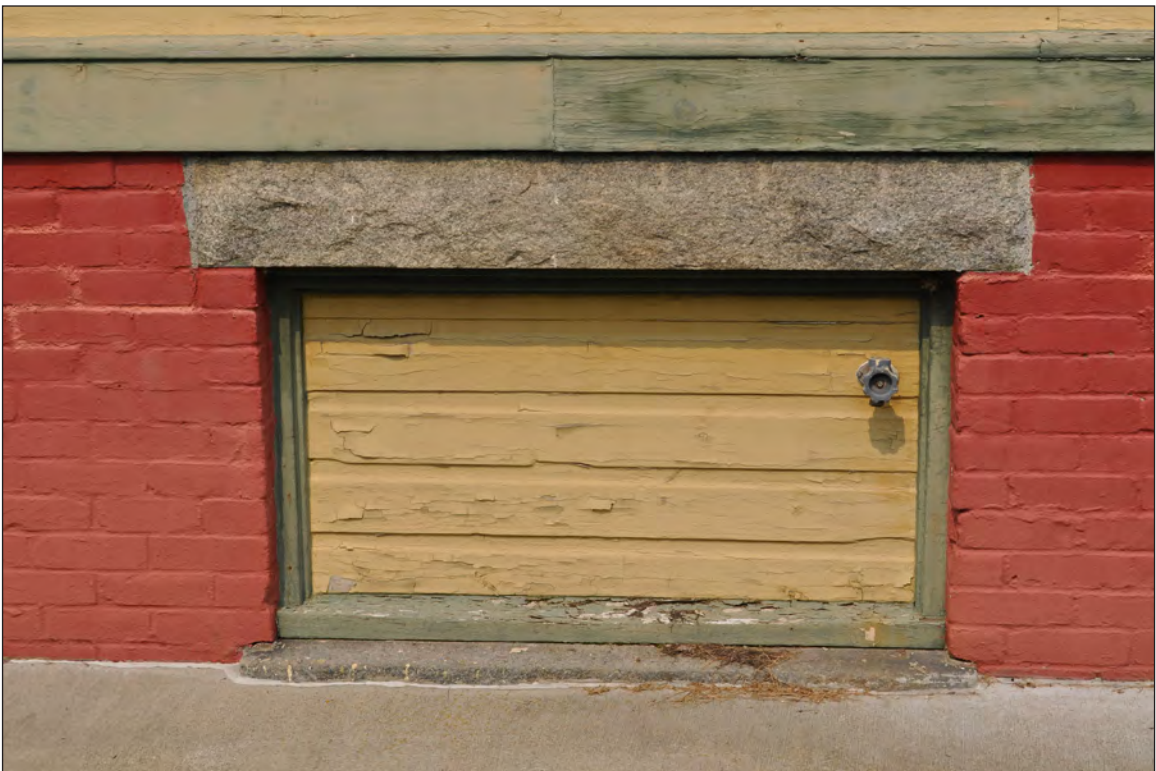
64. West elevation, infilled window, camera facing down and east.

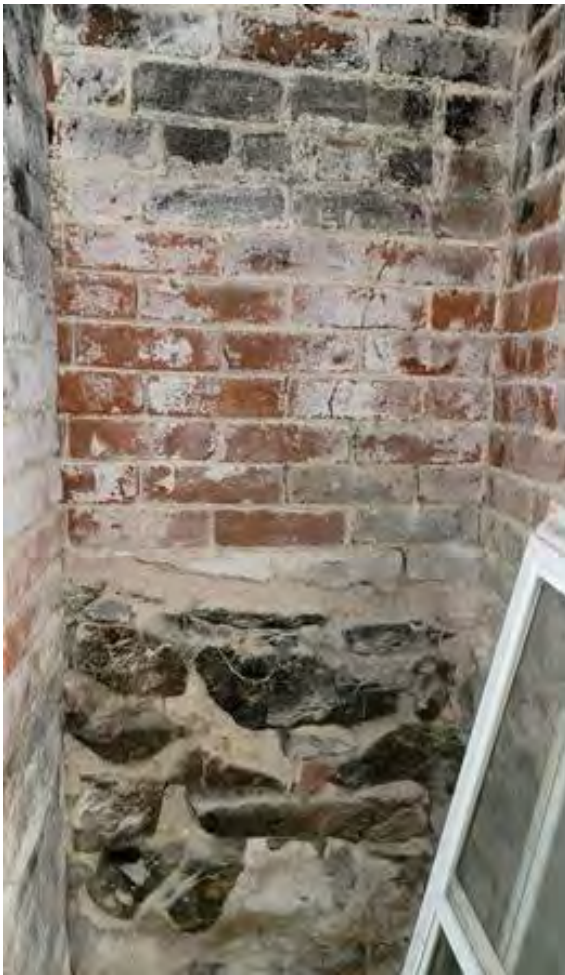
3. Interior face of north foundation wall with hairline crack in brick wall.

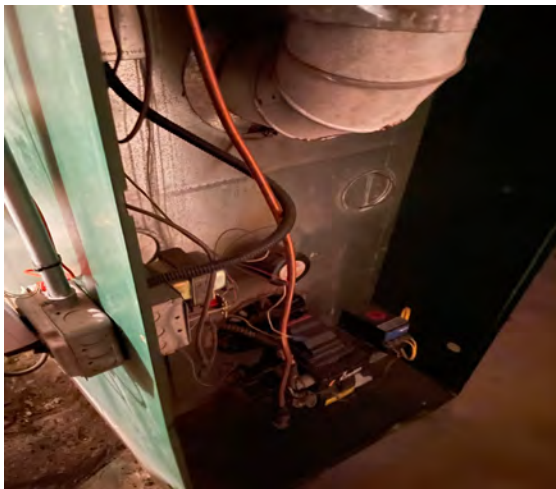
Figure 1 - Air Furnace

The first floor and basement is served by a ducted split system using an oil fired forced air furnace. The furnace is manufactured by Metzger Machine Corp and has a rating of 140,000 BTU/hr input, or 1.0 gallon per hour #2 heating oil. The furnace was manufactured in 1996 and is in fair to poor condition. The furnace is beyond its useful life and should be replaced in the next five years.

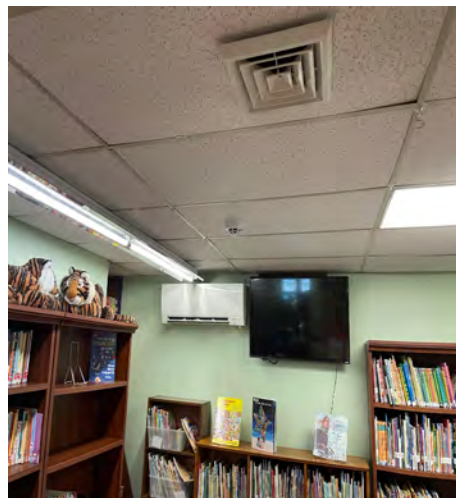
Figure 2 - Basement Mini Split

The furnace has a DX refrigerant coil rated at 4 tons, or about 1,600 CFM. The refrigerant lines are copper and in fair condition and could be cleaned, re-insulated and used in conjunction with new equipment. The air conditioning condensing unit is of "York" manufacturer and in fair condition. It is assumed this unit was also installed around 1996 and is recommended to be replaced as well as the DX coil. The basement has a dedicated mini split heat pump unit recently installed for additional zoning and comfort.

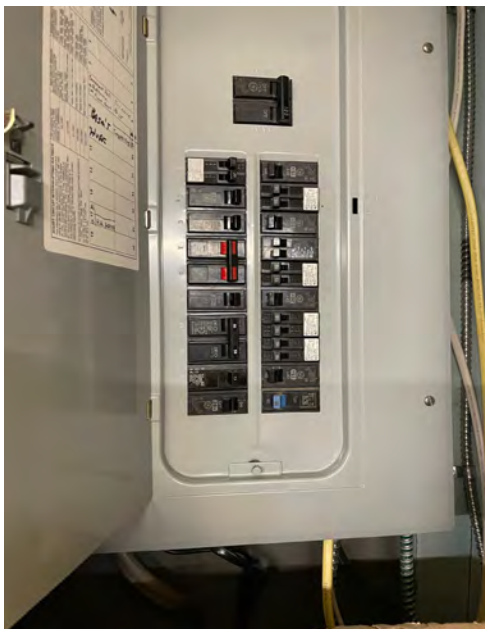
Figure 3 - Electrical Panel

The building has a 100 Amp, single phase 120/240 volt service. The 20-circuit breaker panel appears to be about 15-20 years old and in good condition. All wiring observed is NM type (Romex) and in good condition. Additional receptacles may be required to limit the use of extension cords.

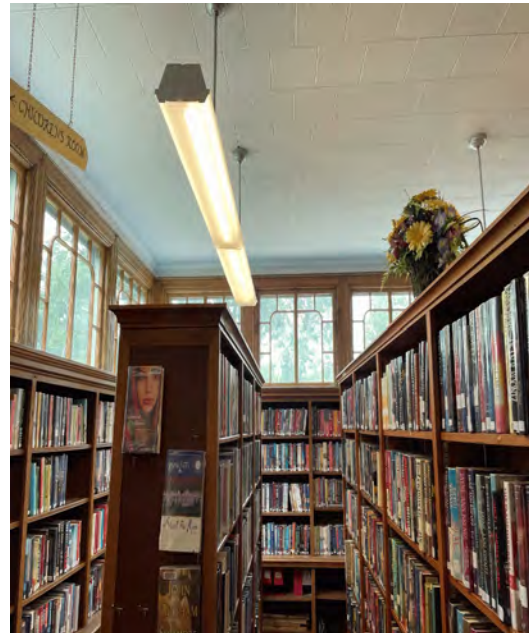
Figure 4 - Pendant Light Fixture

The lighting is primary florescent lamp pendant type on the first floor and recessed 2x4 in the basement. Lighting levels appear inadequate for recommended library lighting levels. There is a high level of ambient light and many windows. We recommend a complete fixture replacement using more energy efficient LED lamped fixtures. Emergency lighting is achieved by using battery wall pack fixtures. These fixtures are antiquated and recommended to be replaced.
